Kingswood Park: Our park at the heart of our community

# KINGSWOOD PARK ACCESS PLAN

# KINGSWOOD PARK ACCESS AUDIT

October 2019 (Updated April 2021)

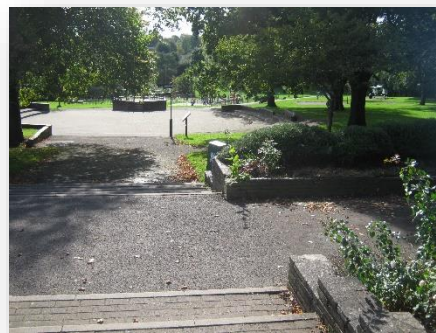
- The topography of the park is varied and challenging in some areas. The northern formal garden section is relatively level however the topography falls steeply to the central and southern areas of the park and many paths in these areas have challenging gradients for wheelchair users and people with mobility difficulties

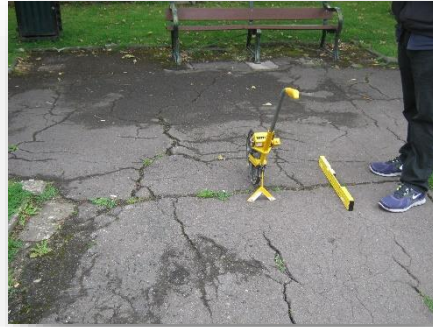
- A large number of paths are in poor condition, with cracks, bumps and surface breaks due to tree root heave, weathering, and wear and tear. There are also crossfalls on many paths which are greater than the 1:50 maximum standard. The poor state of the paths and crossfalls restrict access for some people.

- Most path surfaces are in poor condition with surface breaks and uneven surfaces caused by tree root heave, wear and weathering. There are also crossfalls on most paths which are greater than 1:50

### **Recommendation 1: Improve existing path surfaces, crossfalls and widths**

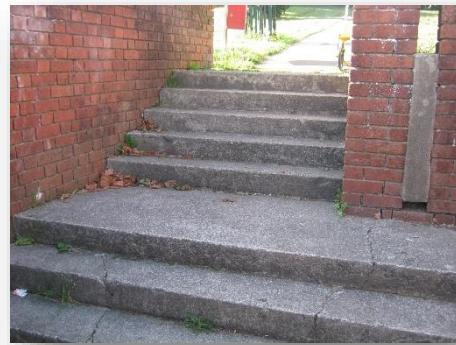
- There are flights of steps at six locations within the park which act as a barrier for some people. The only route avoiding steps from the northern formal gardens to the central area (amphitheatre / bandstand / play area) involves negotiating path 12 which has gradients up to 1:9. Steps also restrict access to the park for some people from Hollow Road along paths 25 and 15, and also from Orchard Road (path 22).

- The steps were identified as a major barrier to access and there was agreement that where it was not possible to remove them, they should be re-built to BS8300 standards with handrails in place
- The option to remove the steps on path 9 and replace them with ramped access was discussed and it was agreed that this was a good option and should be linked via a new path to the proposed new disabled parking area at the brick maintenance building

### **Recommendation 3: Improve the accessibility of step flights**

Path 9 – remove steps where they link with path 10. Replace steps with a ramped access with landings to BS8300 standards to join with path 10 and the new path to the disabled parking area proposed in recommendation 2.

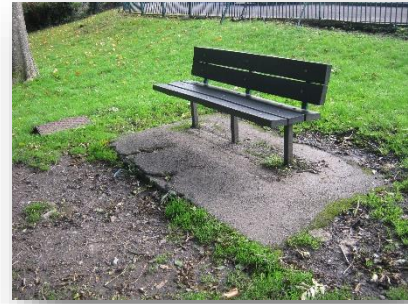
- There are 26 seats / benches in the park. These are mostly on tarmac or concrete plinths, and many are recessed back from the path. The surfaces around the seats are often breaking up and contain multiple steps and surface breaks. Some seats have room for a wheelchair adjacent on a hard surface, but others do not. There are empty seat plinths where seats have been removed in the past and not replaced. Three seats are located on grass areas with no hard surfacing access. There are two seat / picnic sculptures which are located on grass with no hard surface access. There are also two seats in the play area which have no hard surface access and are inaccessible for some people with disabilities. There are no seats along path 22 from the Orchard Road entrance or path 19 from Hollow Road entrance D. Nine seats / benches do not have arms which makes it difficult for some people to lever themselves upwards when standing, this includes the three benches in the Community Garden (path 16). The height and position of seating needs to be considered to ensure full accessibility.

There are 26 seats / benches in the park and many are positioned on plinths with broken and degraded surfaces and some are on grass. There are areas of the park where there are few, or no resting points.

### **Recommendation 4: Provide more accessible seating & resting points**

As per recommendation 1, all existing seat plinth areas should be resurfaced so that there are no surface breaks or steps.

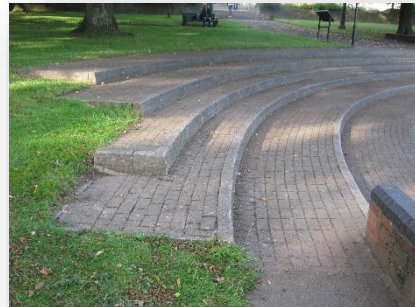
- Access to the amphitheatre / bandstand area is challenging for people with mobility difficulties due to numerous step flights, steep gradients, narrow path widths and poor surfaces on the surrounding path network. The accessibility of the amphitheatre and bandstand features is also poor due to steps, gradients, crossfalls and surface breaks.

The accessibility of the amphitheatre and bandstand area is poor. The height of amphitheatre seat steps and landings is not uniform, there are surface breaks, loose blocks forming steps, gradients and crossfalls, and steps on concrete access paths. Access to the bandstand is via six steps which is a barrier to disabled performers.

### **Recommendation 6: Enhance the accessibility of the amphitheatre / bandstand area**
