SOUTH GLOUCESTERSHIRE COUNCIL - REGISTER OF BUILDINGS AT RISK (UPDATED MAY 2024)

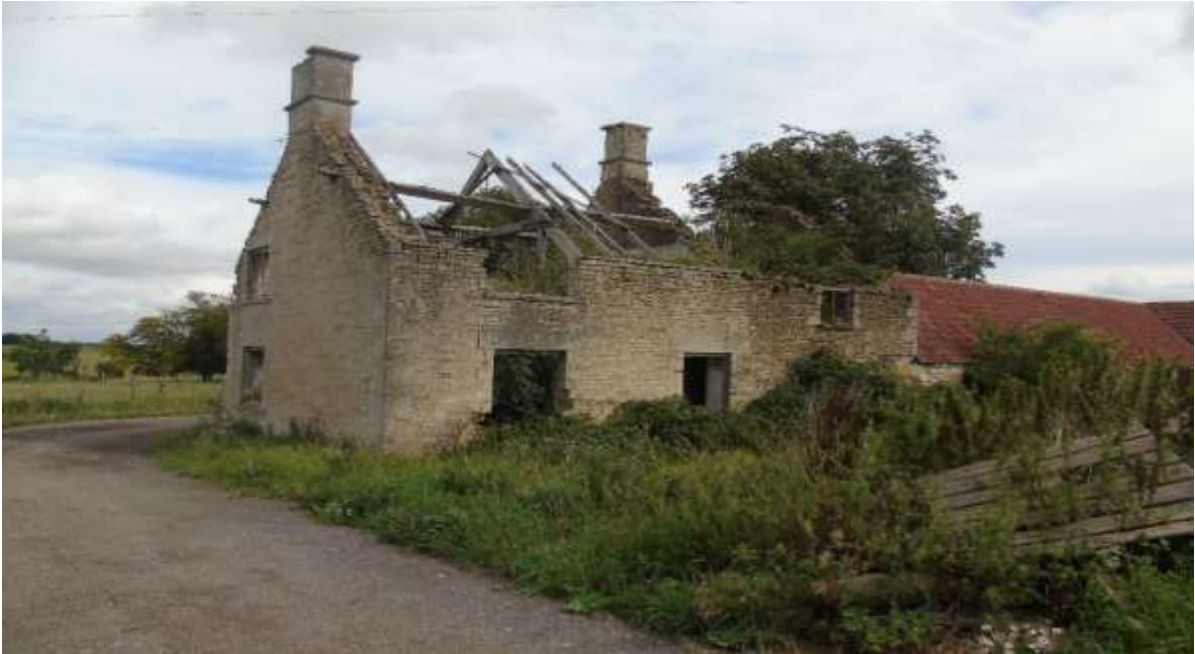
This building was previously on the 2010 BAR register. While the byre has been reroofed, the farm cottage remains a in ruinous state with invasive planting now established, delaminating and cracking masonry especially to the wall tops due to washing out of joints. Roof and first floor collapsed and sections of walling now failing and significant collapse to stone gables to be expected. Agricultural buildings in poor condition with deteriorating roof covering and gradual decay of masonry. No guttering. Mix of stone tiles, asbestos and polycarbonate sheet roofing, all in deteriorating condition.

Overall Condition: Very Bad

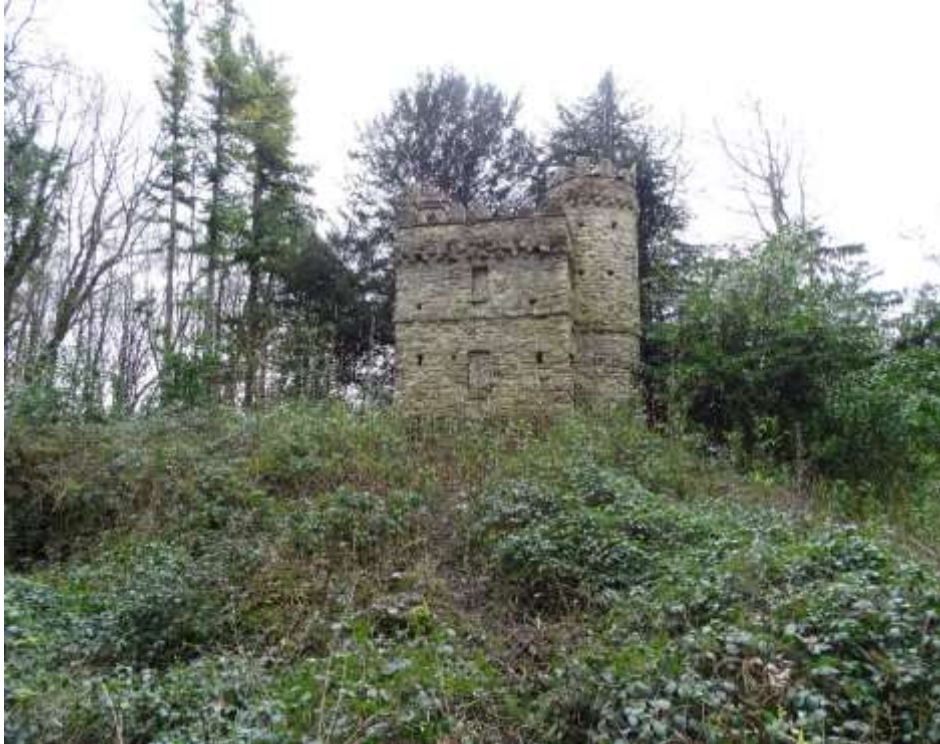
Condition: Clear evidence of consolidation works and structurally looks sound externally. Internally though floors and roof still missing and embedded timbers now heavily decayed (lintels over openings) and compaction will lead to structural issues. Internal plasters also still being lost as exposed to elements.

Overall Condition: Poor

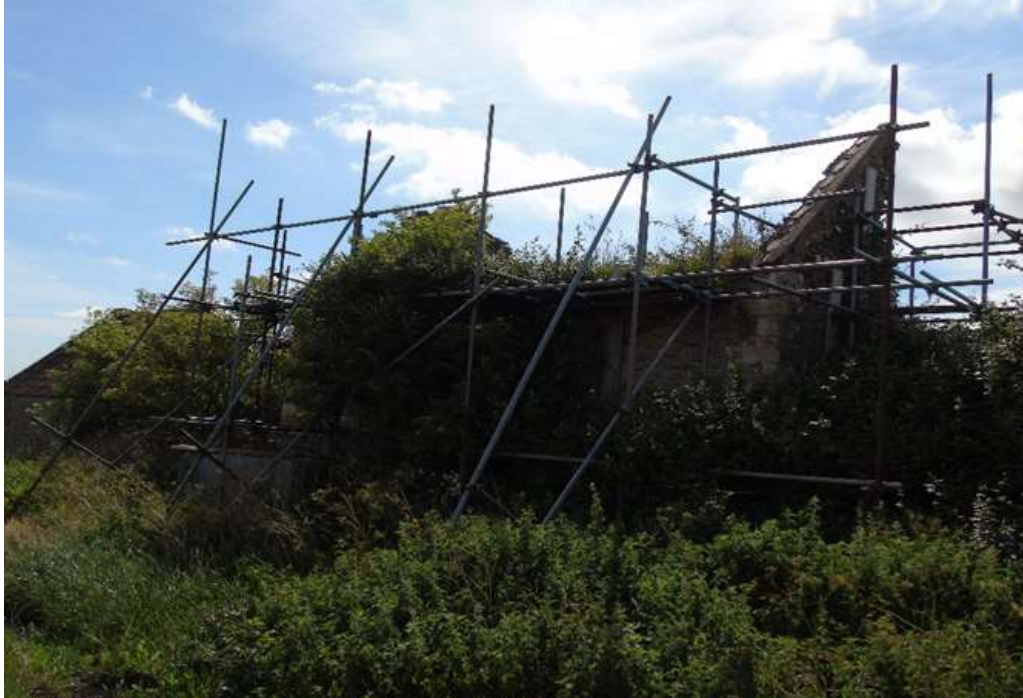
Condition: Lack of maintenance has led to collapse of roof between 2 barns, substantial collapse of walls and serious dilapidation. Roof unsafe and liable to collapse in remain parts. Vegetation growth in wall tops. Walls to enclosed yard parlous. Scaffolding in place to limit further collapse although gable end walls now look very fragile and would have certainly collapsed if not supported. Is now largely ruinous and in need of intervention.

Overall Condition: Very Bad

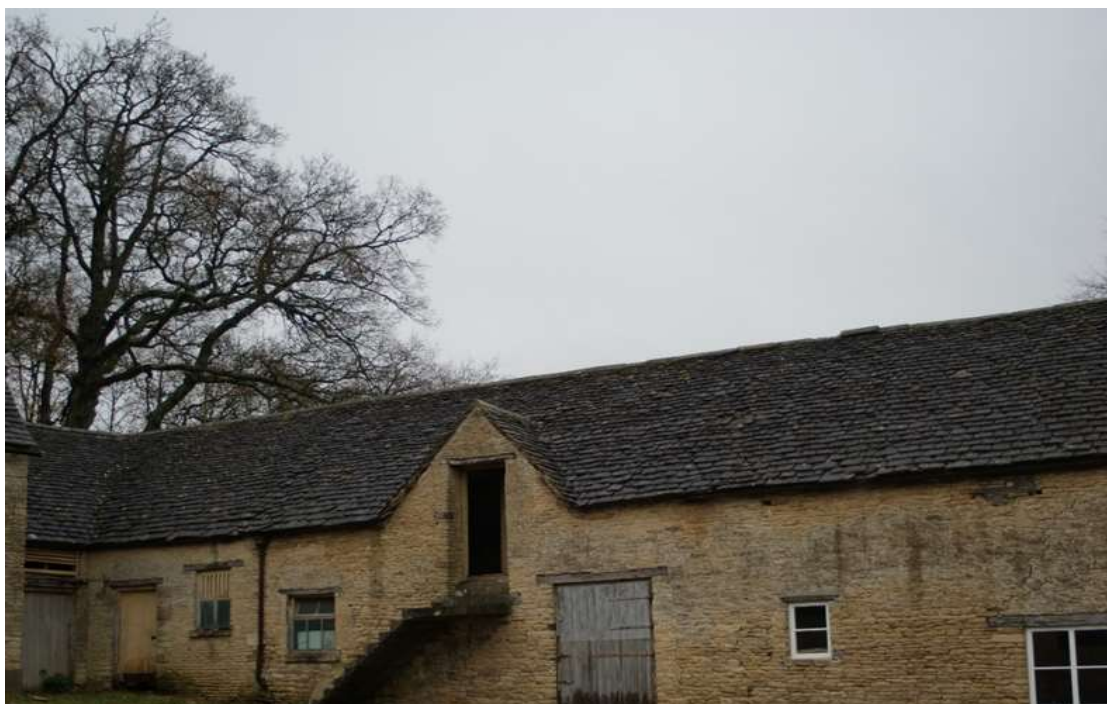
Condition: This relates to the east wing only, as the north and west wing are in better condition. Overall, general lack of maintenance with some sagging eaves and notable cracking in elevations. Stone tile roof in need of some repair also. Some notable reconstruction/ repairs but overall does appear to be need of refurbishment.

Overall Condition: Poor

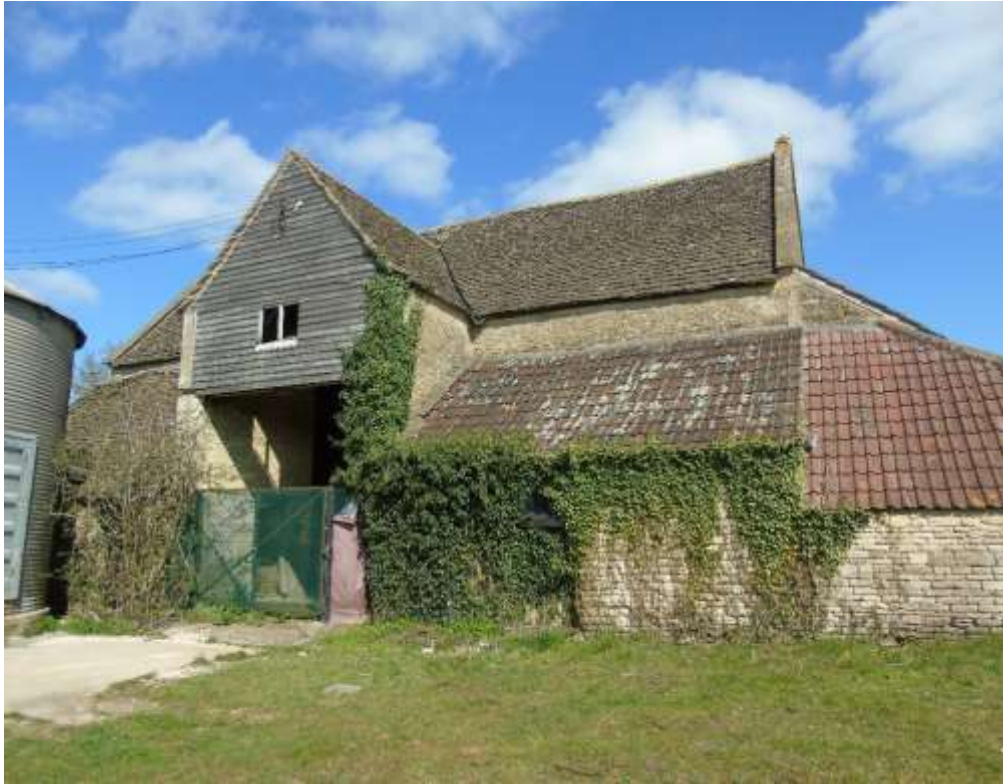
Condition: Gutters absent to every roof with no subsequent proper disposal of rainwater which is impacting on the condition of the fabric of the building. Threshing elevation has metal gate and there are visible cracks in the stone elevations. There are also slipped tiles and undulated slates in areas suggesting decayed structure. Water saturation of some walls evident. Timber lintel to east entry heavily decayed. Holes in roof and semi-collapsed in areas (north facing).

Overall Condition: Poor

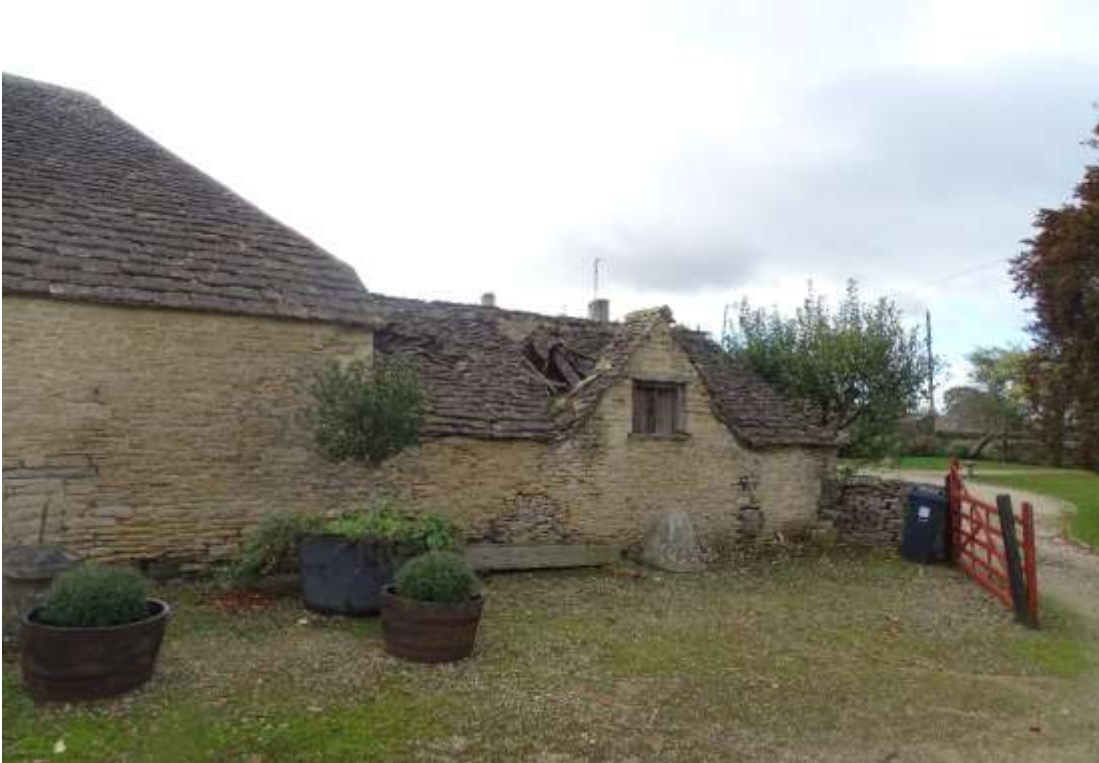
Condition: Area of roof collapse both partial and total. Rainwater goods missing causing issues to walls tops (likely roof plate issues as well) with spalling to stone. Lintels to windows rotting and sagging

Overall Condition: Very Bad

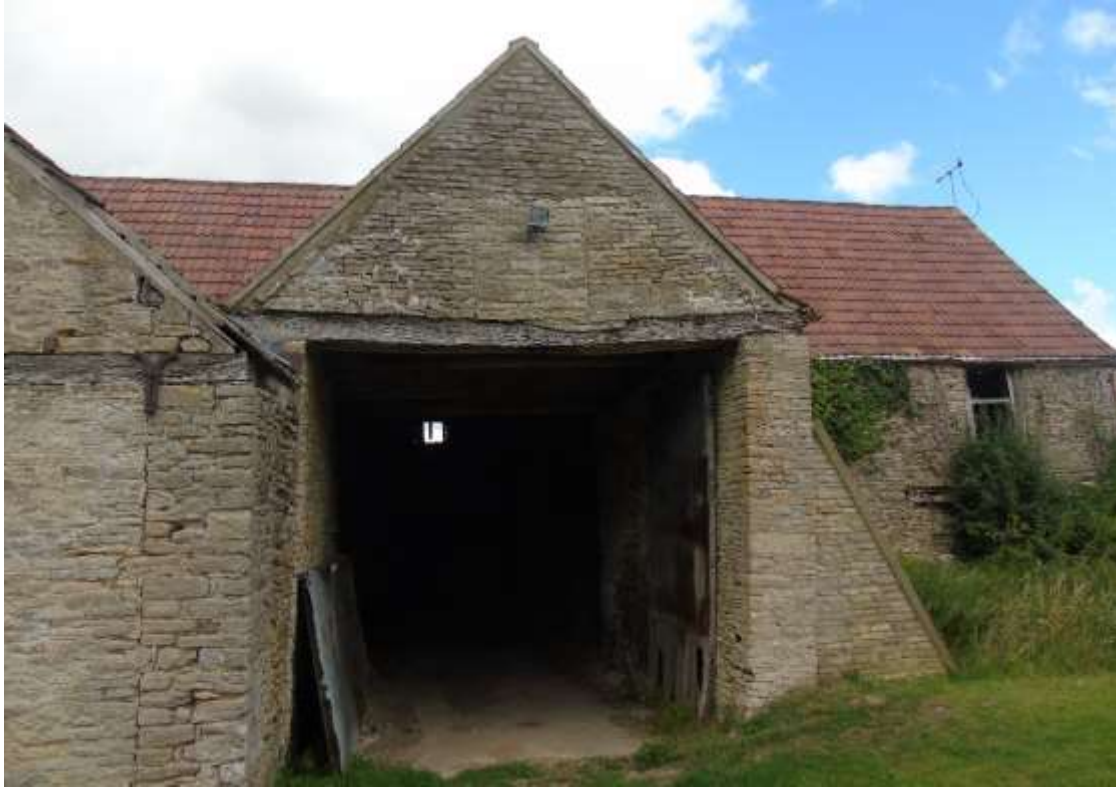
Condition: Generally poor as lack of use has clearly led to lack of maintenance. The immediate risk is failure of sagging lintels and all embedded timbers which will cause localised collapse. Settlement of buttress also an issue. Lack of rainwater goods has also impacted on joints at wall tops.

Overall Condition: Poor

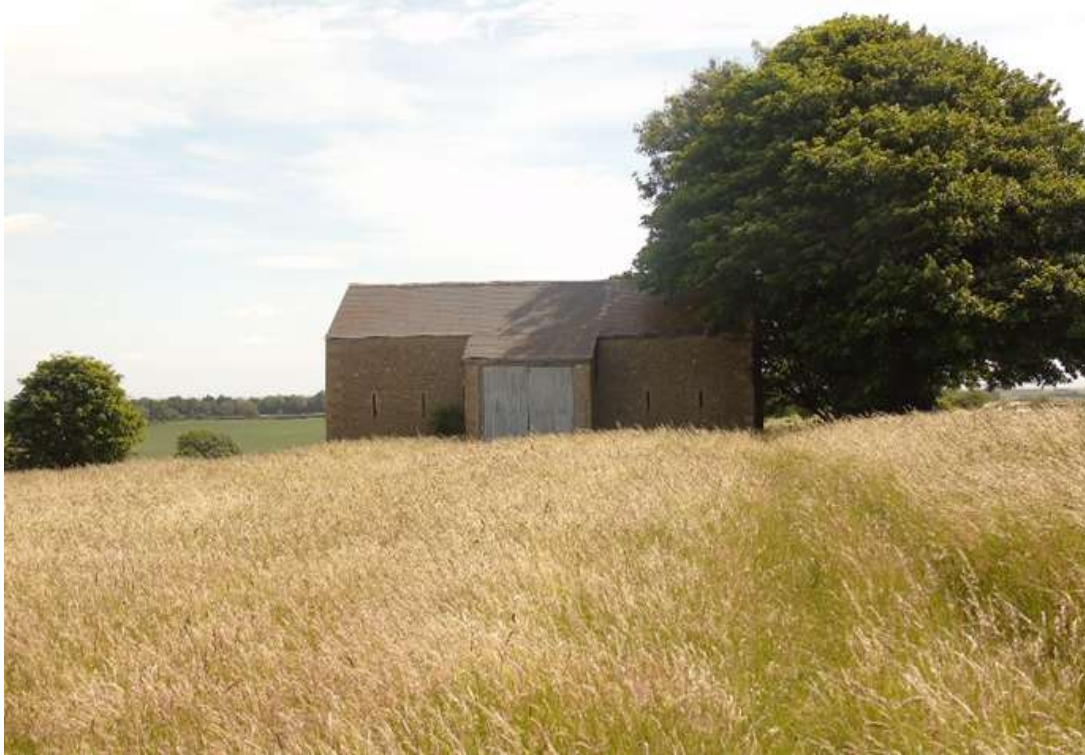
Condition: Given its isolated location, main barn in reasonable condition. The structures to the rear are collapsing and being restraining by propping. Rainwater goods largely though lost which would be accelerating weathering to wall tops.

Overall Condition: Fair

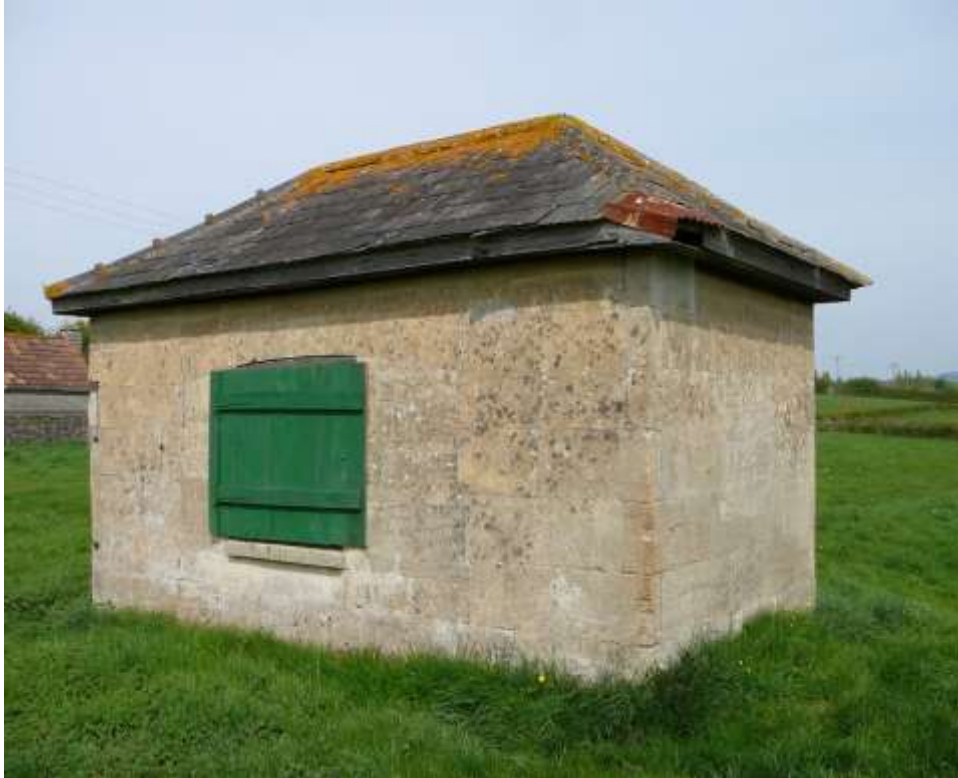
Condition: Unoccupied and neglected. Evidence of rot and decay of timber structure and possible structural movement. Gutters are all missing but there is a reasonable throw from the overhanging eaves. Signs of the ashlar moving, associated with the rusting and expansion of the iron cramps. Ridge is a mix of concrete, stone, tile and clay – the stone is cracked in places. The window opening has a modern shutter over and the door is decaying at base – retains original pintle hinges. Cementitious repairs are now cracking.

Overall Condition – Poor

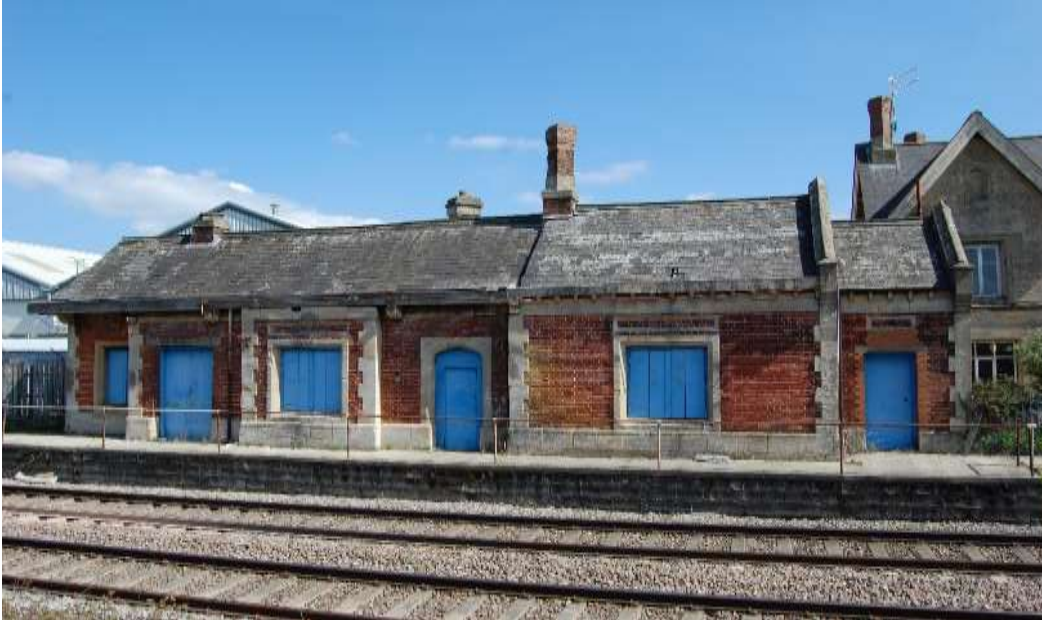
Condition: Derelict although partially used by local garage for storage. Slates slipping along length of roof and flashing missing or beginning to slip. One area has rafter exposed. Ridge tiles may be loose, with open joints or missing mortar. Question over the condition of the guttering which comprises channel guttering supported on corbels. Areas of ashlar masonry below the gutter in very poor condition and beginning to spall and decay. Brickwork also showing signs of water penetration and salt staining and pointing beginning to fail.

Overall Condition: Poor

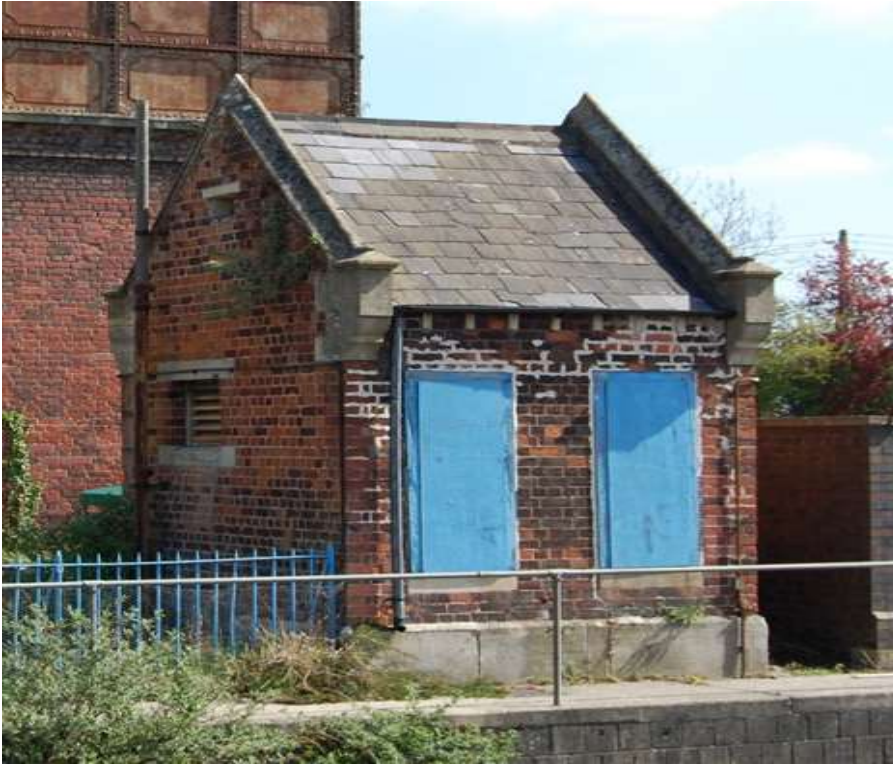
Watertight but signs that slates are starting to slip. Gutter to rear dropping on one side and potentially allowing water into the fabric. Vacant and unused. Vegetation starting to grow on gables. Pointing beginning to fail in places.

Overall Condition: Fair

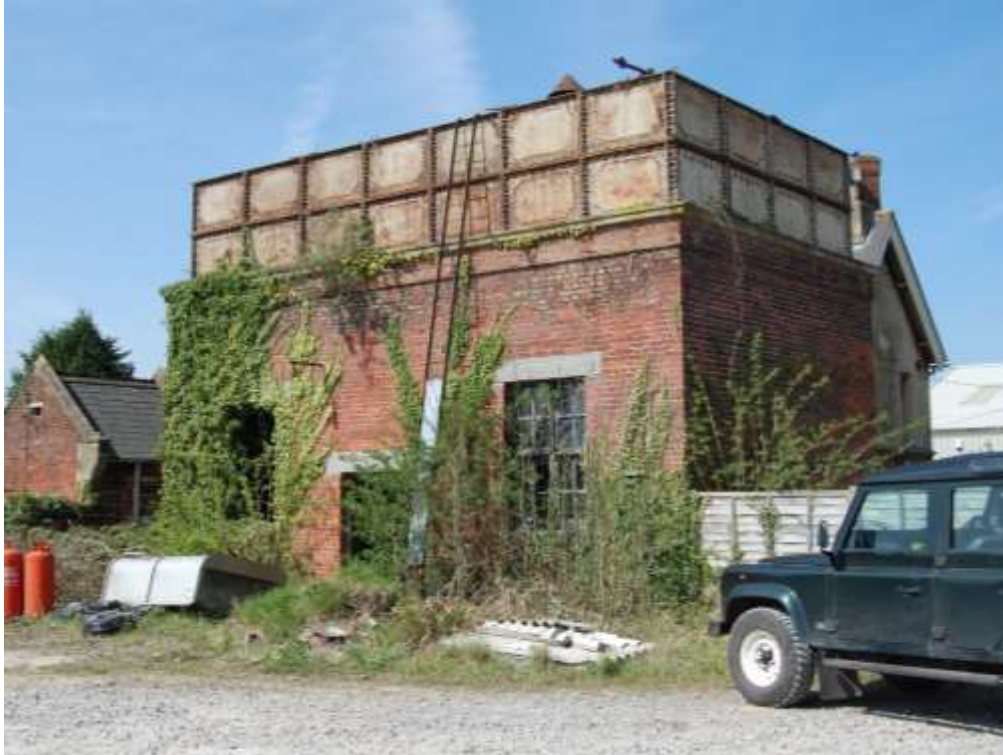
Condition: Used partially as storage. Walls in fair condition although vegetation beginning to take hold. Windows missing

Overall Condition: Poor

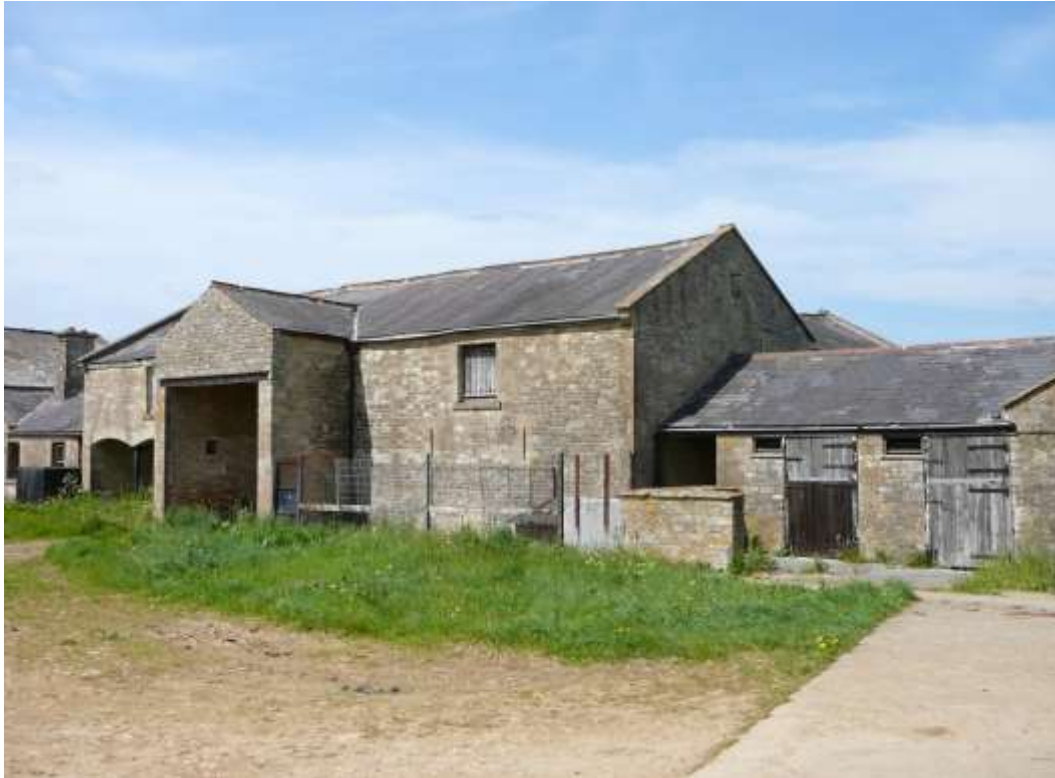
Condition: Partially used. Dilapidated through lack of maintenance although some holding repairs being carried out.

Overall Condition: Poor

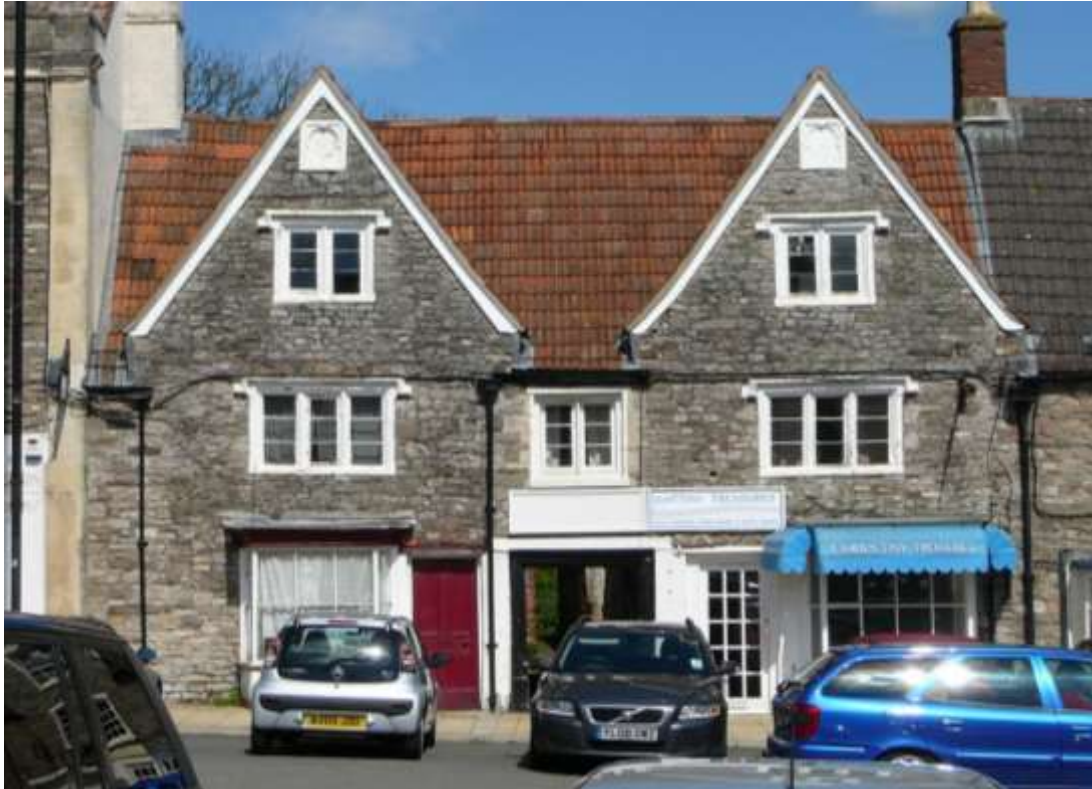
Little maintenance carried out over last few years. Roof has been retiled and 3 courses of stone tile above eaves has been lost. Windows to front are deteriorating beneath layers of paint. Central passage door in bad condition and requires repair. To rear, similar condition.

Overall Condition Fair/Poor

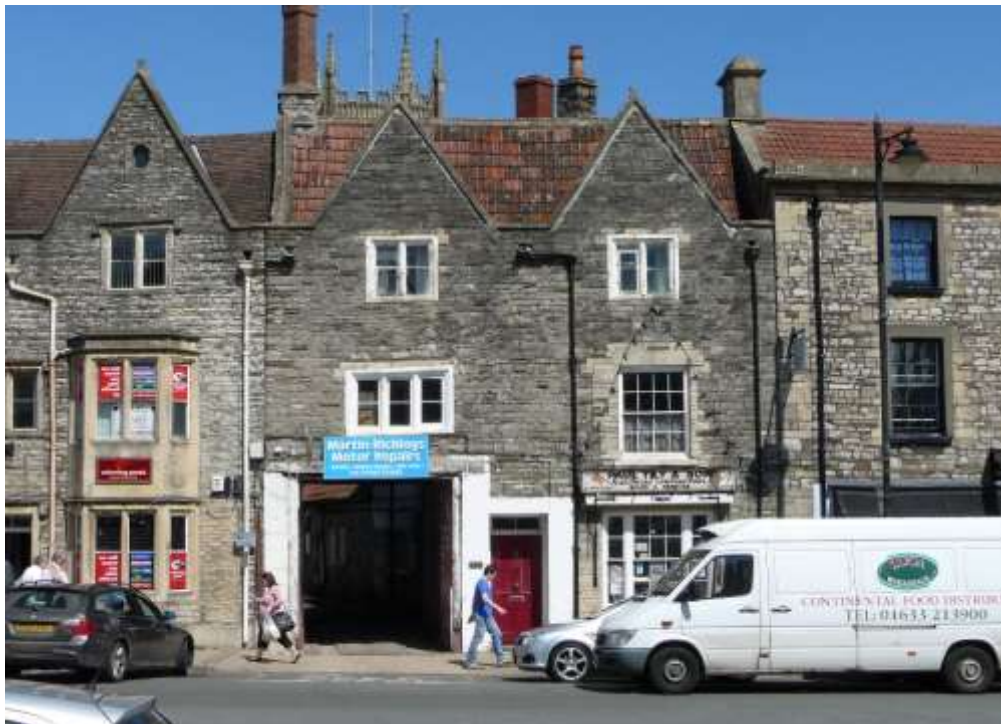
Condition: No apparent maintenance for many years. Leaking gutters causing damage to stone-work and walls to side and rear in poor condition and in need of re-pointing. Windows to 2nd floor in very poor condition and decaying. Door to left in poor condition. Ball finials missing and heavily eroded/ broken coping stones to gables. Rear wing also in poor condition

Overall Condition: Poor

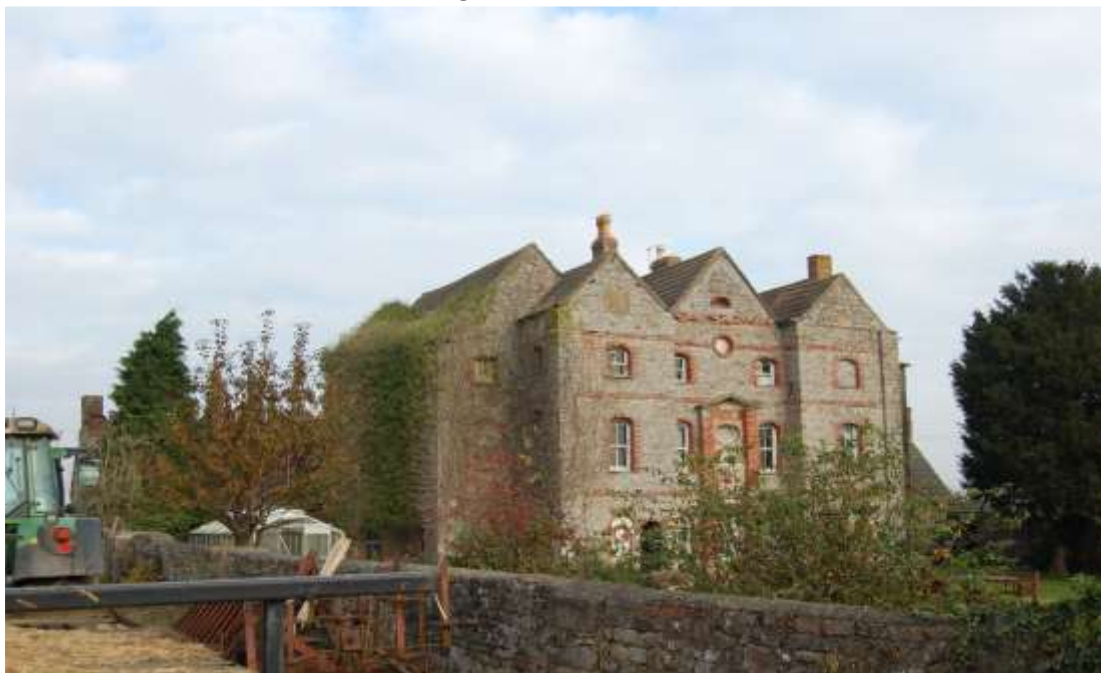
Condition: Partially occupied. Unoccupied parts have suffered significant water ingress in the past. Re-roofed since then, Patch repair of stone slate on single storey range recently completed and works on-going, but at a slow pace.

Overall Condition: Poor
Priority Category: C
OS Grid Ref: ST 7218 8590

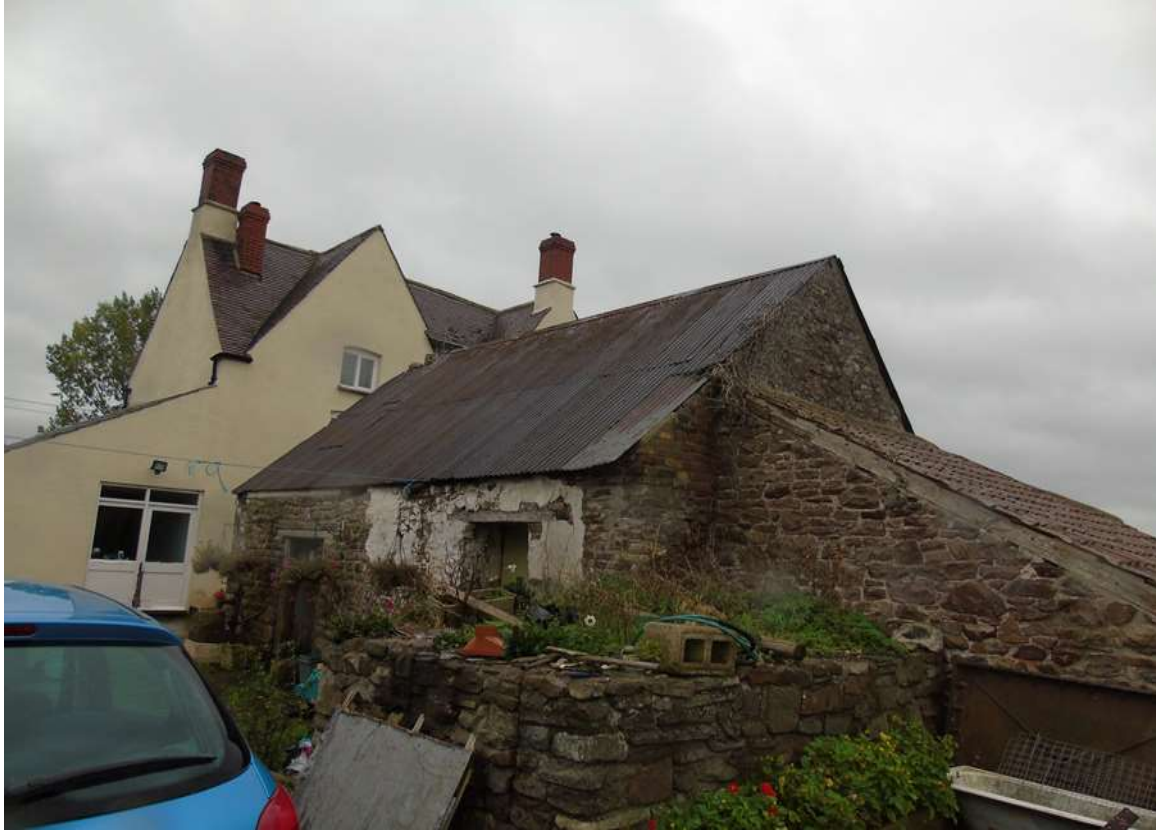
Roof failing allowing water ingress which is rotting internal timbers to both roof and floor (1st floor structure in particular). Insect attack to structural roof timbers also evident. Whilst historic fabric survives, it is at risk of being lost – first floor now inaccessible to poor condition of floor structure.

Overall Condition: Poor

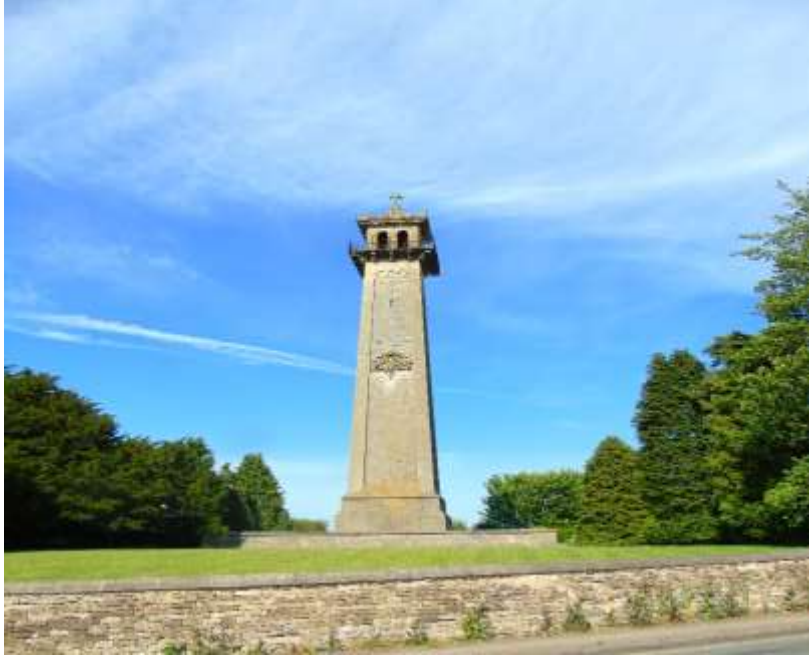
Condition: Dilapidated. Previous Iron cramp failure issues have been addressed by balcony metal structure appears corroded and devoid of any protective coat to shield it from the elements. Delaminated stone-work above crest and other places note. Inscription to plinth also being lost to vegetation and localised cracking. Walls to boundary have been repaired although frost action has damaged recently laid stone coping.

Overall Condition: Poor
Priority Category: C

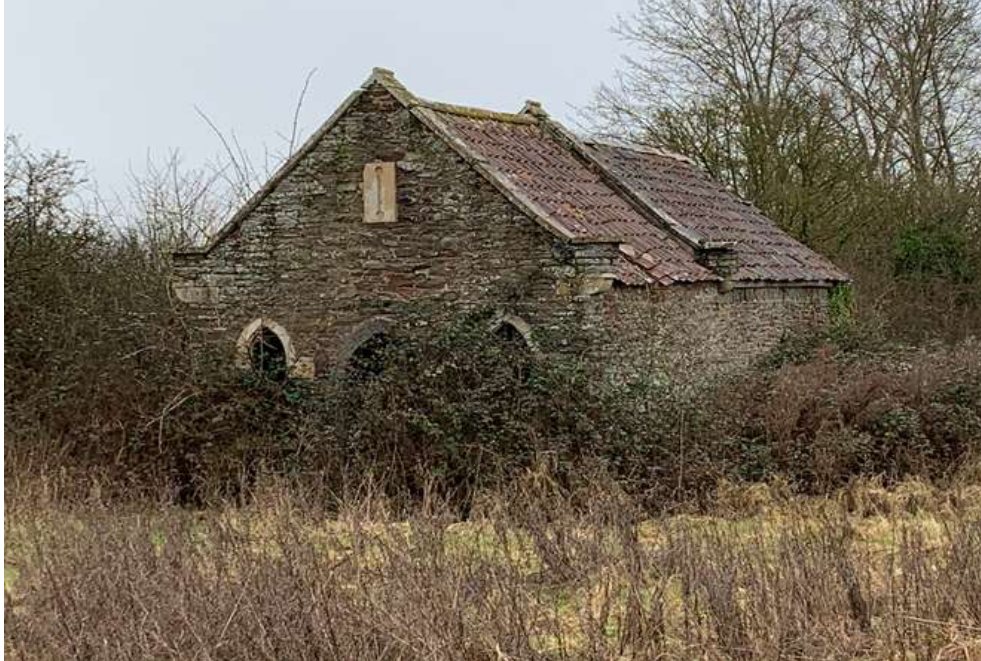
Condition: Significant roof failure to rear elevation and lost/slipped pantile elsewhere. Walls in fair/poor condition but loose joints around kneelers and joints to coped verges are heavily washed out. Ridge is also starting to fail. Windows and doors are open and prone to vandalism. Interior has been trashed and subject to numerous attacks. Stone window jambs have been removed/fallen out to both window openings. Vegetation starting to take hold at the base.

Overall Condition: Very bad

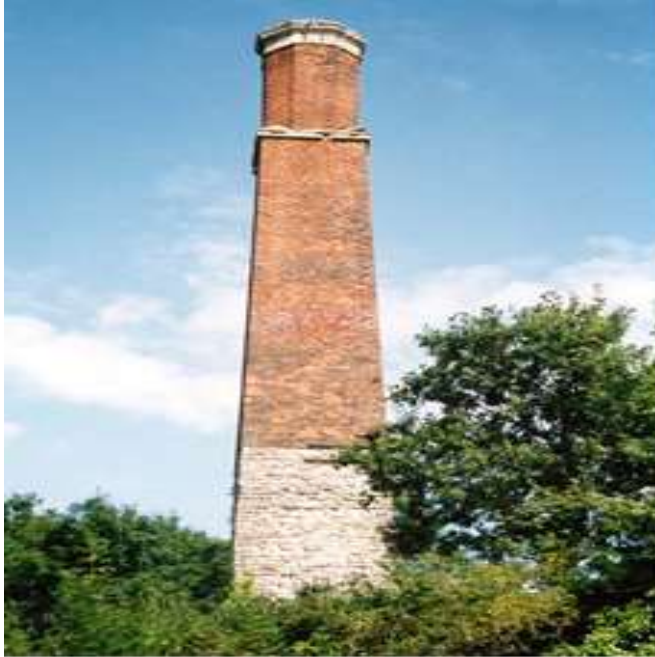
Improving. Funding was granted in 2014 from Historic England for a scheme of on-going repairs which has helped with vegetation clearance and stabilise the structures in previously the worst condition. Further repairs still required and on-going but lack of sustainable future leaves it at risk. Also on Historic England's "At Risk Register" where it notes that a Heritage Partnership Agreement document forms the basis of an on-going programme of repair and research.

Overall Condition: Fair

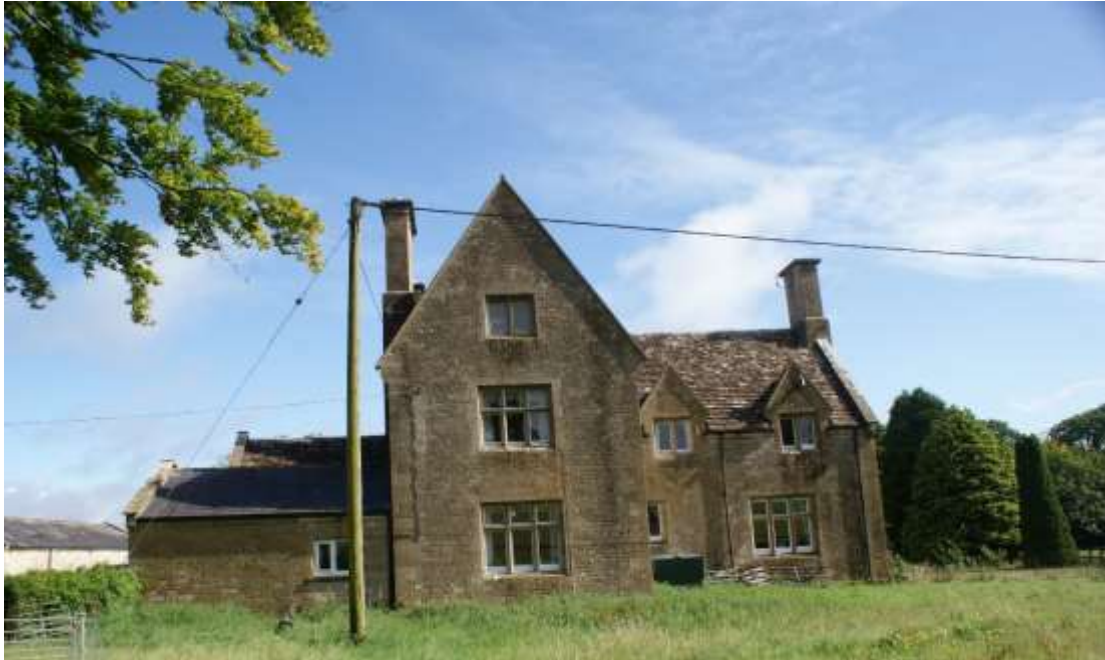
Condition: Lack a maintenance and concerns and presents a long terms threat to the condition and appearance of the building. Rainwater goods in particular.
