SOUTH GLOUCESTERSHIRE COUNCIL - REGISTER OF BUILDINGS AT RISK JULY 2022

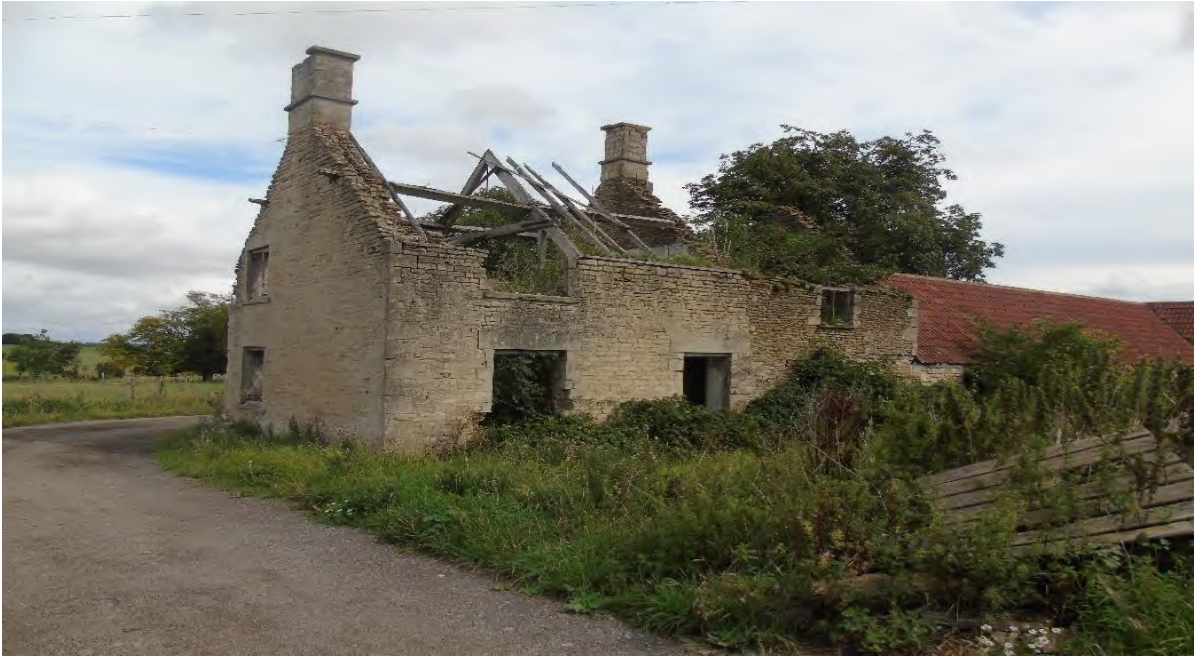
This building was previously on the 2010 BAR register. While the byre has been reroofed, the farm cottage remains a in ruinous state with invasive planting now established, delaminating and cracking masonry especially to the wall tops due to washing out of joints. Roof and first floor collapsed and sections of walling now failing and significant collapse to stone gables to be expected. Agricultural buildings in poor condition with deteriorating roof covering and gradual decay of masonry. No guttering. Mix of stone tiles, asbestos and polycarbonate sheet roofing, all in deteriorating condition.

Overall Condition: Very Bad

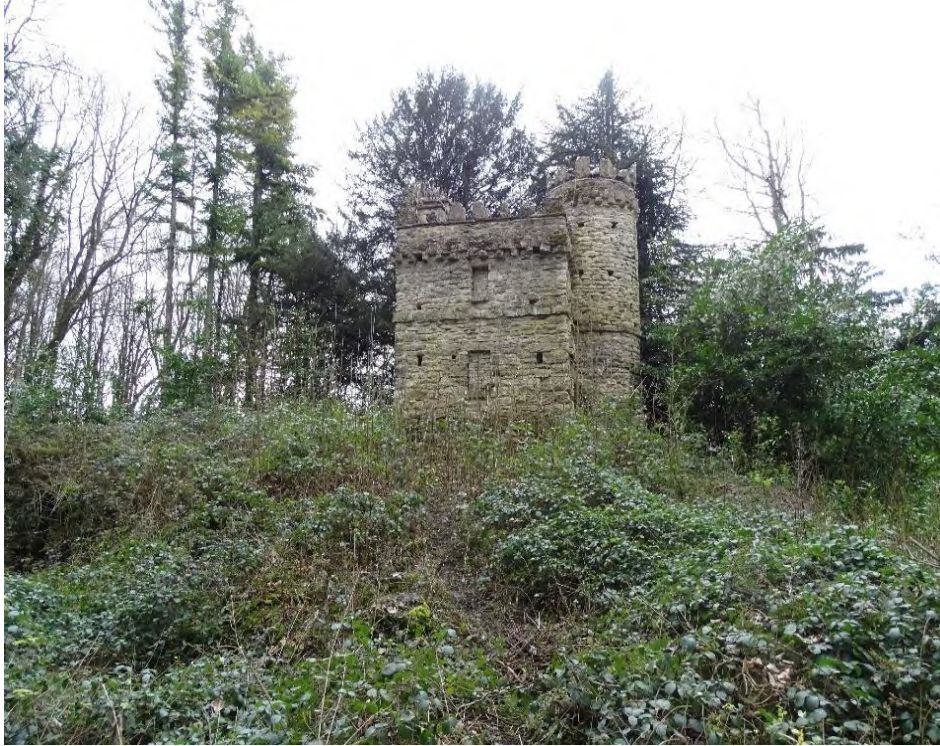
Condition: Clear evidence of consolidation works and structurally looks sound externally. Internally though floors and roof still missing and embedded timbers now heavily decayed (lintels over openings) and compaction will lead to structural issues. Internal plasters also still being lost as exposed to elements.

Overall Condition: Poor

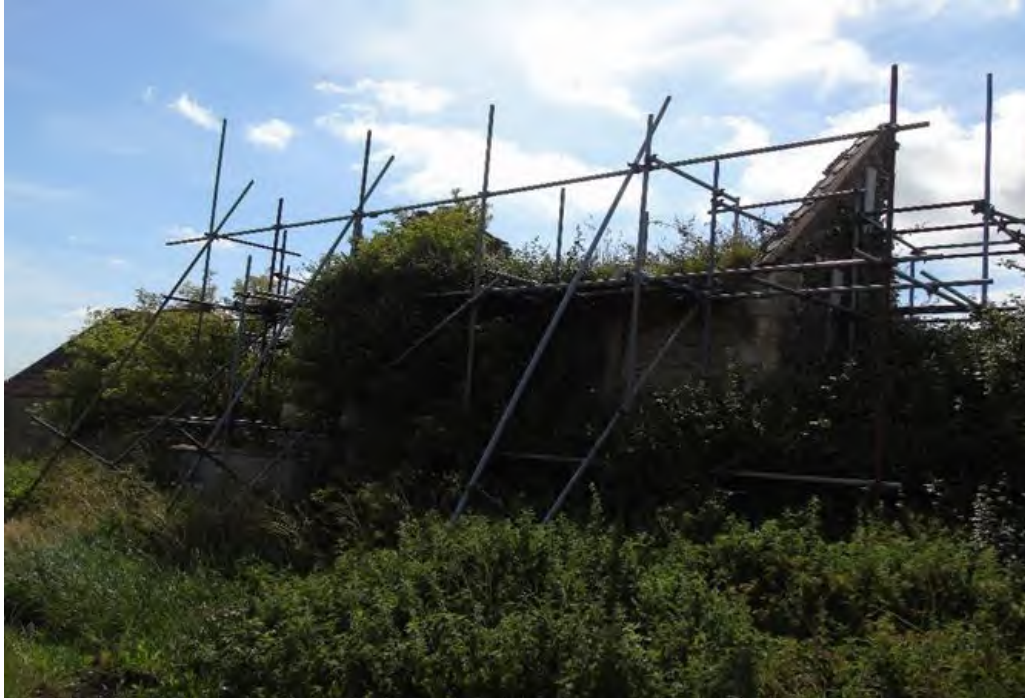
Condition: Lack of maintenance has led to collapse of roof between 2 barns, substantial collapse of walls and serious dilapidation. Roof unsafe and liable to collapse in remain parts. Vegetation growth in wall tops. Walls to enclosed yard parlous. Scaffolding in place to limit further collapse although gable end walls now look very fragile and would have certainly collapsed if not supported. Is now largely ruinous and in need of intervention.

Overall Condition: Very Bad

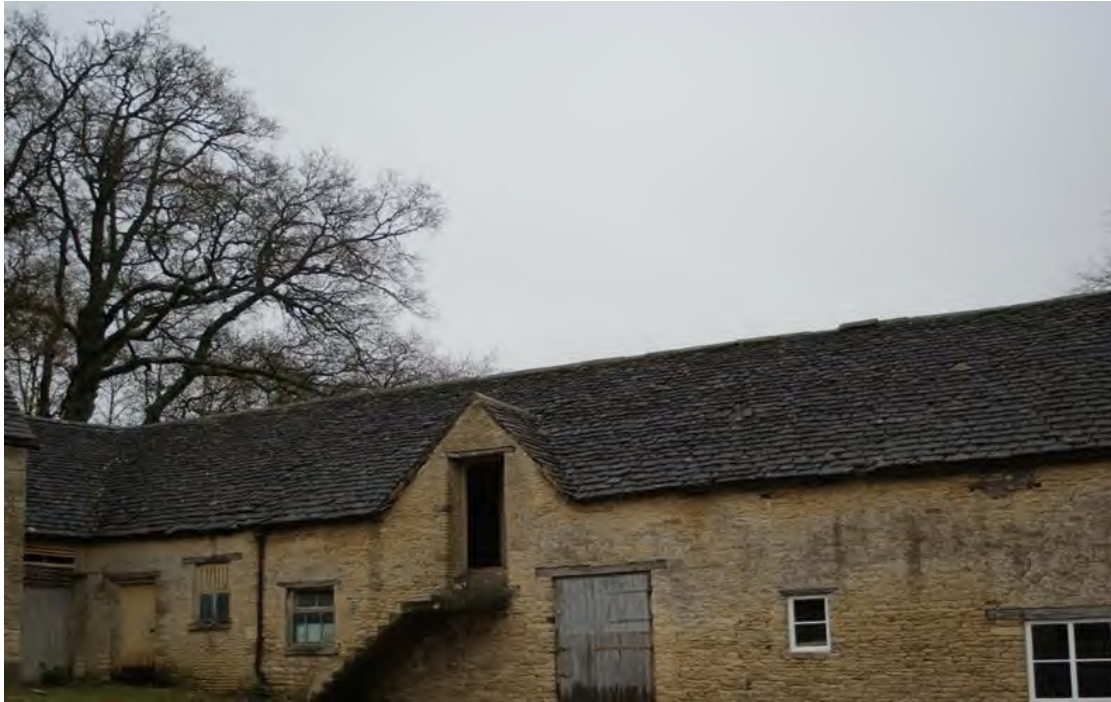
Condition: This relates to the east wing only, as the north and west wing are in better condition. Overall, general lack of maintenance with some sagging eaves and notable cracking in elevations. Stone tile roof in need of some repair also. Some notable reconstruction/ repairs but overall does appear to be need of refurbishment.

Overall Condition: Poor

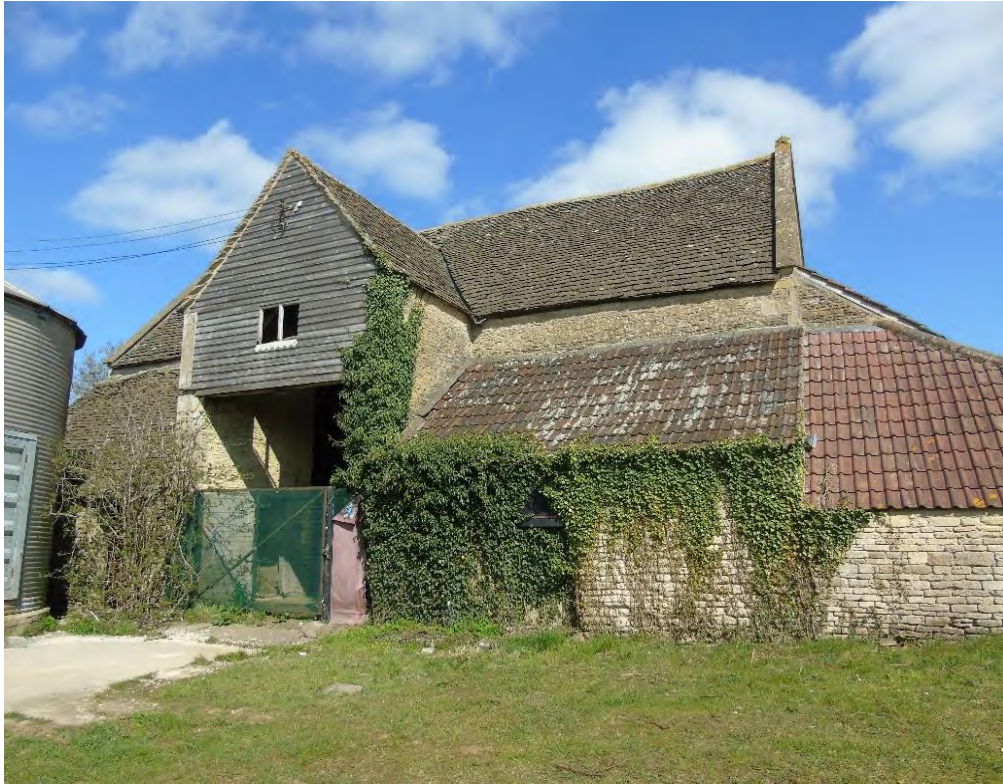
Condition: Gutters absent to every roof with no subsequent proper disposal of rainwater which is impacting on the condition of the fabric of the building. Threshing elevation has metal gate and there are visible cracks in the stone elevations. There are also slipped tiles and undulated slates in areas suggesting decayed structure. Water saturation of some walls evident. Timber lintel to east entry heavily decayed. Holes in roof and semi-collapsed in areas (north facing).

Overall Condition: Poor

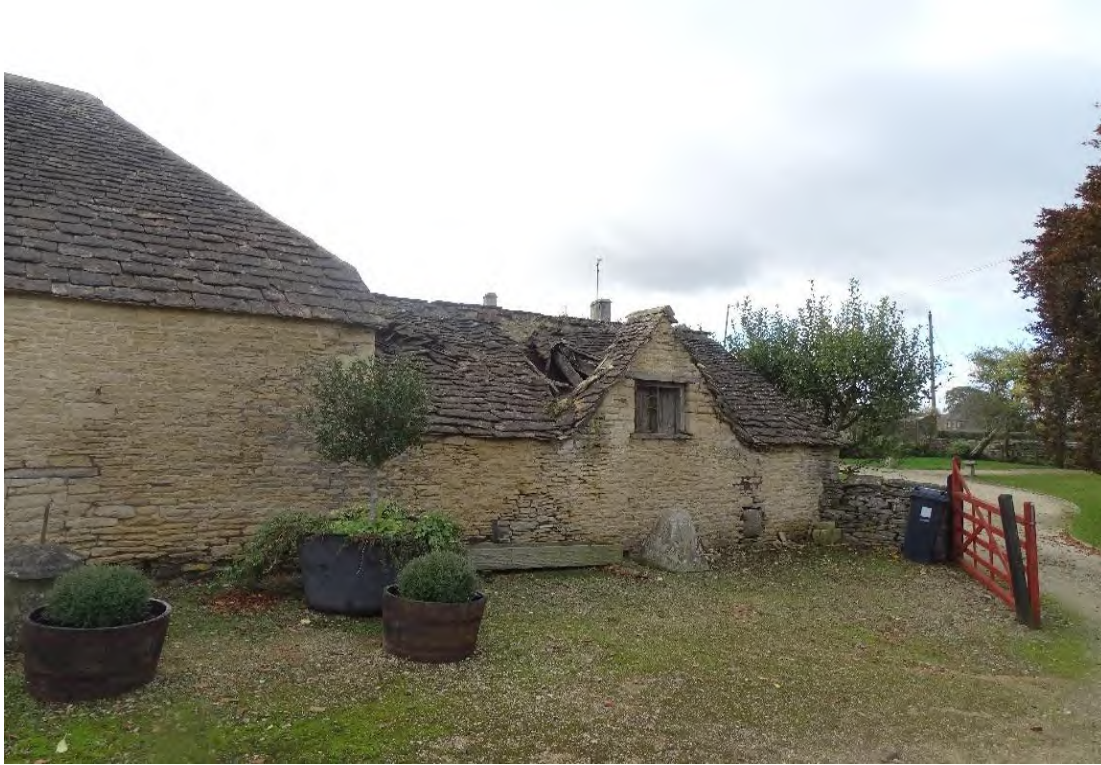
Condition: Area of roof collapse both partial and total. Rainwater goods missing causing issues to walls tops (likely roof plate issues as well) with spalling to stone. Lintels to windows rotting and sagging

Overall Condition: Very Bad

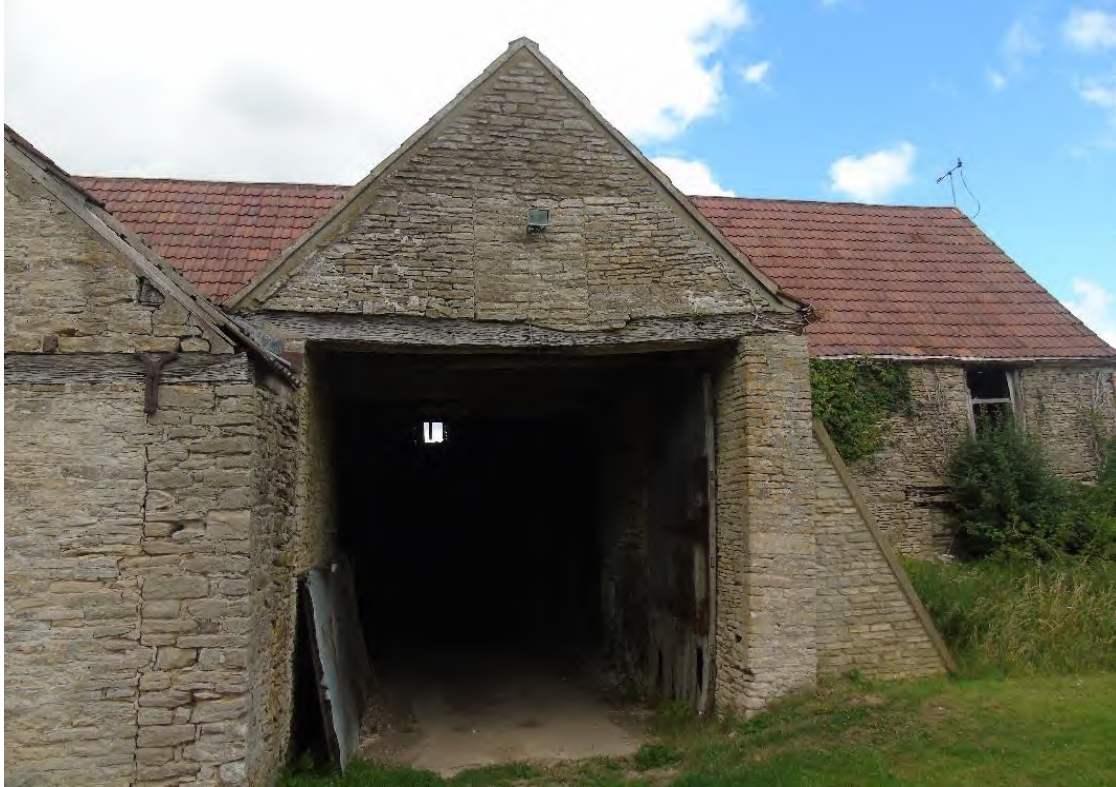
Condition: Generally poor as lack of use has clearly led to lack of maintenance. The immediate risk is failure of sagging lintels and all embedded timbers which will cause localised collapse. Settlement of buttress also an issue. Lack of rainwater goods has also impacted on joints at wall tops.

Overall Condition: Poor

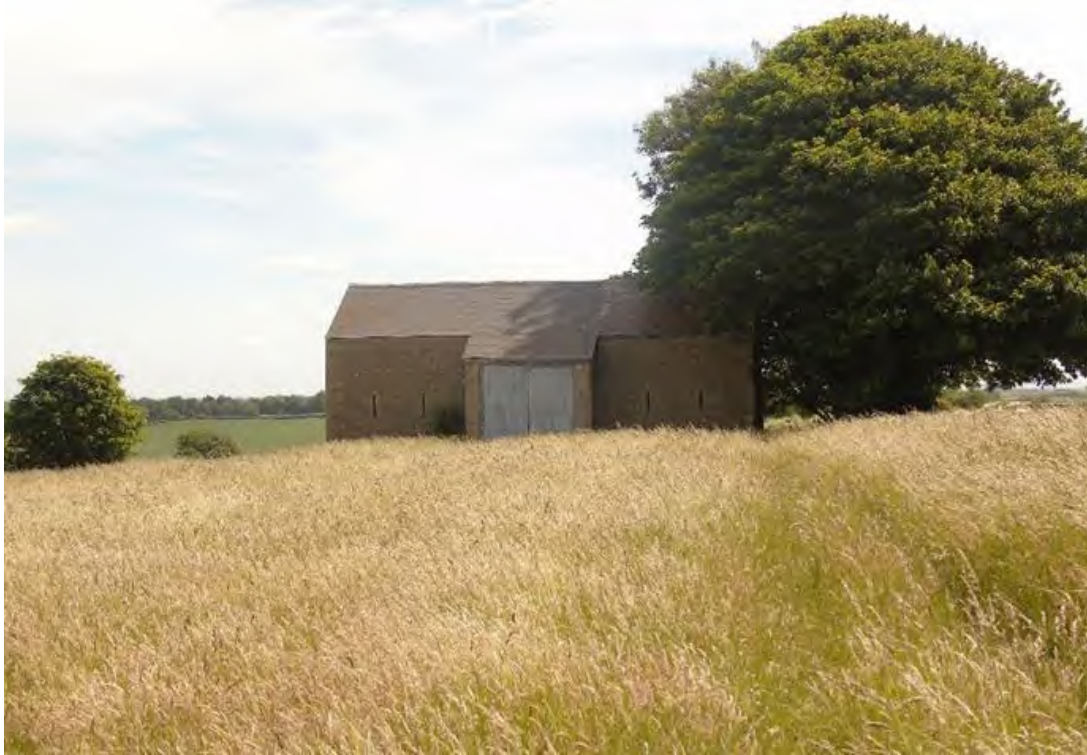
Condition: Given its isolated location, main barn in reasonable condition. The structures to the rear are collapsing and being restraining by propping. Rainwater goods largely though lost which would be accelerating weathering to wall tops.

Overall Condition: Fair

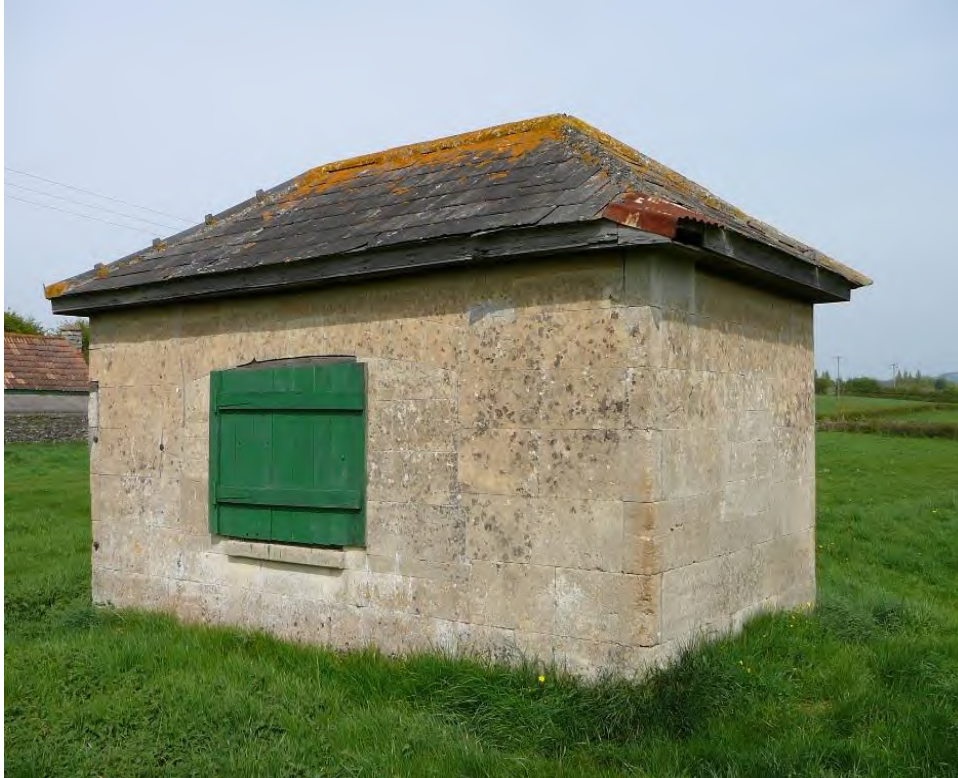
Condition: Unoccupied and neglected. Evidence of rot and decay of timber structure and possible structural movement. Gutters are all missing but there is a reasonable throw from the overhanging eaves. Signs of the ashlar moving, associated with the rusting and expansion of the iron cramps. Ridge is a mix of concrete, stone, tile and clay – the stone is cracked in places. The window opening has a modern shutter over and the door is decaying at base – retains original pintle hinges. Cementitious repairs are now cracking.

Overall Condition – Poor

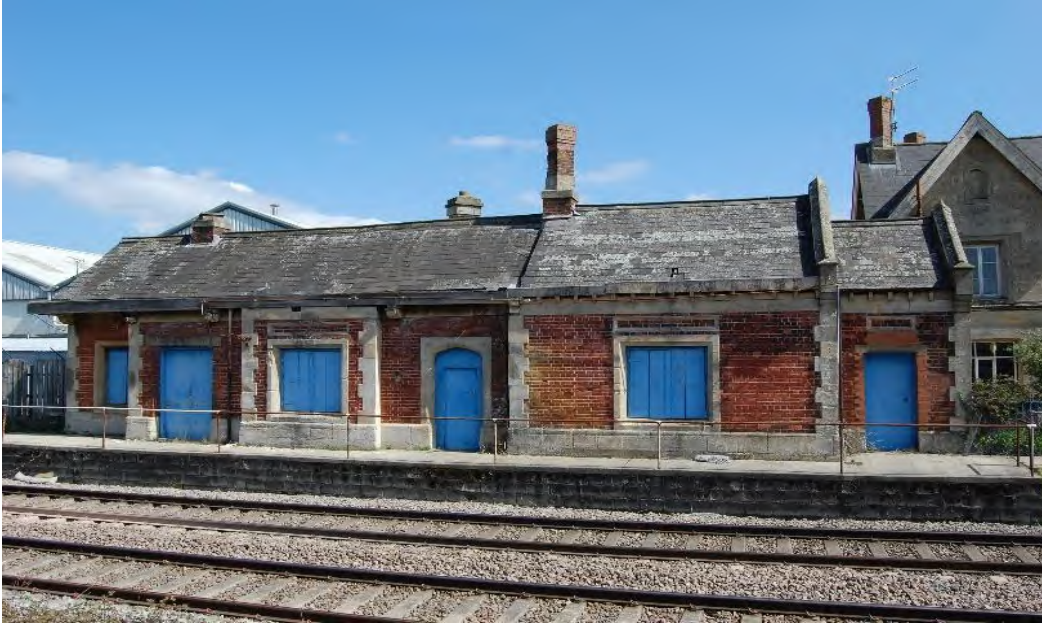
Condition: Derelict although partially used by local garage for storage. Slates slipping along length of roof and flashing missing or beginning to slip. One area has rafter exposed. Ridge tiles may be loose, with open joints or missing mortar. Question over the condition of the guttering which comprises channel guttering supported on corbels. Areas of ashlar masonry below the gutter in very poor condition and beginning to spall and decay. Brickwork also showing signs of water penetration and salt staining and pointing beginning to fail.

Overall Condition: Poor

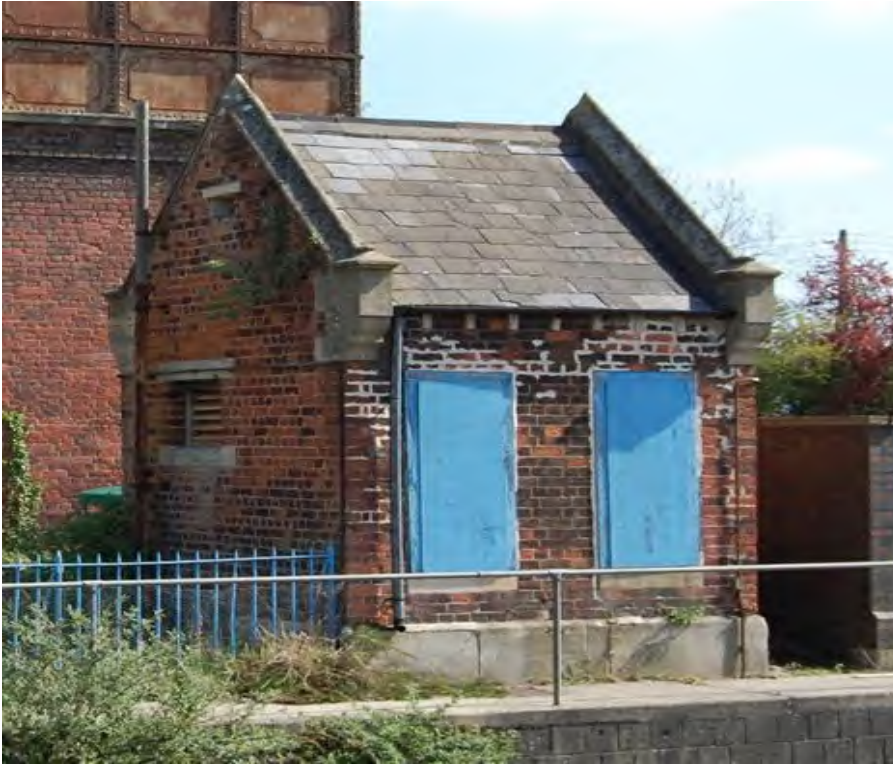
Watertight but signs that slates are starting to slip. Gutter to rear dropping on one side and potentially allowing water into the fabric. Vacant and unused. Vegetation starting to grow on gables. Pointing beginning to fail in places.

Overall Condition: Fair

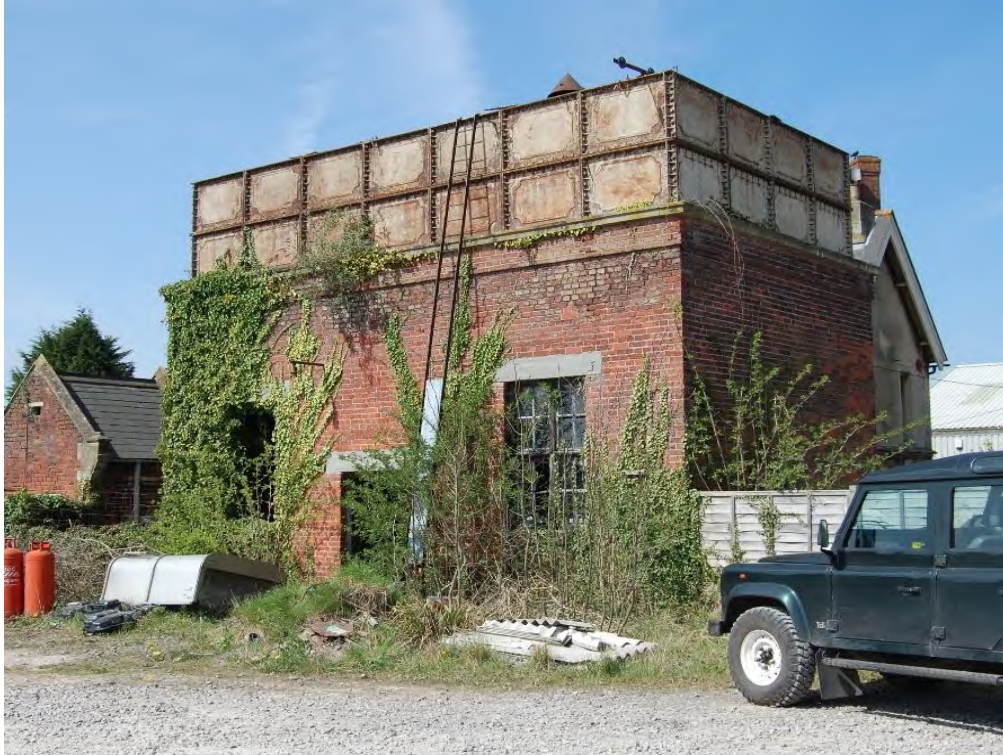
Condition: Used partially as storage. Walls in fair condition although vegetation beginning to take hold. Windows missing

Overall Condition: Poor

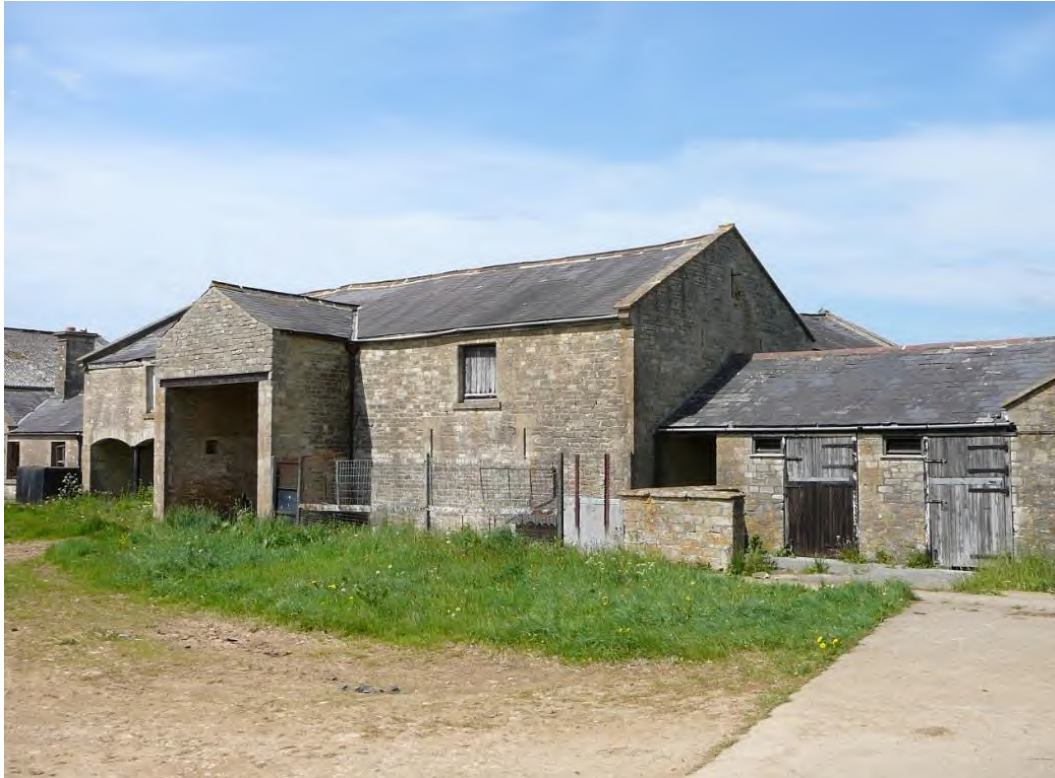
Condition: Partially used. Dilapidated through lack of maintenance although some holding repairs being carried out.

Overall Condition: Poor

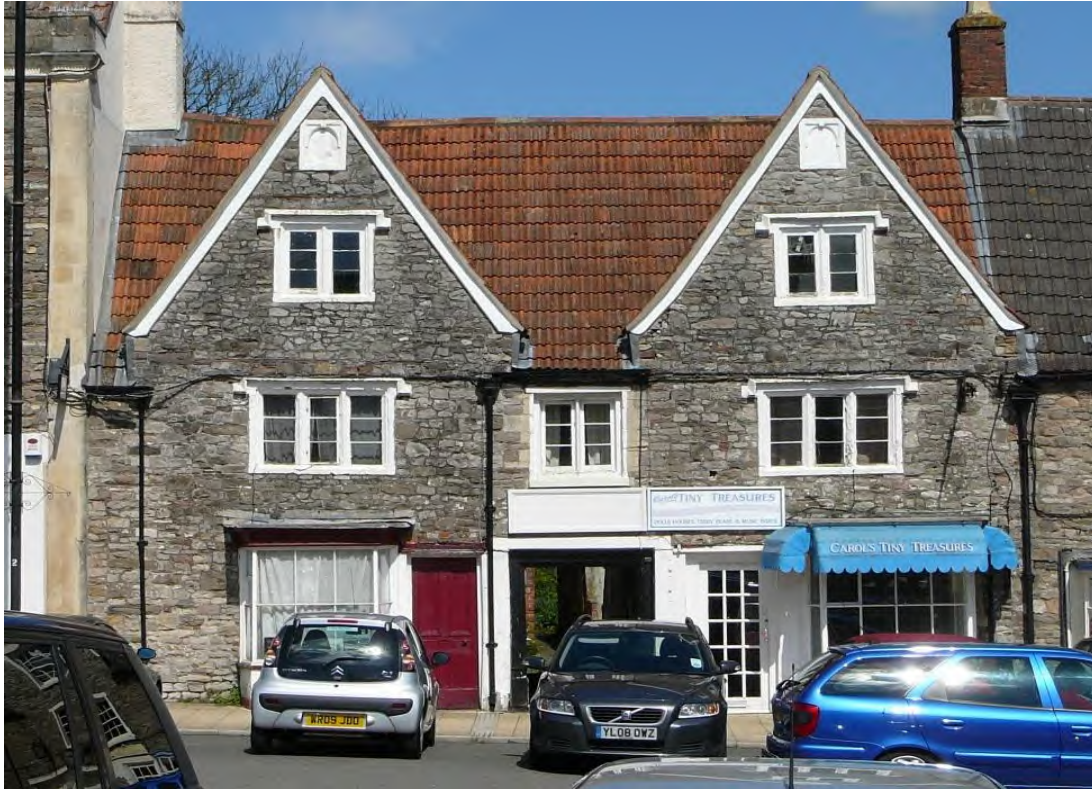
Little maintenance carried out over last few years. Roof has been retiled and 3 courses of stone tile above eaves has been lost. Windows to front are deteriorating beneath layers of paint. Central passage door in bad condition and requires repair. To rear, similar condition.

Overall Condition Fair/Poor

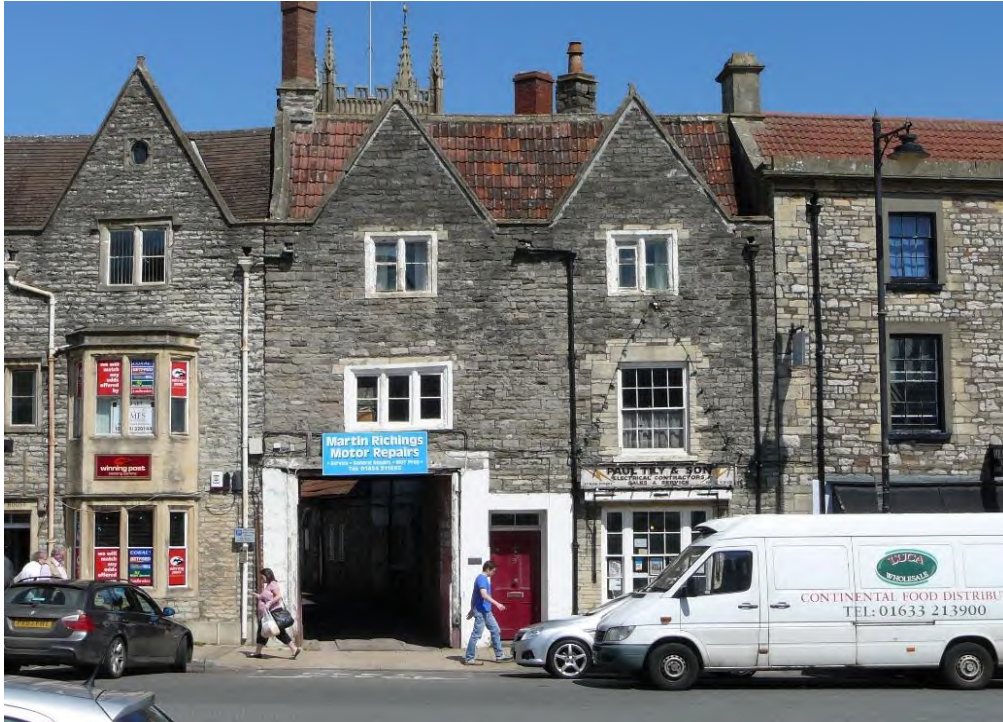
Condition: No apparent maintenance for many years. Leaking gutters causing damage to stone-work and walls to side and rear in poor condition and in need of re-pointing. Windows to 2nd floor in very poor condition and decaying. Door to left in poor condition. Ball finials missing and heavily eroded/ broken coping stones to gables. Rear wing also in poor condition

Overall Condition: Poor

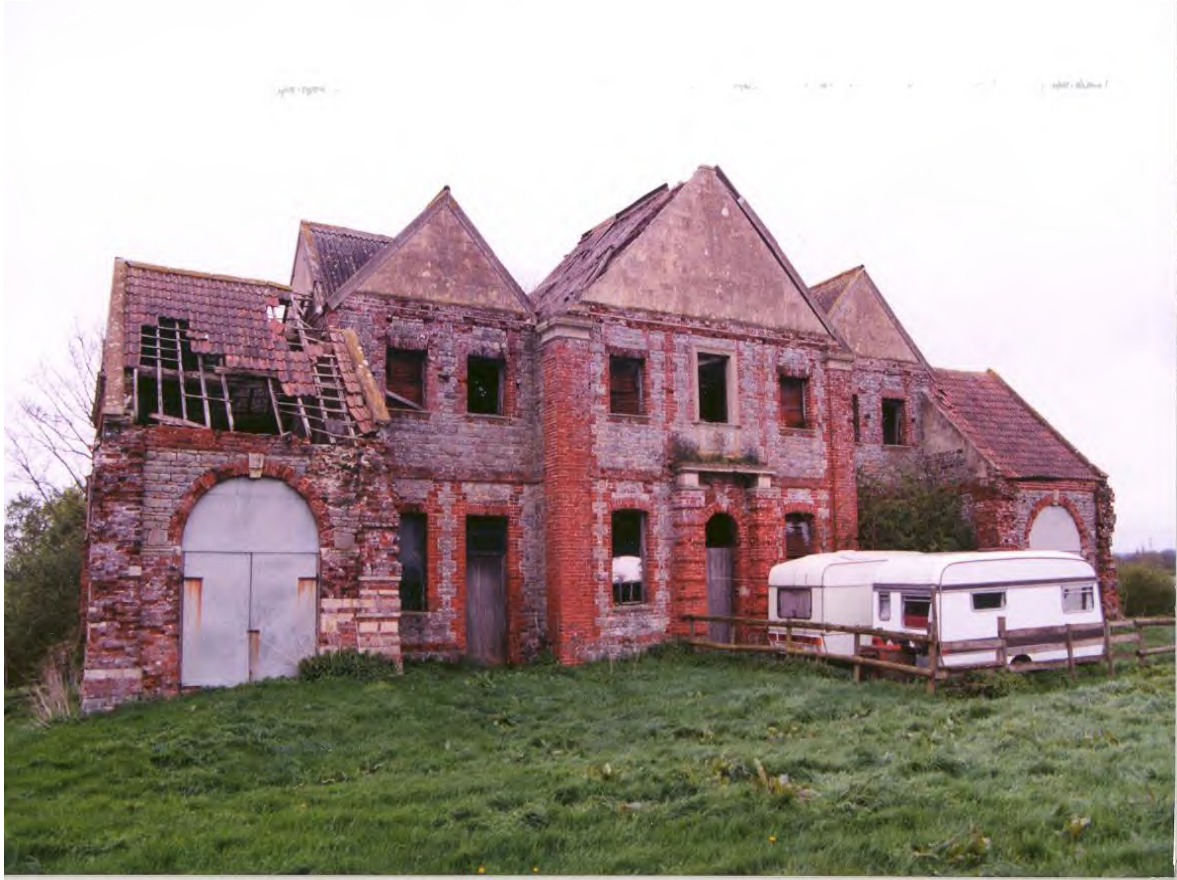
Overall Condition: Very bad

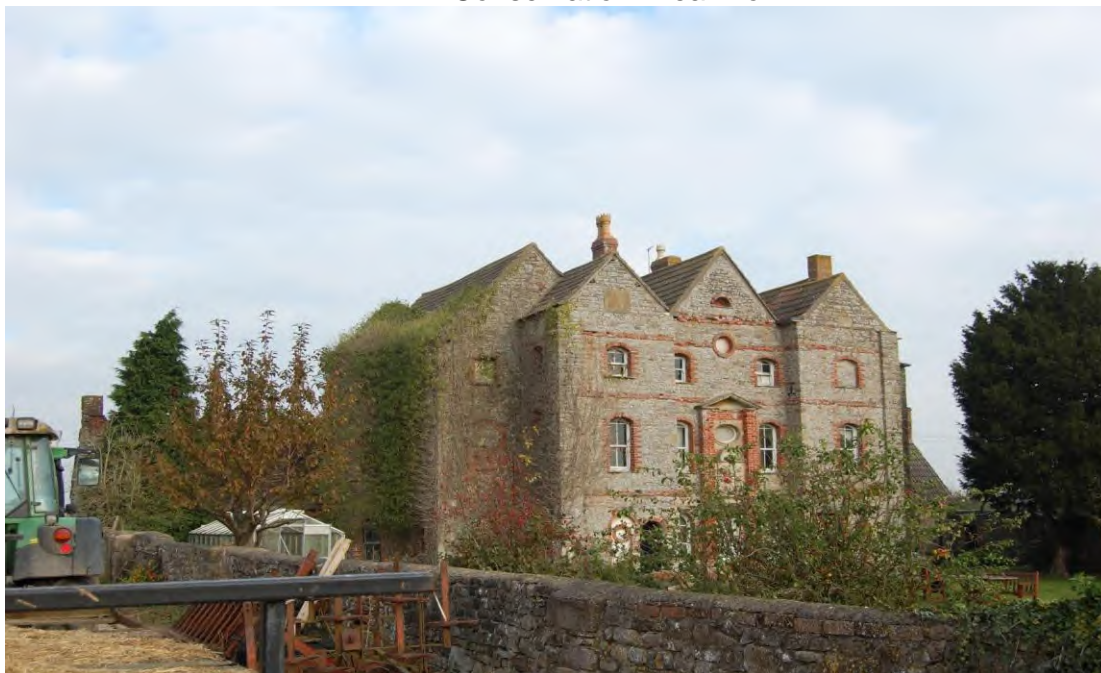
Condition: Partially occupied. Unoccupied parts have suffered significant water ingress in the past. Re-roofed since then, Patch repair of stone slate on single storey range recently completed and works on-going, but at a slow pace.

Overall Condition: Poor
Priority Category: C
OS Grid Ref: ST 7218 8590

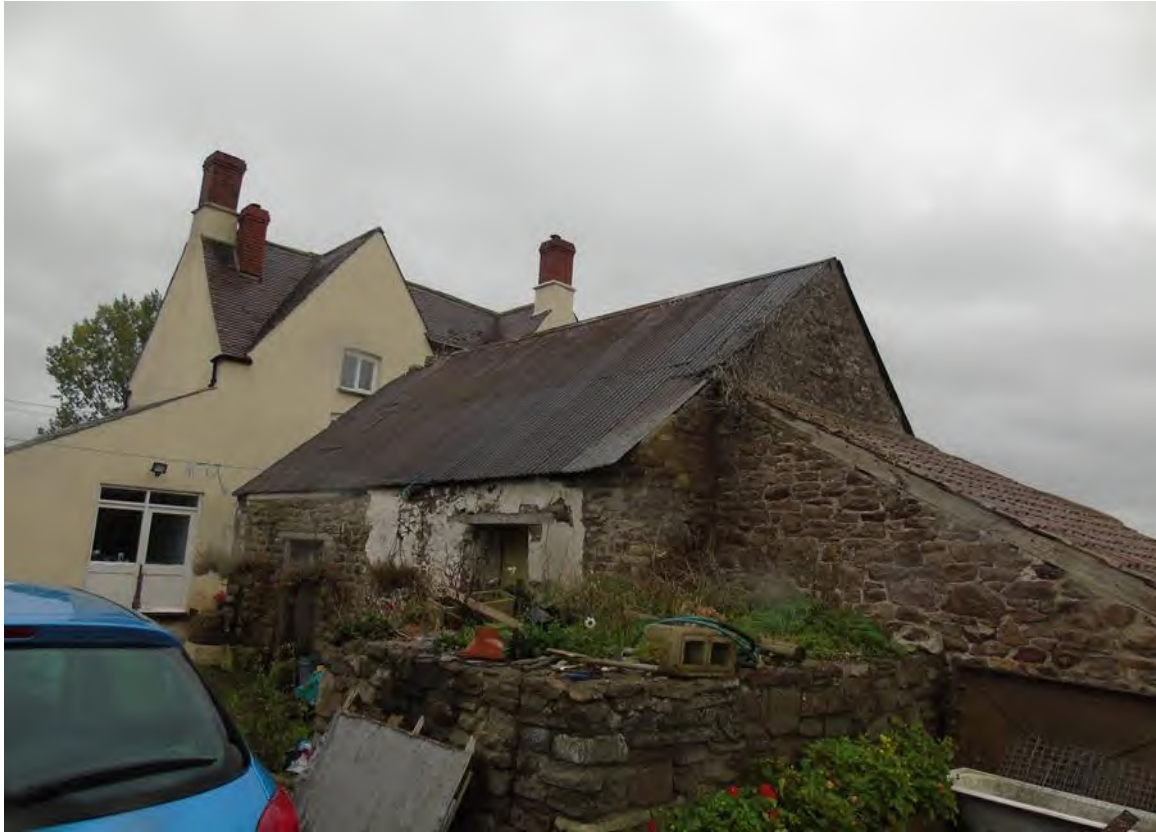
Roof failing allowing water ingress which is rotting internal timbers to both roof and floor (1st floor structure in particular). Insect attack to structural roof timbers also evident. Whilst historic fabric survives, it is at risk of being lost – first floor now inaccessible to poor condition of floor structure.

Overall Condition: Poor

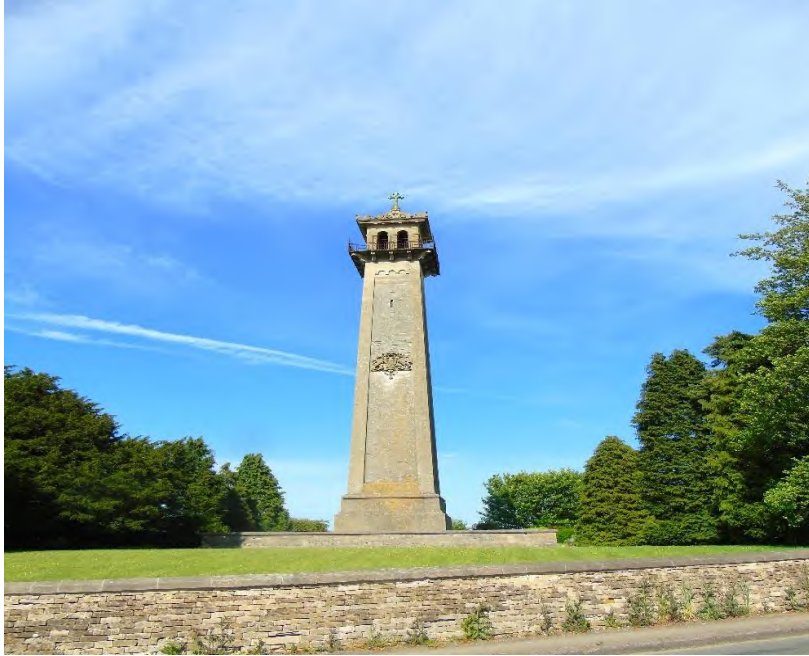
Condition: Dilapidated. Previous Iron cramp failure issues have been addressed by balcony metal structure appears corroded and devoid of any protective coat to shield it from the elements. Delaminated stone-work above crest and other places note. Inscription to plinth also being lost to vegetation and localised cracking. Walls to boundary have been repaired although frost action has damaged recently laid stone coping.

Overall Condition: Poor
Priority Category: C

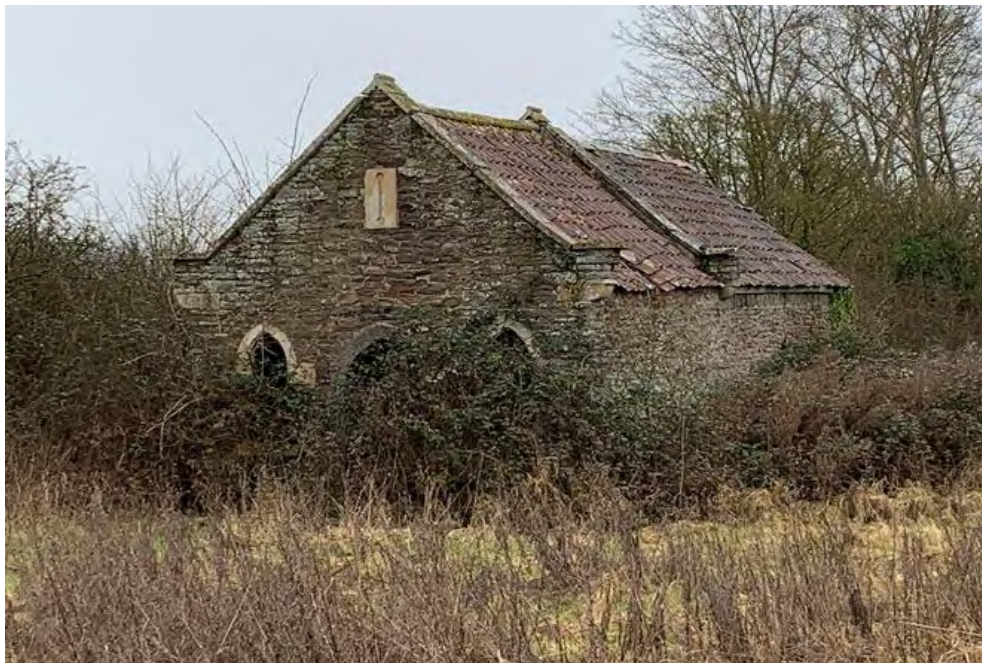
Condition: Significant roof failure to rear elevation and lost/slipped pantile elsewhere. Walls in fair/poor condition but loose joints around kneelers and joints to coped verges are heavily washed out. Ridge is also starting to fail. Windows and doors are open and prone to vandalism. Interior has been trashed and subject to numerous attacks. Stone window jambs have been removed/fallen out to both window openings. Vegetation starting to take hold at the base.

Overall Condition: Very bad

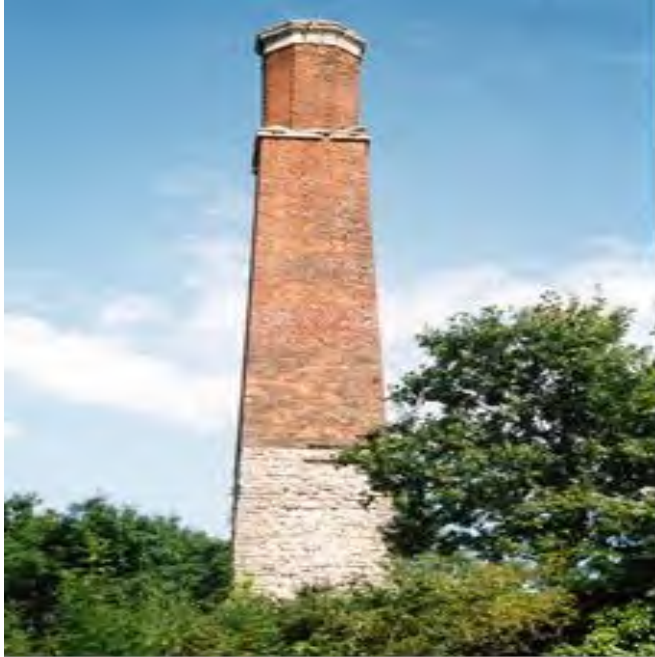
Improving. Funding was granted in 2014 from Historic England for a scheme of on-going repairs which has helped with vegetation clearance and stabilise the structures in previously the worst condition. Further repairs still required and on-going but lack of sustainable future leaves it at risk. Also on Historic England's "At Risk Register" where it notes that a Heritage Partnership Agreement document forms the basis of an on-going programme of repair and research.

Overall Condition: Fair

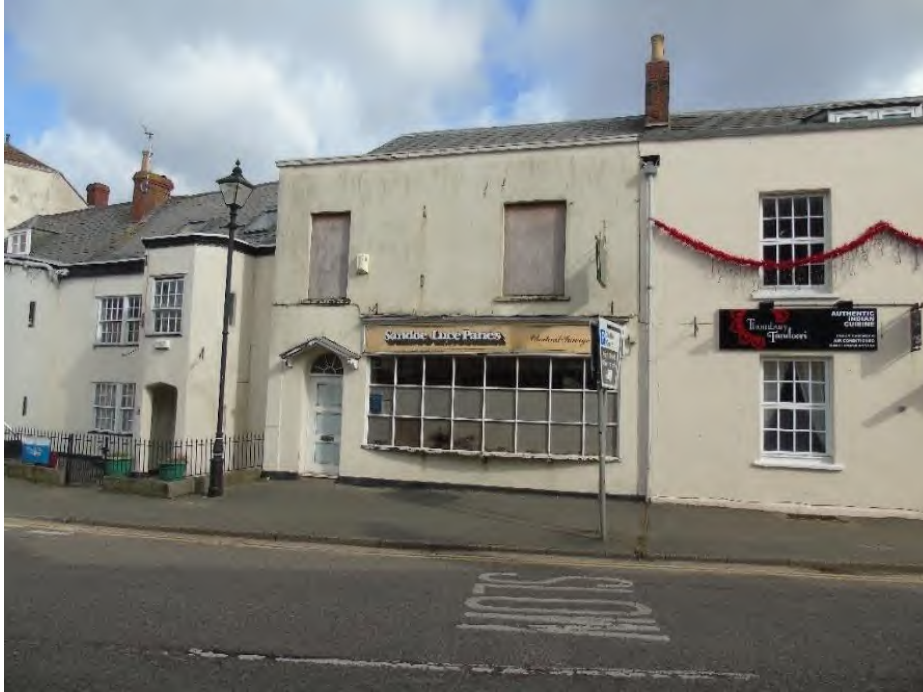
All external features in poor condition with windows boarded up due to lack of maintenance. Whether or not historic windows to first floor is unknown. Number cracks in render, although nothing to suggest structural failure although cracks to top of window head to right window betrays a degree of movement. The flashing to the sharded chimney is cracked and reports have been received about the poor condition of the roof.

Overall Condition: Poor

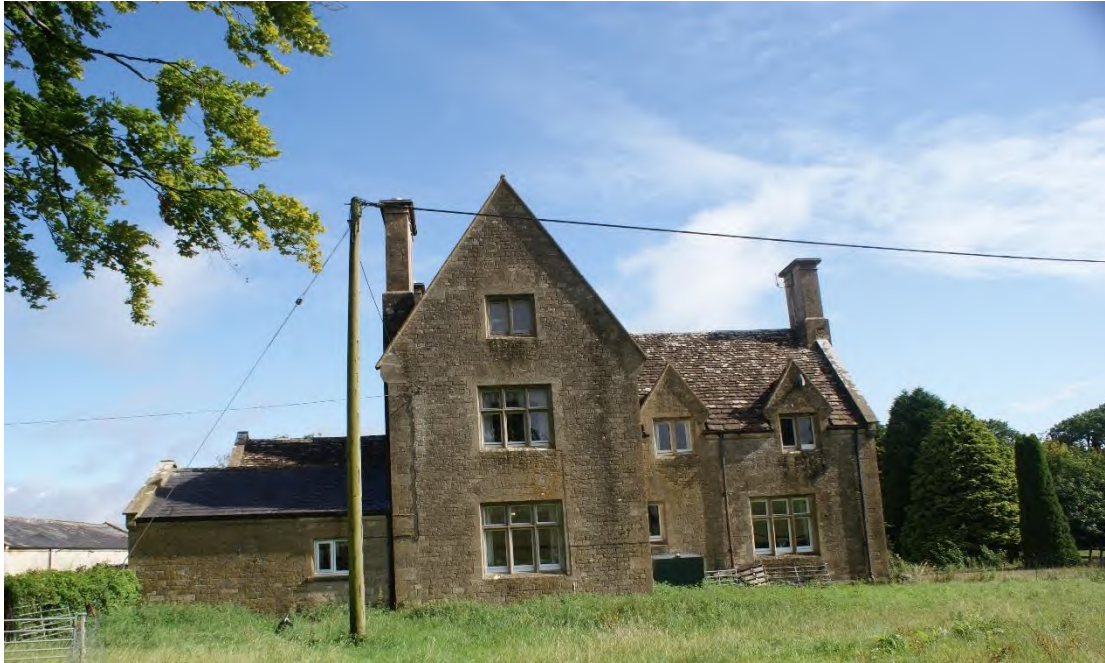
Condition: Lack a maintenance and concerns and presents a long terms threat to the condition and appearance of the building. Rainwater goods in particular.
