Flood Investigation (Section 19  
Report)  
NHS Blood & Transplant Centre  
(24<sup>th</sup> September 2012)

South Gloucestershire Council

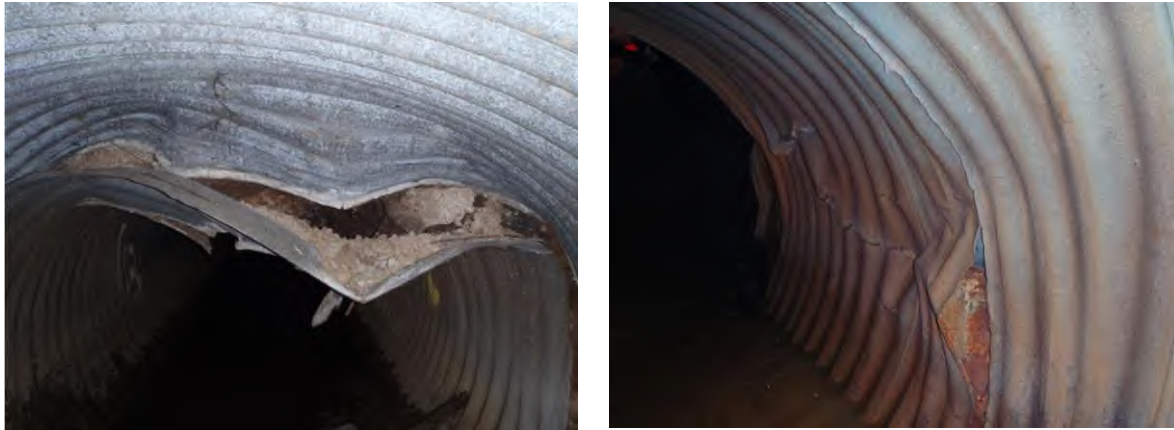
The culvert under the landfill site was constructed from a 1.8m diameter Armco culvert. Following unexpected high water levels upstream of this culvert in January 2011 the condition of this culvert was investigated by Network Rail and found to have deformed and fractured in a number of locations.

**Photos of typical damage to Armco culvert (Note that these photographs were taken after the flood event and may not be reflective of the damage that was there at the time of the flooding)**

Whilst agreement was being reached on a long term solution to a replacement for this culvert, remedial works were undertaken to ensure there would be no further deformation of the culvert and any resulting risk of blockage. This included reinforcement works within the culvert and the provision of over-pumping in the event of high water levels.

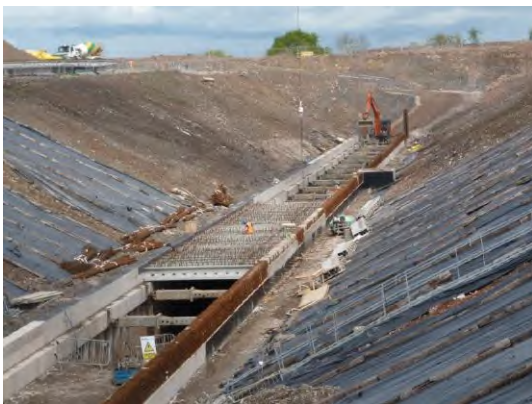
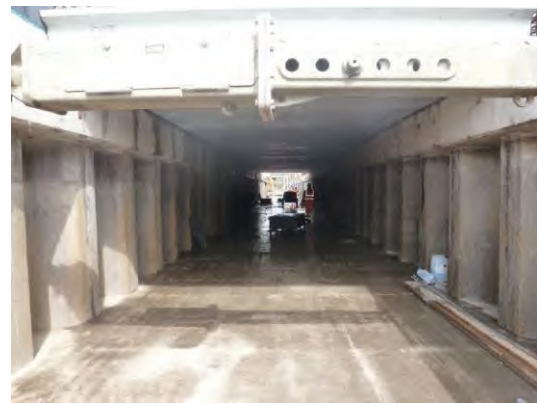
**Photos during construction within the North East quadrant**

The following photos were taken during construction of the new culvert within the North East quadrant.
