Kingswood Park: Our park at the heart of our community

# KINGSWOOD PARK ACCESS PLAN

# KINGSWOOD PARK ACCESS AUDIT

October 2019 (Updated April 2021)

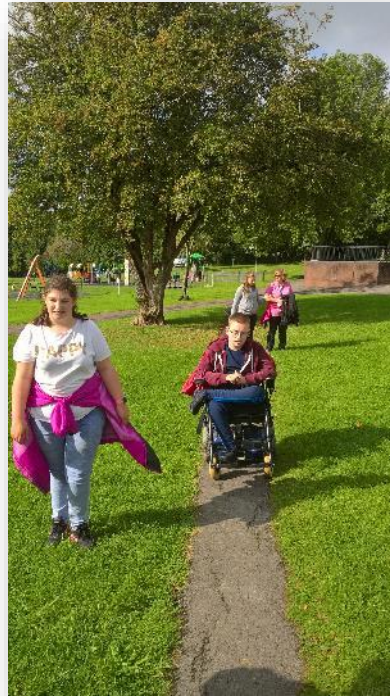
- They observed that there was not a café in the park, but the café at the Park Centre was quite close
- Other observations included that the Forest School / wildlife area was in need of care, however the trim trail equipment was ok

- In terms of sports and other outdoor facilities the students observed that the tennis courts had poor access for wheelchairs due to a narrow path, the basketball area needs updating and the football goal area was not inspiring

Improvements to the toilets and provision of more shade were issues picked up by the students on the survey day.

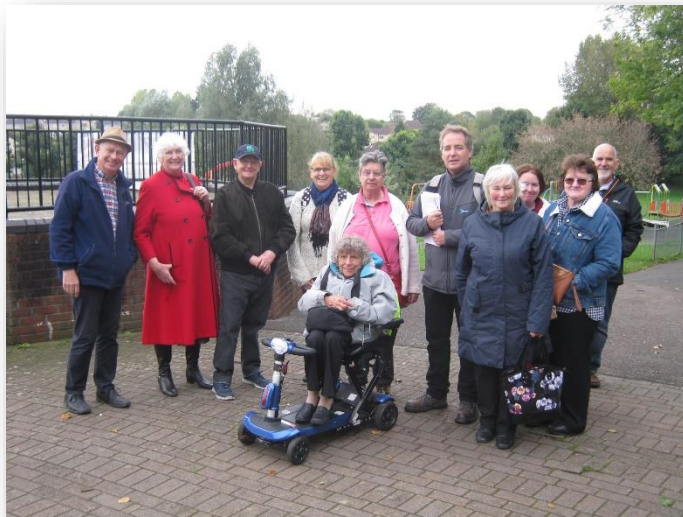
Consultation with South Gloucestershire Disability Action Group took place on 21<sup>st</sup> October 2019. The consultation involved a pre-meeting to describe Kingswood Park and the aims of the audit, an overview of the proposals for the NHLF bid, and an introduction to the Friends of Kingswood Park group. Following the introduction, the group undertook an inspection of the paths and facilities around the park and a working lunch was held to discuss ideas for improvement.

The aim of the consultation was to obtain the views of people with a range of different disabilities on how access can be improved both within and to the site. The DAG participants included a mobility scooter user, stick user and people with other disabilities
