SOUTH GLOUCESTERSHIRE COUNCIL - REGISTER OF BUILDINGS AT RISK (UPDATED MAY 2024)

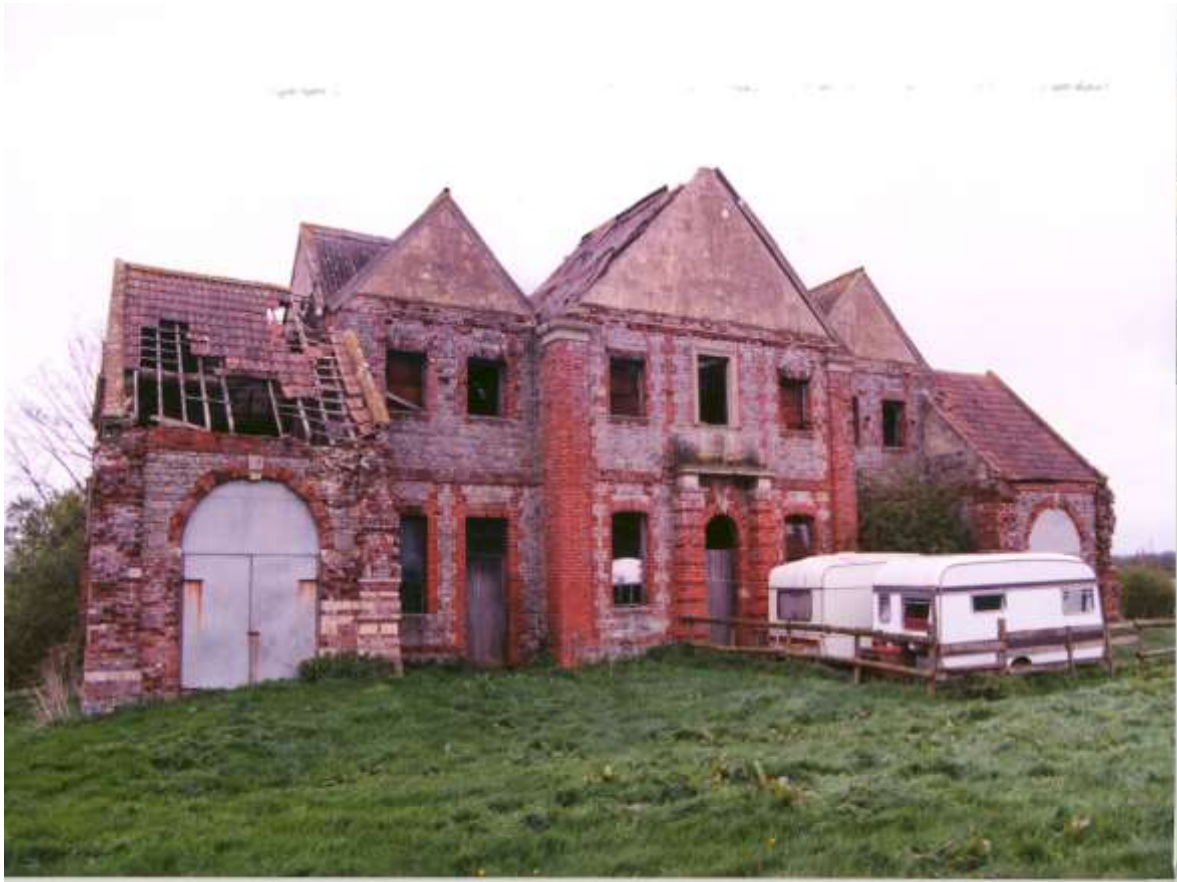
Ref.: SOD3

Overall Condition: Very bad

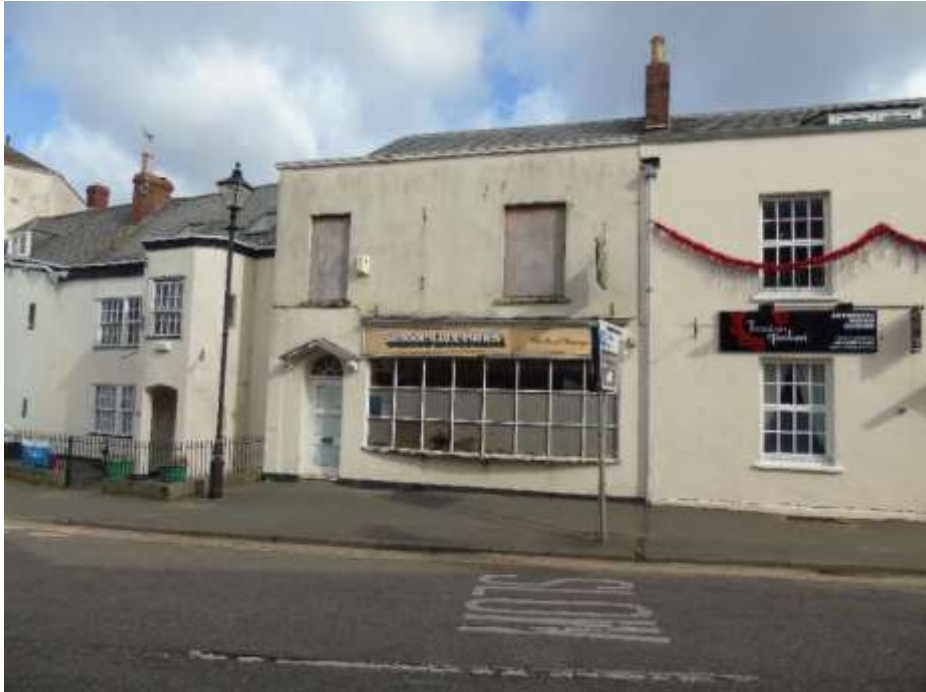
Ref: THO1

All external features in poor condition with windows boarded up due to lack of maintenance. Whether or not historic windows to first floor is unknown. Number cracks in render, although nothing to suggest structural failure although cracks to top of window head to right window betrays a degree of movement. The flashing to the sharded chimney is cracked and reports have been received about the poor condition of the roof.

Overall Condition: Poor

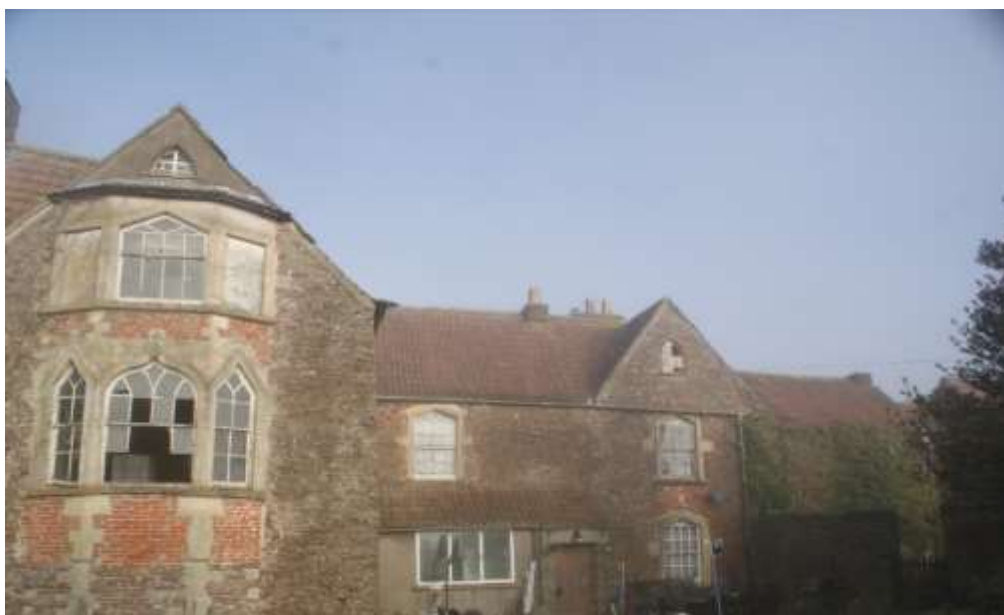
Ref.: IRO1

Condition: Like a number of farmhouses, it is not being maintained to its required level and has suffered from some unsympathetic alterations. Its condition will continue to deteriorate and as can be seen in the photograph, a trend whet comes to farmhouses is the abandonment of a room rather than meet the cost of any repair to keep it liveable. This ultimately leads to the abandonment of the house and a subsequently loss of fabric due to decay and ultimately structural failure. Unless the decent in its condition is addressed, there is a long-term concern about sustainability of the building.

Overall Condition: Poor

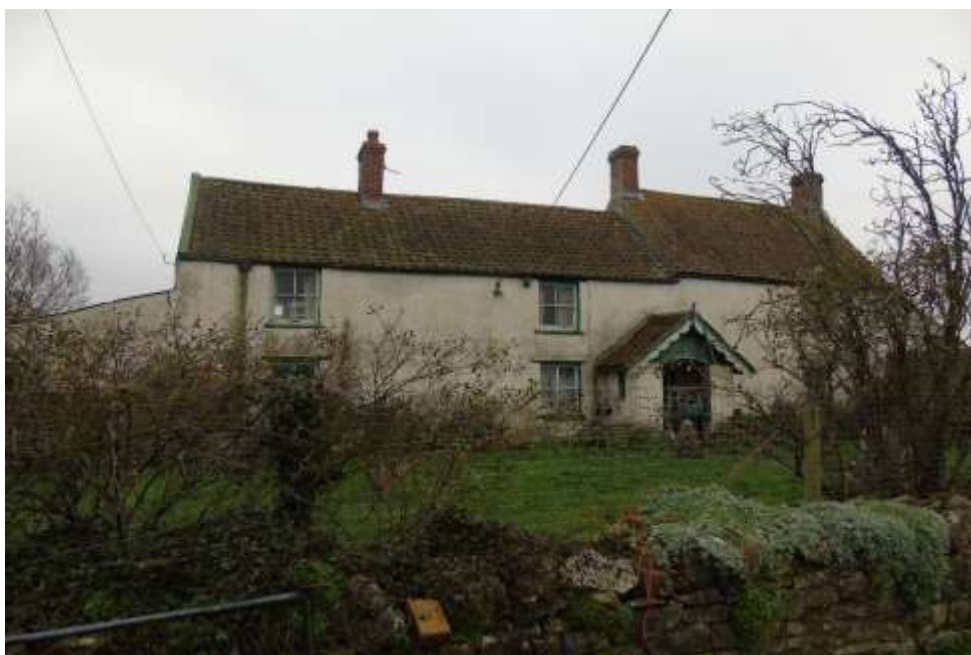
Ref.: ALM1

Condition: Windows and doors significantly decayed with some limited surviving historic glass. Guttering also failing – blocked downpipes evident. Overall appears to be in poor condition and in a state of abandonment. If allowed to deteriorate, there is a concern that the implications could go beyond what are hopefully relatively superficial matters which can be addressed.

Overall Condition: Poor

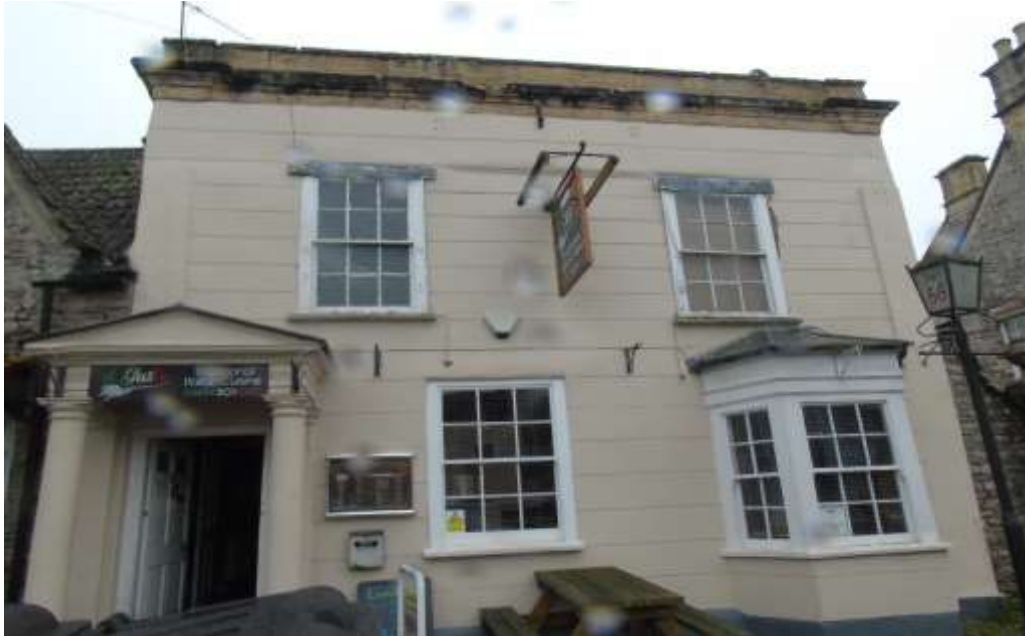
Ref.:SOD5

Overall Condition: Poor

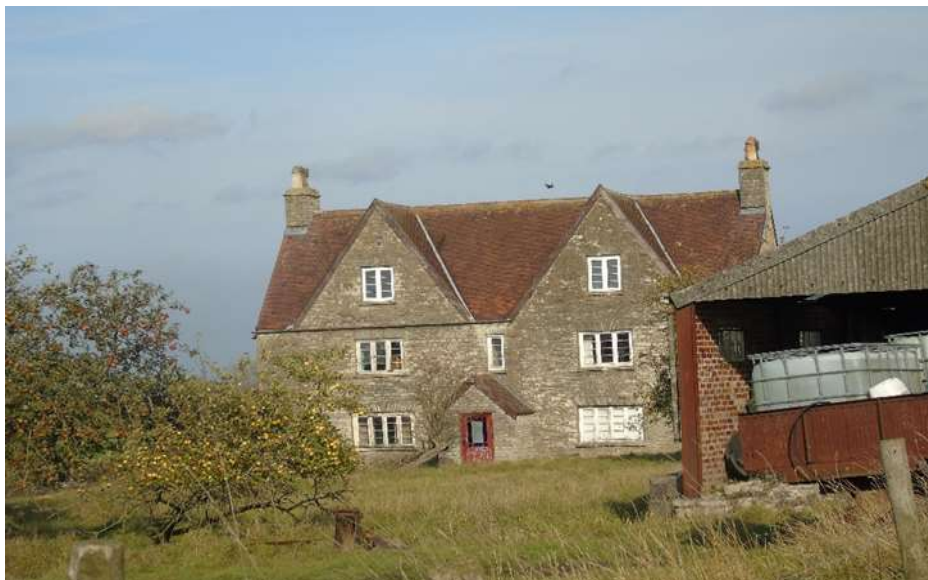
Ref.:WES1

Condition: Clear signs of lack of any meaningful maintenance – loss of sub-sills, all windows and doors in need of redecoration. Structurally sound but lack of use is a concern as will continue to deteriorate when windows already allowing the elements into the house.

Overall Condition: Fair/Poor

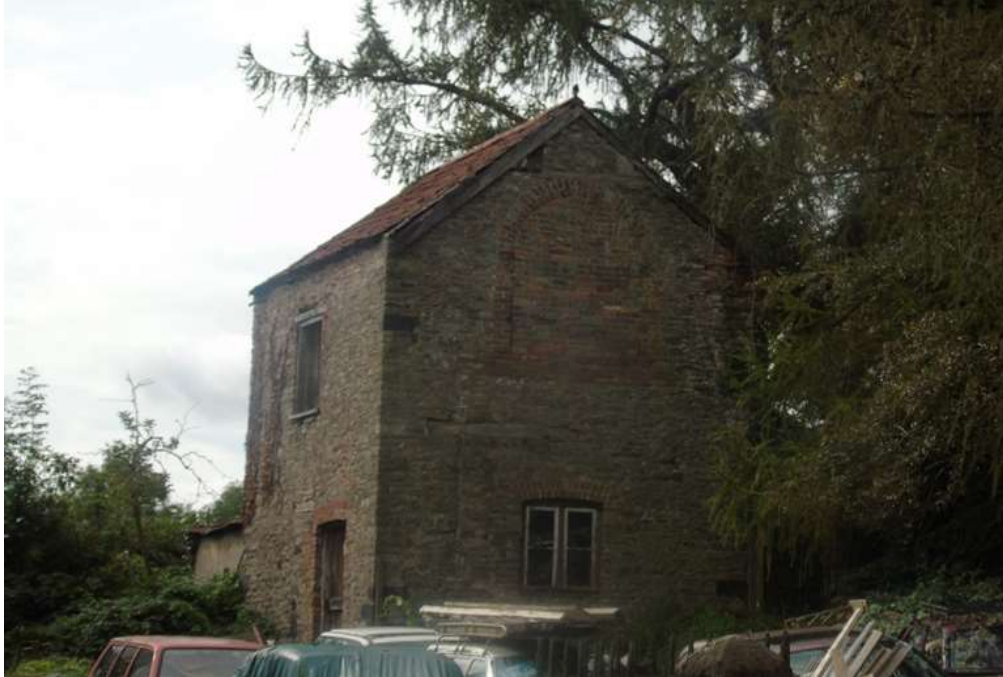
Ref.: KIN1

Condition: Roof in poor condition with overgrown tree adjacent causing likely impact damage. Rainwater goods lost and all doors and windows in poor condition. Significant vertical crack to roadside elevation with also areas of failing masonry to eaves – to the right of the bricked up arched opening to first floor.

Date of last survey	07/09/2020	Occupancy	Occupied
PRN	4797	Use	Storage
Roof	Very bad	Walls	Poor
Chimneys	n/a	Rainwater Goods	Missing
Doors/Windows	Very bad

Overall Condition: Poor

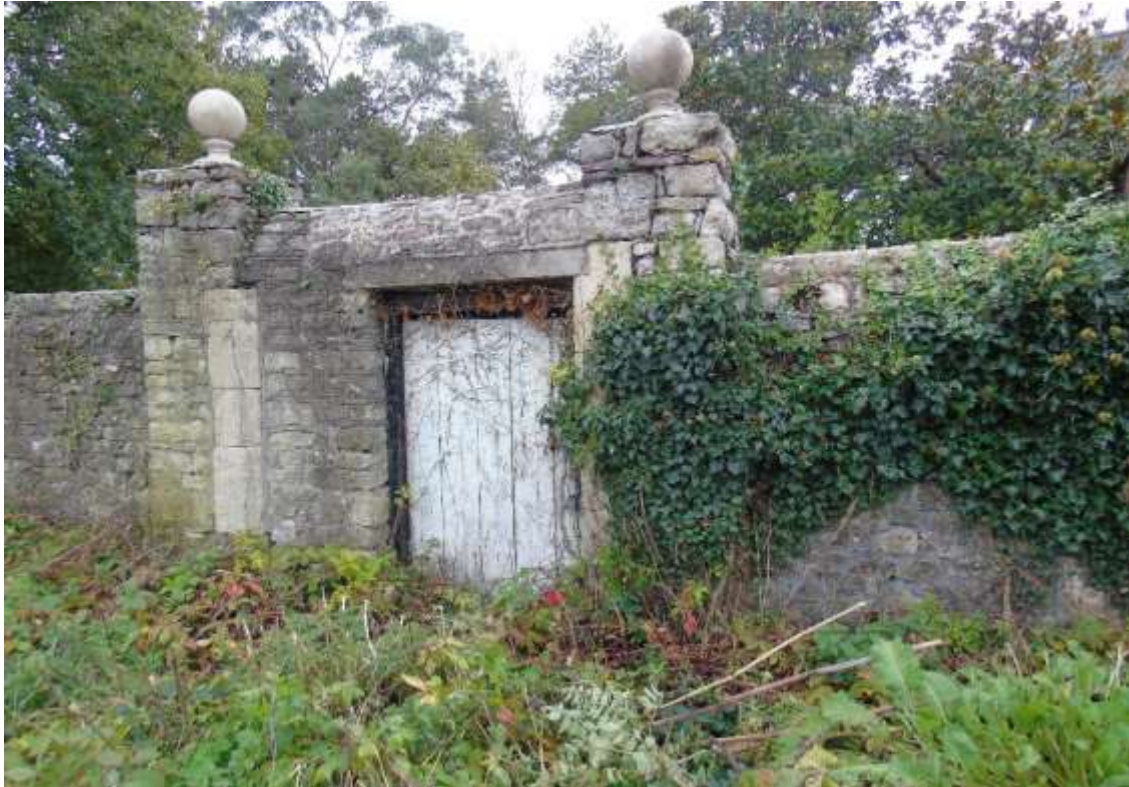
Ref.: AUS1

Condition: Washed out joints to tops of piers and in need of consolidation. The ashlar cornice missing with concrete lintel cut into an ashlar jamb.

Overall Condition: Poor

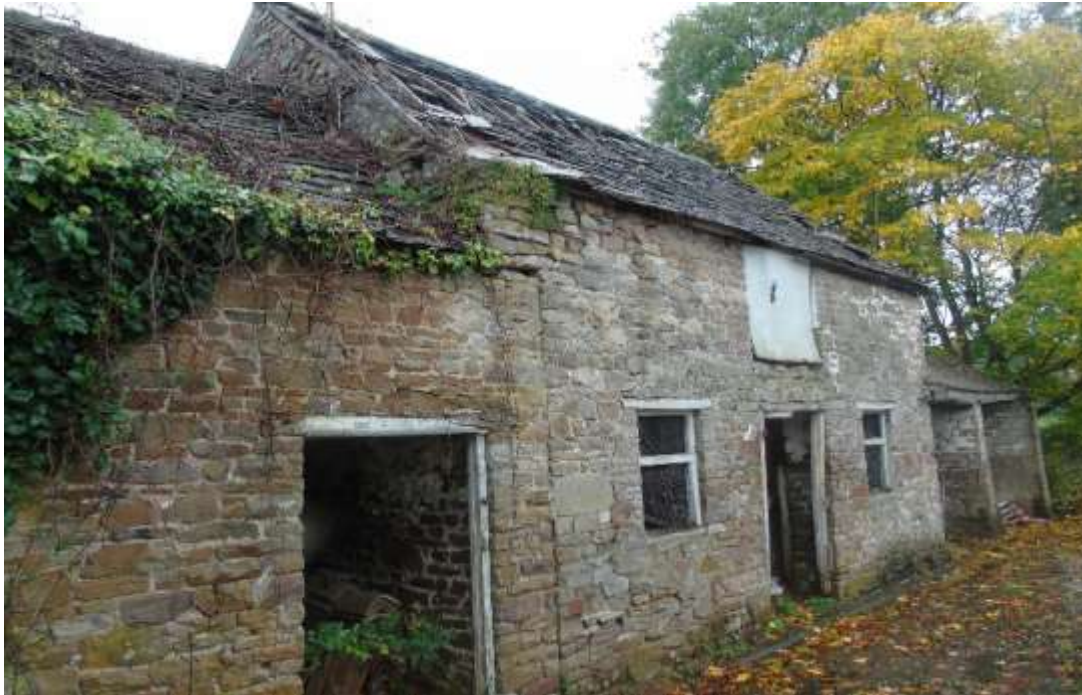
Ref.: WIC2

Condition: The outbuildings (barn and bakehouse) in poor/ very bad condition – lack of any maintenance has led to lost roofs, rotting structural timbers and resulting cracking and failing masonry.

Overall Condition: Very bad

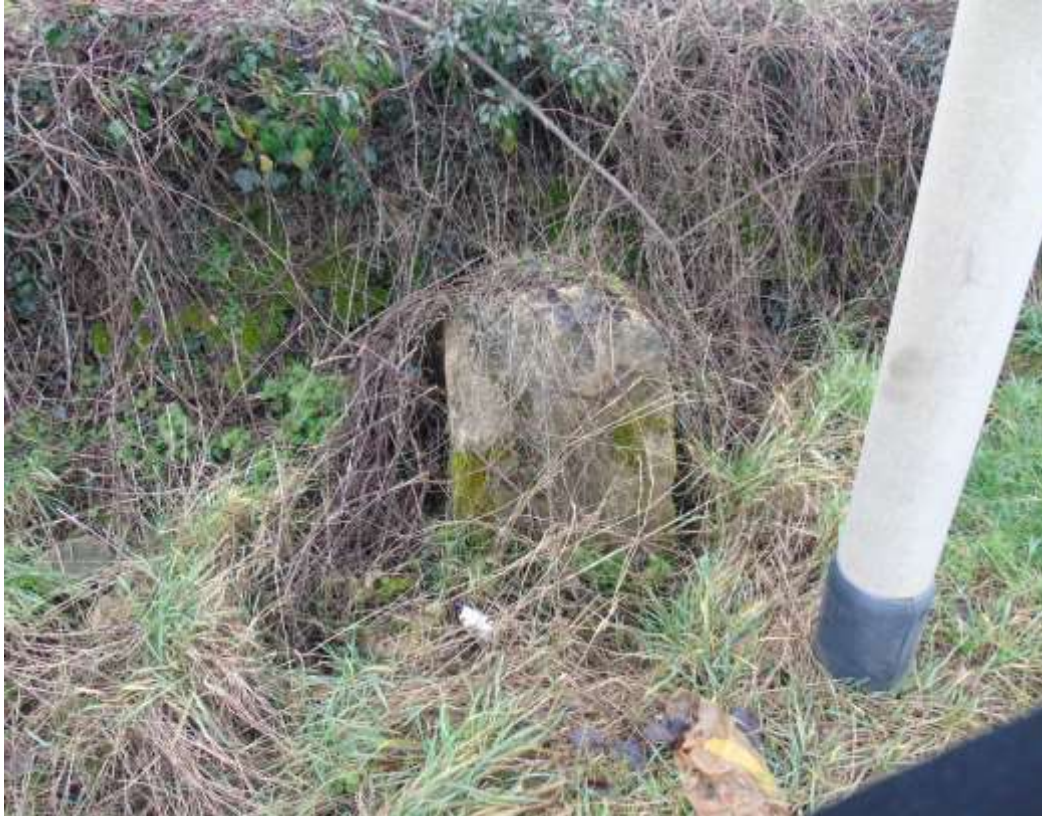
Ref.: SOD6

Condition: Cast iron fixed plate has been lost as is gradually the presence of this feature from the roadside.

Overall Condition: Very bad

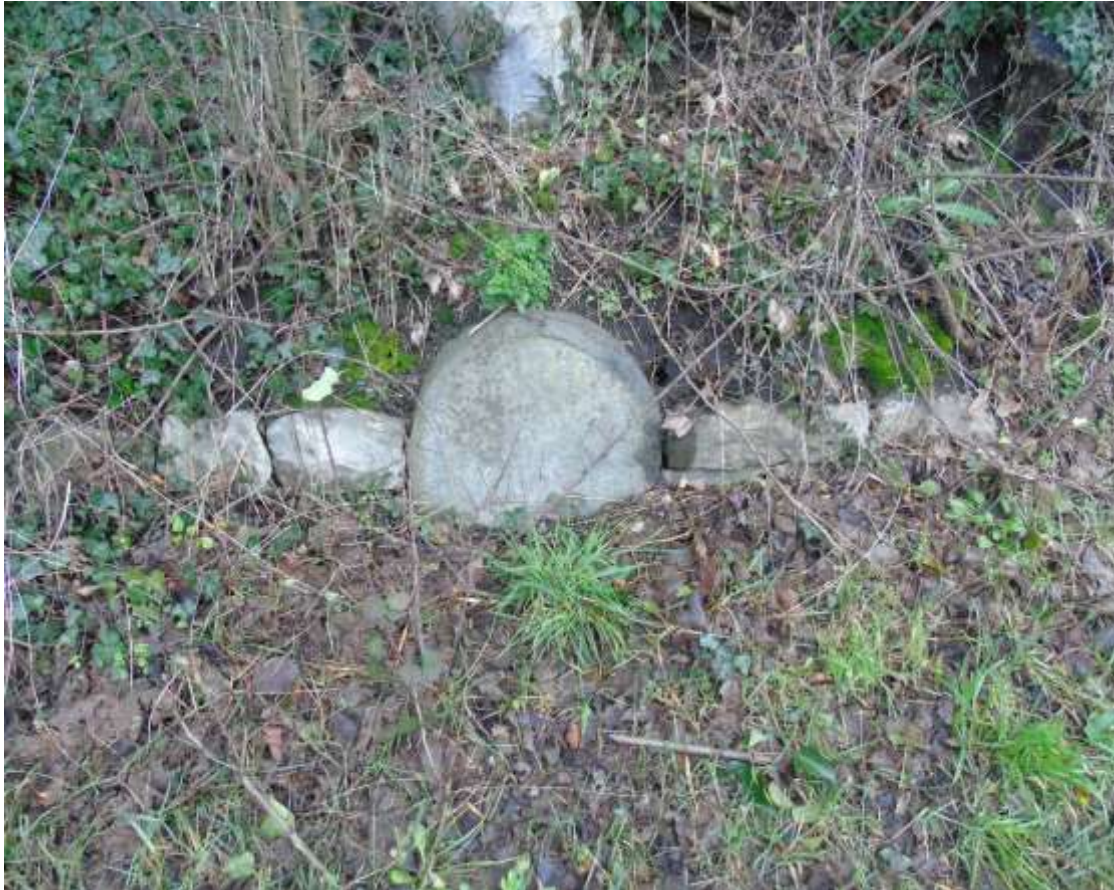
Ref.: SOD7

Condition: Appears to be sinking into the ground and all lettering now largely indiscernible. Fragments of the white paint used to distinguish the letters remain at close inspect, but in clear need of some restoration and reducing ground level would also help.

Overall Condition: Poor

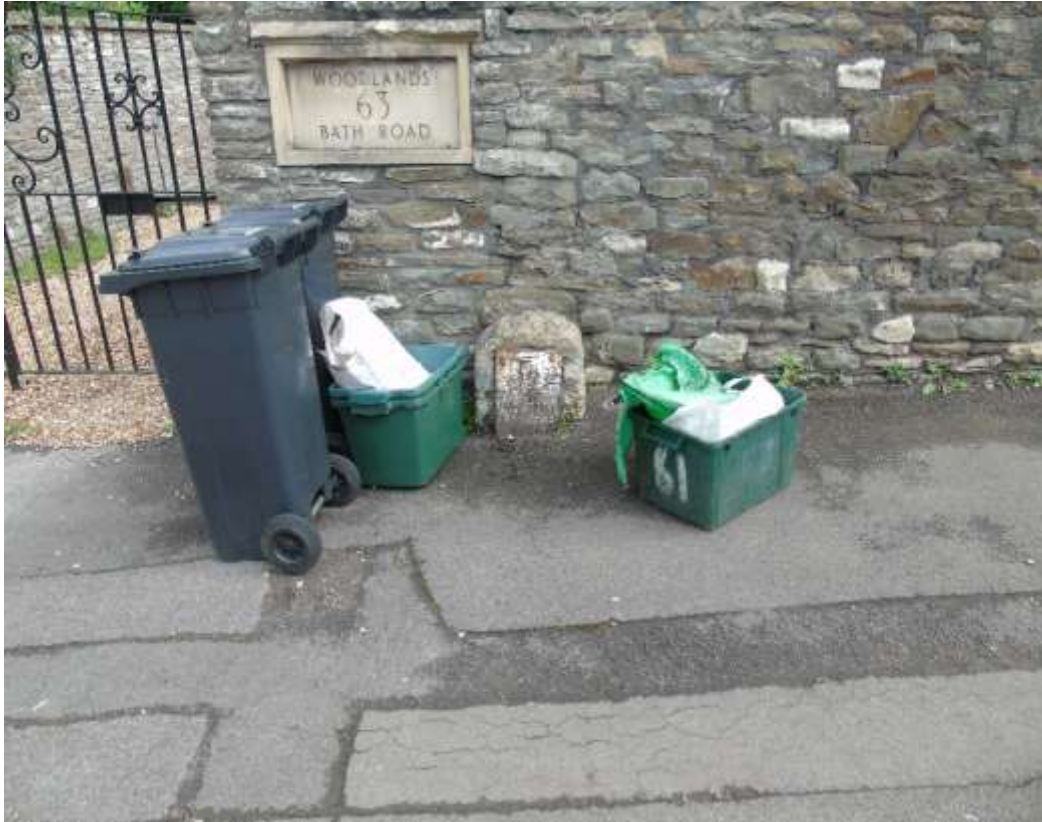
Ref.: OLD1

Condition: Cast iron plaque in poor condition and as noted in listed above, now partially submerged. The stone itself is showing signs of erosion but the prominence of this feature has already been compromised and risks being lost for good.

Overall Condition: Poor

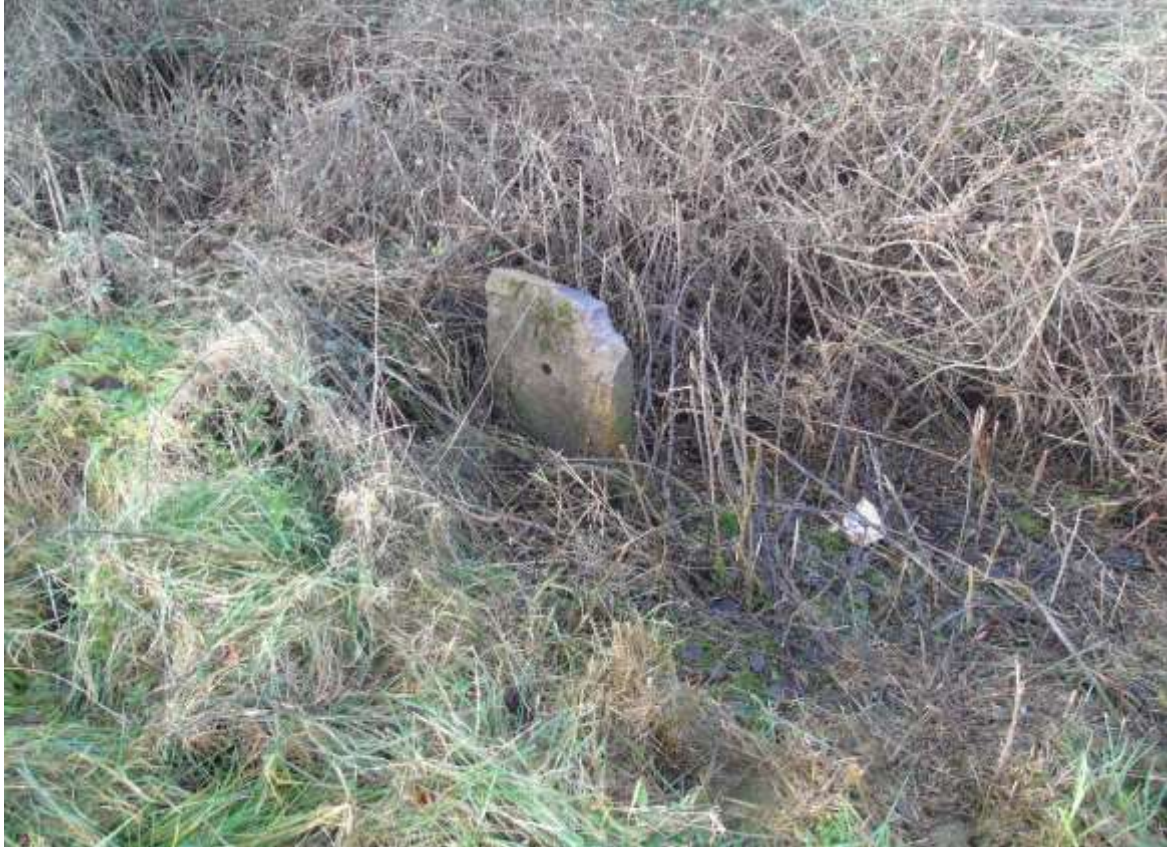
Ref.: HAW3

Condition: Iron plate lost and been subject to some heavy impact damage – either as result of the theft of the plate or through landscape management works. Again, like other milestones, the prominence of this historic feature has been all but lost.

Overall Condition: Very bad

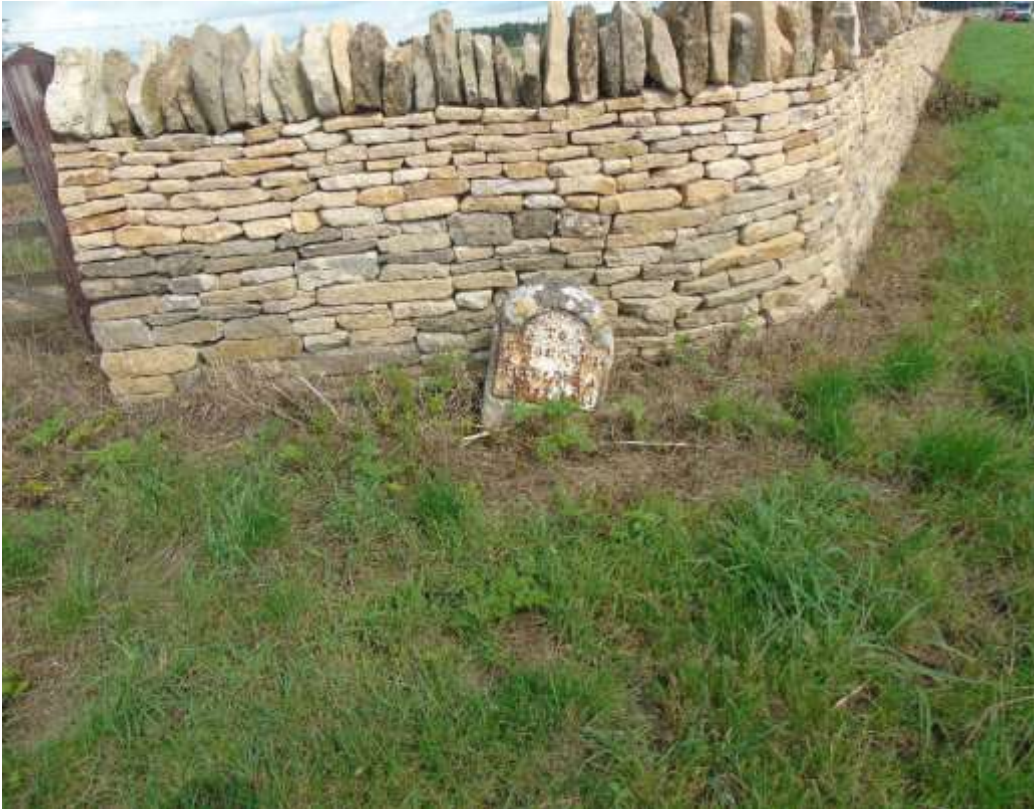
Ref.: DYR1

Condition: The cast iron plate remains in situ but could do with restoration as painted finish being lost to surface corrosion. Also dropped on one side and so could be with resetting. As with other milestone on this list, the potential contribution this feature should make to the immediate area has been significantly lost and so its future maintenance remains a concern.

Overall Condition: Poor

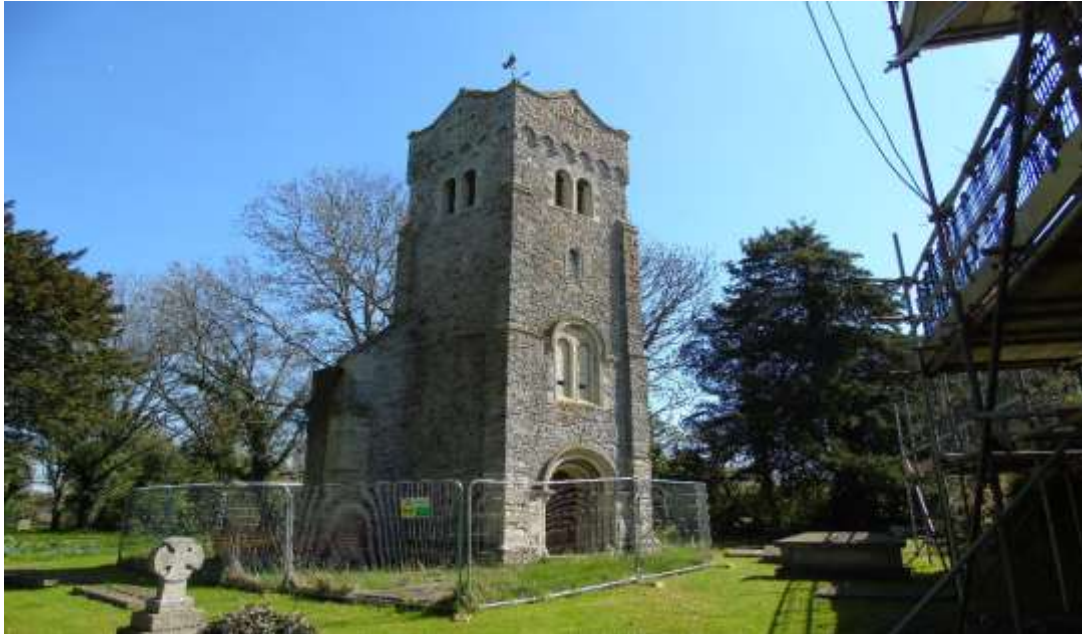
Ref.: PIL1

Condition: Ruinous. Several fractures in stonework to the tower -trackable through masonry and dressed stone windows surrounds. Remnants of nave detaching itself from tower structure with large cracks running along the joints. Roof also understood to be in poor condition. In clear need of some consolidation and investigation into possible settlement of foundations and subsequent remedial works.

Overall Condition: Poor

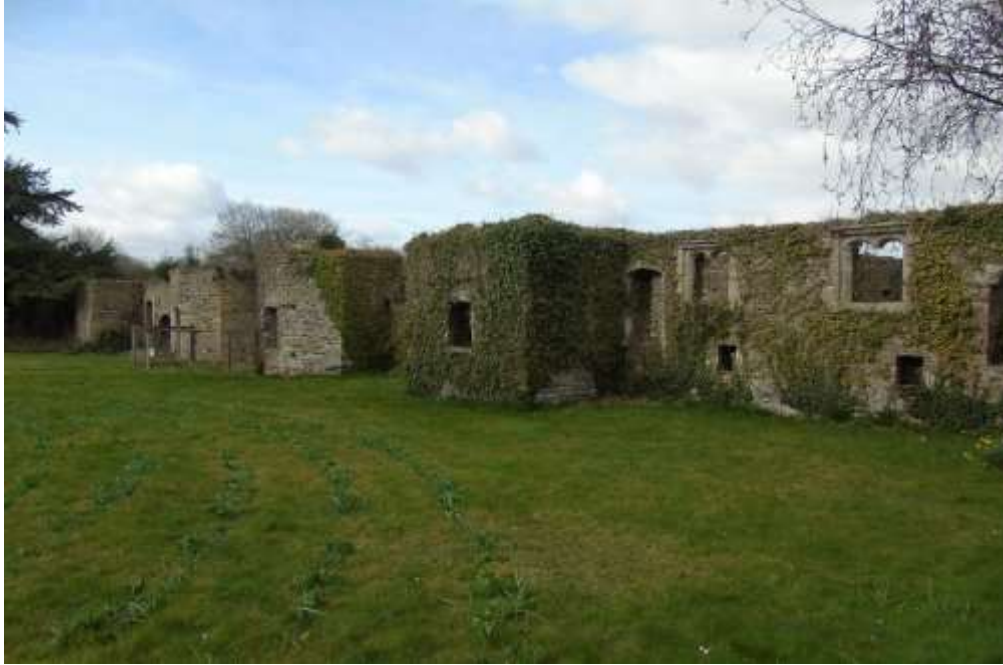
Ref.: THO2

Condition: Asset is expansive in nature but generally it is slowly disintegrating due to a combination of lack of maintenance, invasive planting and exposed walls tops/ core. A scheme of consolidation to stabilise the structure is clearly needed.

Overall Condition: Poor

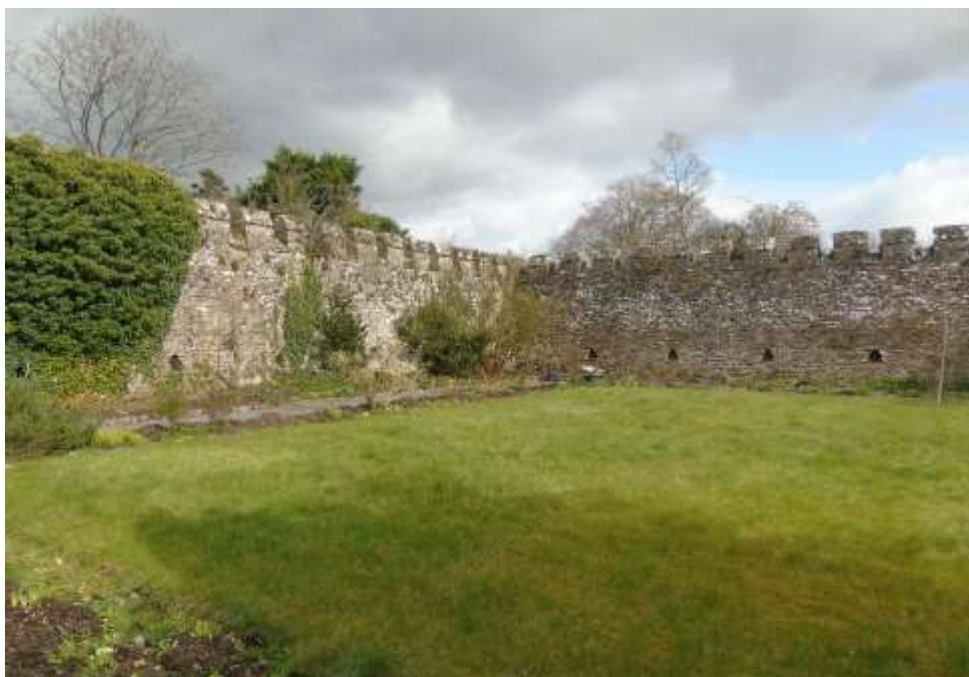
Ref.: THO3

Condition: Embattled parapets covered in ivy and invasive vegetation has penetrated masonry which Same for a number of buttresses. Areas of hungry joints with bedding mortar being eroded. Arches failing and core of wall exposed. In clear need of consolidation/ repointing.

Overall Condition: Poor

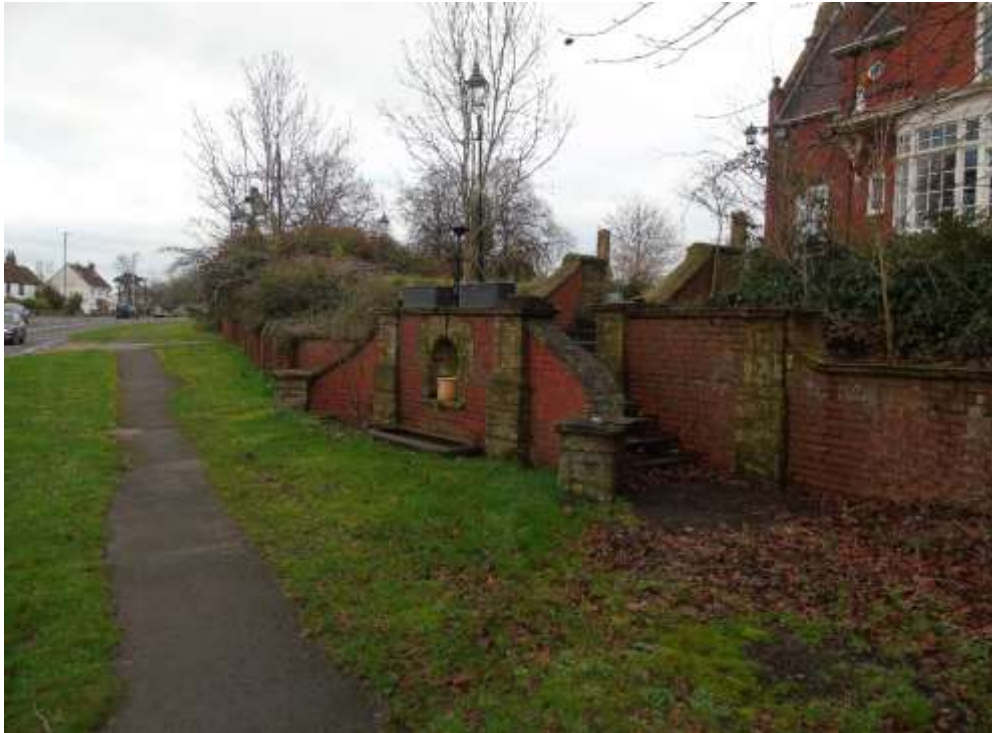
Ref.:ALM2

Condition: Due to lateral pressures being exerted from behind, there are both cracks in brick piers but also horizontal shear approximately 4 courses up from ground. Other brick piers with dressed stone copings have settled and other dressed stone features in poor condition. Sections also covered in ivy and being lost from view.

Overall Condition: Poor

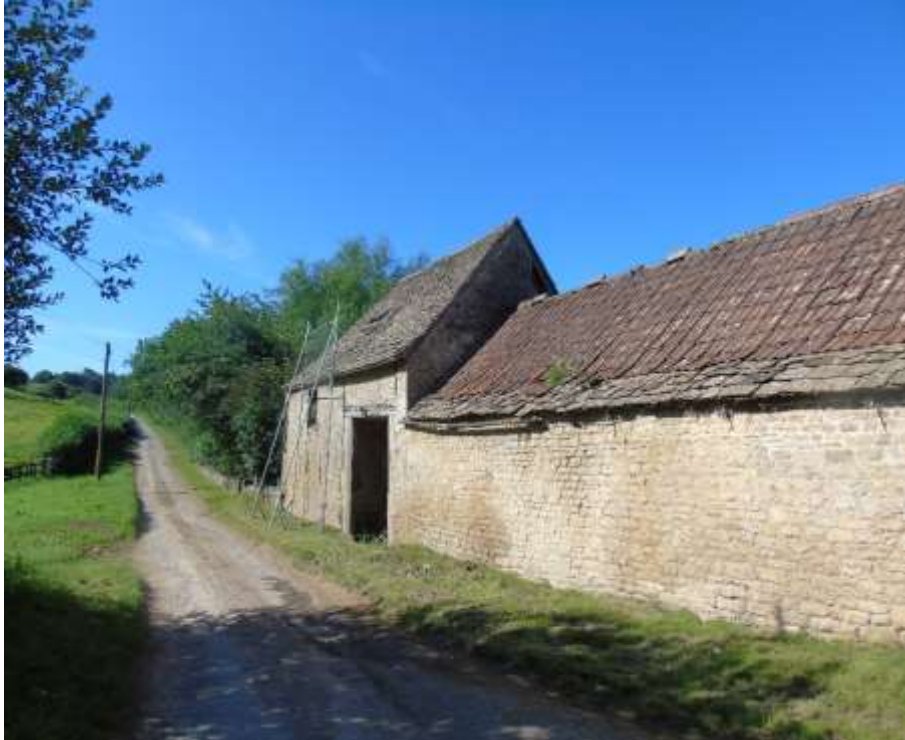
Ref.: HAW4

Partially occupied. Unoccupied parts have suffered significant water ingress in the past. Re-roofed since then, Patch repair of stone slate on single storey range recently completed.

Overall Condition: Poor

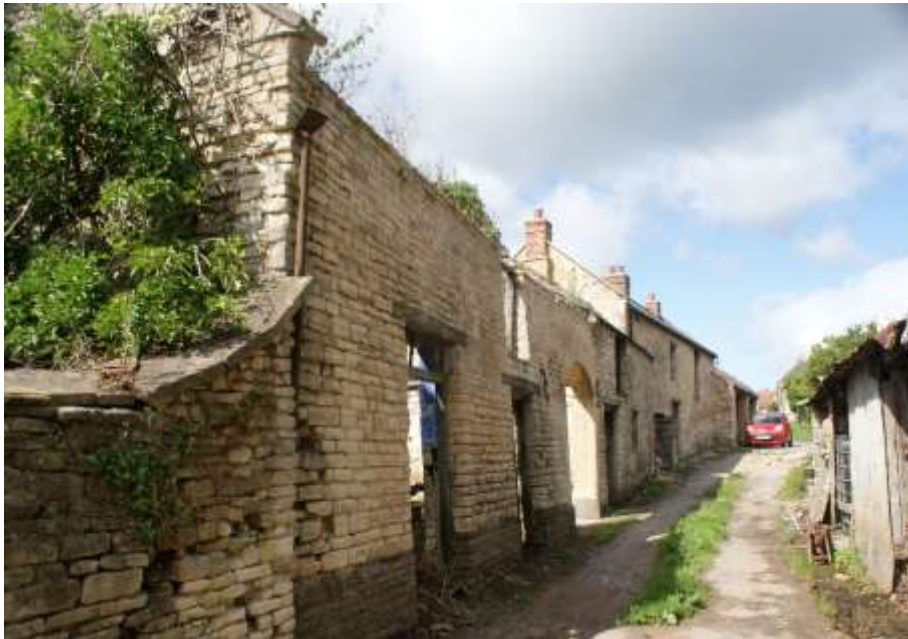
Ref: MAR3

Condition: Main house considered to be in fair condition bar wall of former wing to the left, this doesn't appear to be restrained and appears unstable with fragile stonework with washed out joints and broken transoms. The considered of the ruinous curtilage listed range of outbuildings to the south and east of the house also a concern.

Overall Condition: Fair to Very Bad

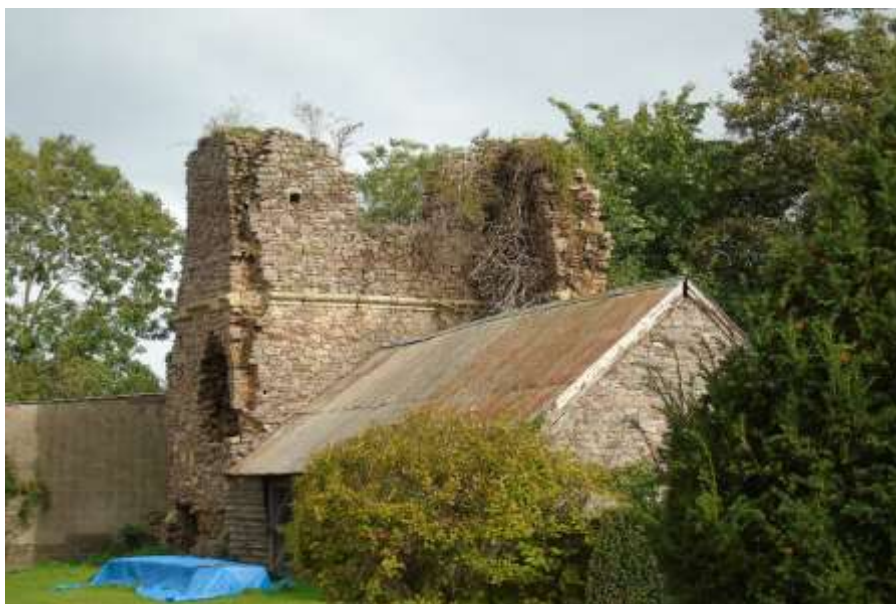
Ref: YAT1

Overall Condition: Poor

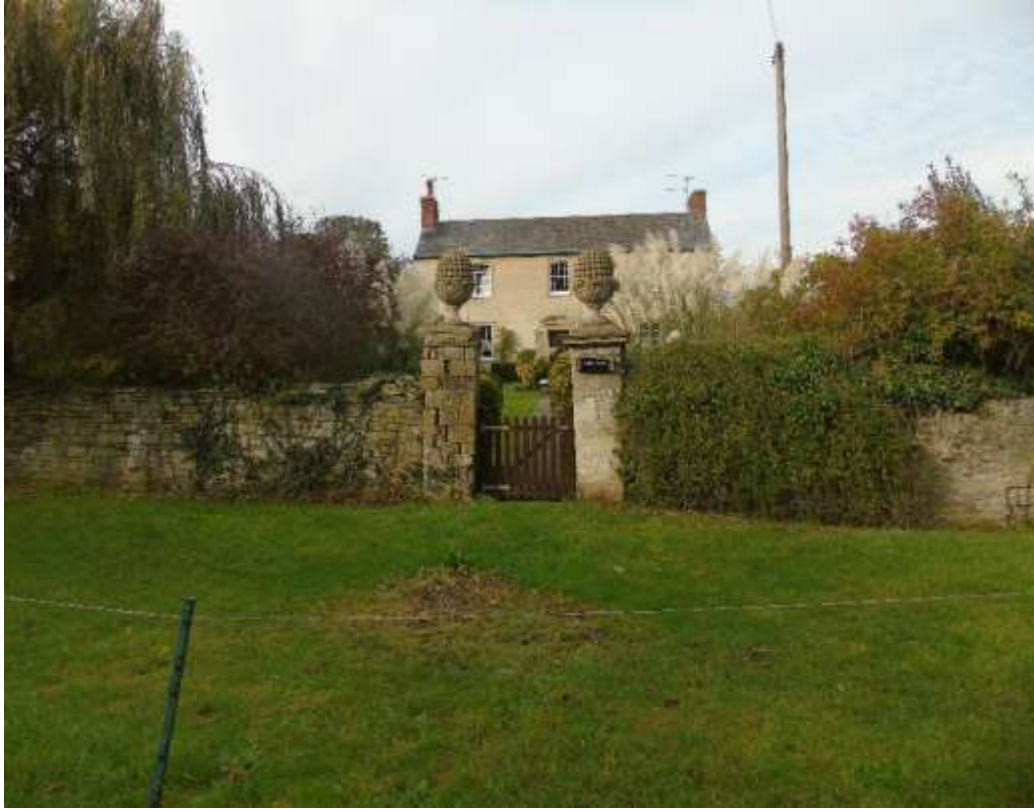
Ref.:OLV1

Overall Condition: Very Bad
Priority Category: C
