SOUTH GLOUCESTERSHIRE COUNCIL - REGISTER OF BUILDINGS AT RISK JULY 2022

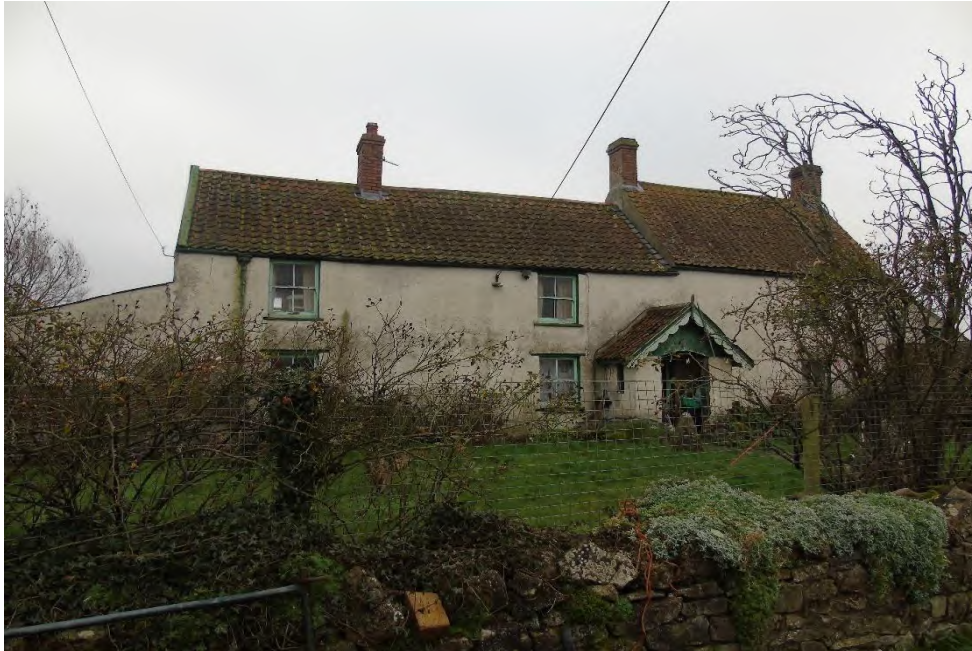
Ref.: ALM1

Condition: Windows and doors significantly decayed with some limited surviving historic glass. Guttering also failing – blocked downpipes evident. Overall appears to be in poor condition and in a state of abandonment. If allowed to deteriorate, there is a concern that the implications could go beyond what are hopefully relatively superficial matters which can be addressed.

Overall Condition: Poor

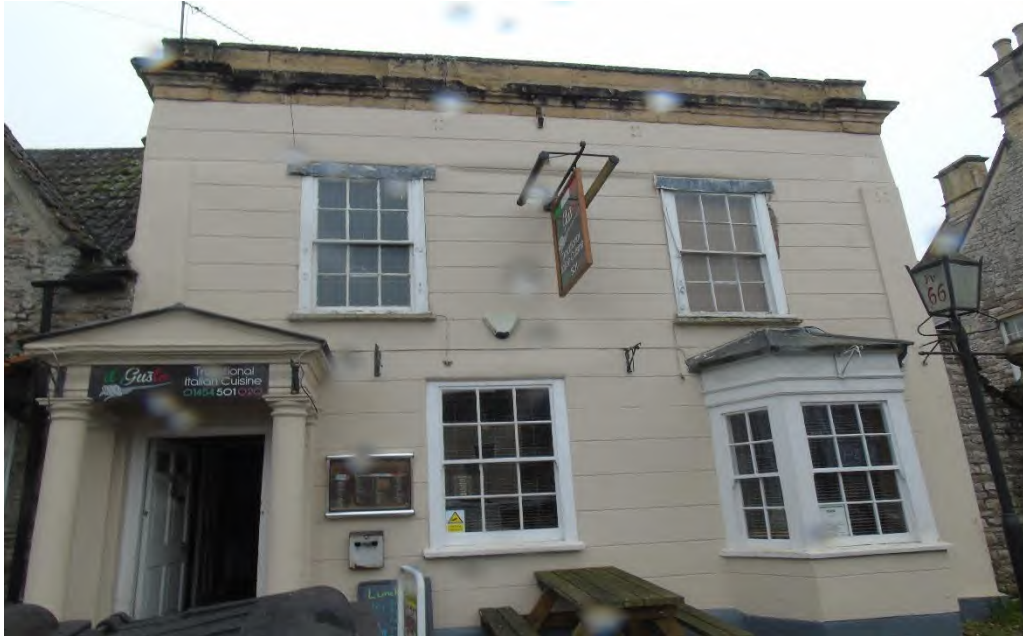
Ref.:SOD5

Overall Condition: Poor

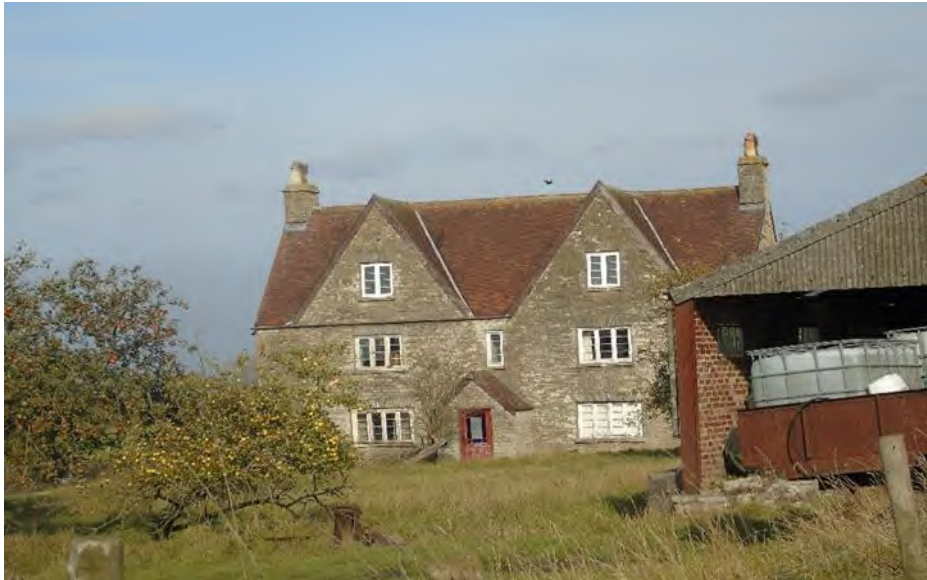
Ref.:WES1

Condition: Clear signs of lack of any meaningful maintenance – loss of sub-sills, all windows and doors in need of redecoration. Structurally sound but lack of use is a concern as will continue to deteriorate when windows already allowing the elements into the house.

Overall Condition: Fair/Poor

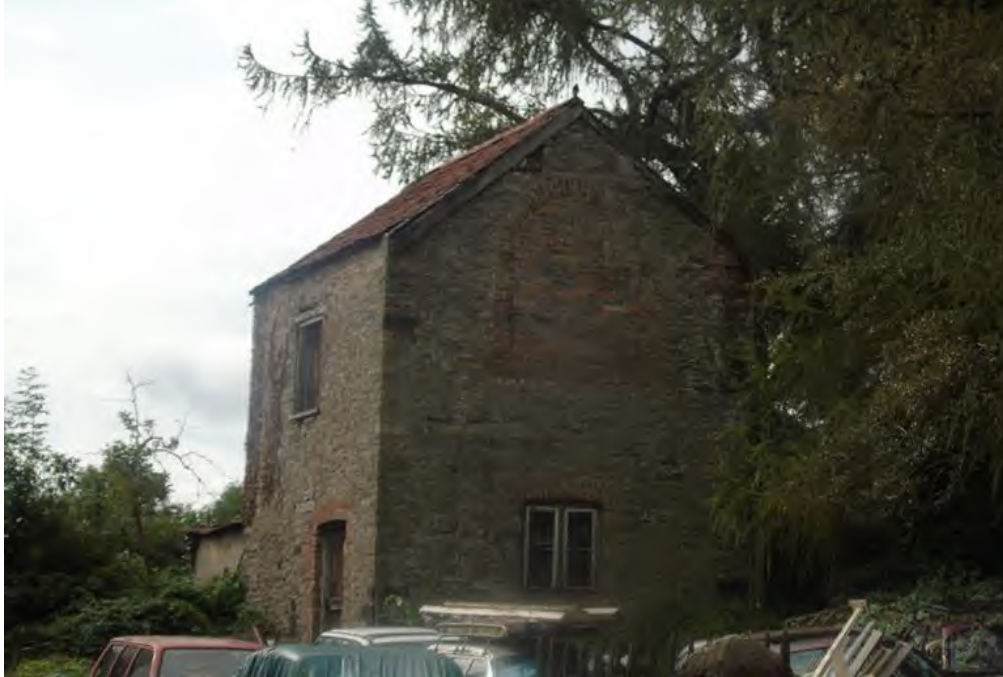
Ref.: KIN1

Condition: Roof in poor condition with overgrown tree adjacent causing likely impact damage. Rainwater goods lost and all doors and windows in poor condition. Significant vertical crack to roadside elevation with also areas of failing masonry to eaves – to the right of the bricked up arched opening to first floor.

Date of last survey	07/09/2020	Occupancy	Occupied
PRN	4797	Use	Storage
Roof	Very bad	Walls	Poor
Chimneys	n/a	Rainwater Goods	Missing
Doors/Windows	Very bad

Overall Condition: Poor

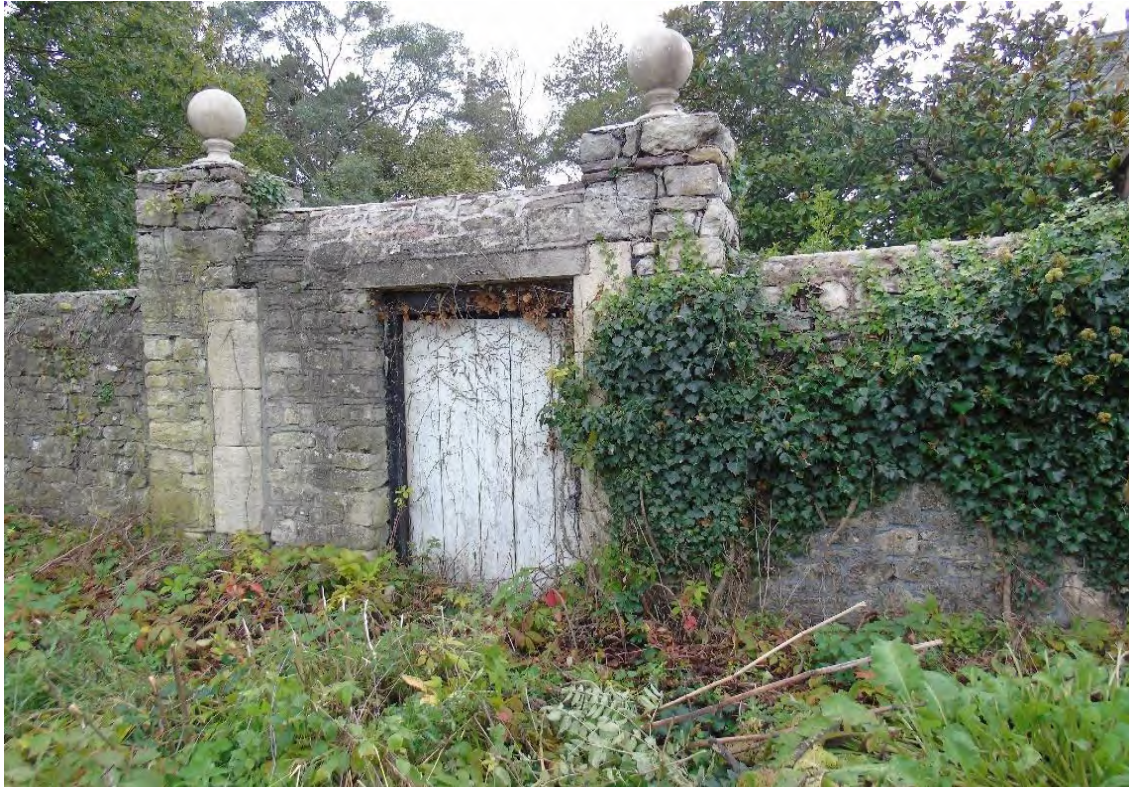
Ref.: AUS1

Condition: Washed out joints to tops of piers and in need of consolidation. The ashlar cornice missing with concrete lintel cut into an ashlar jamb.

Overall Condition: Poor

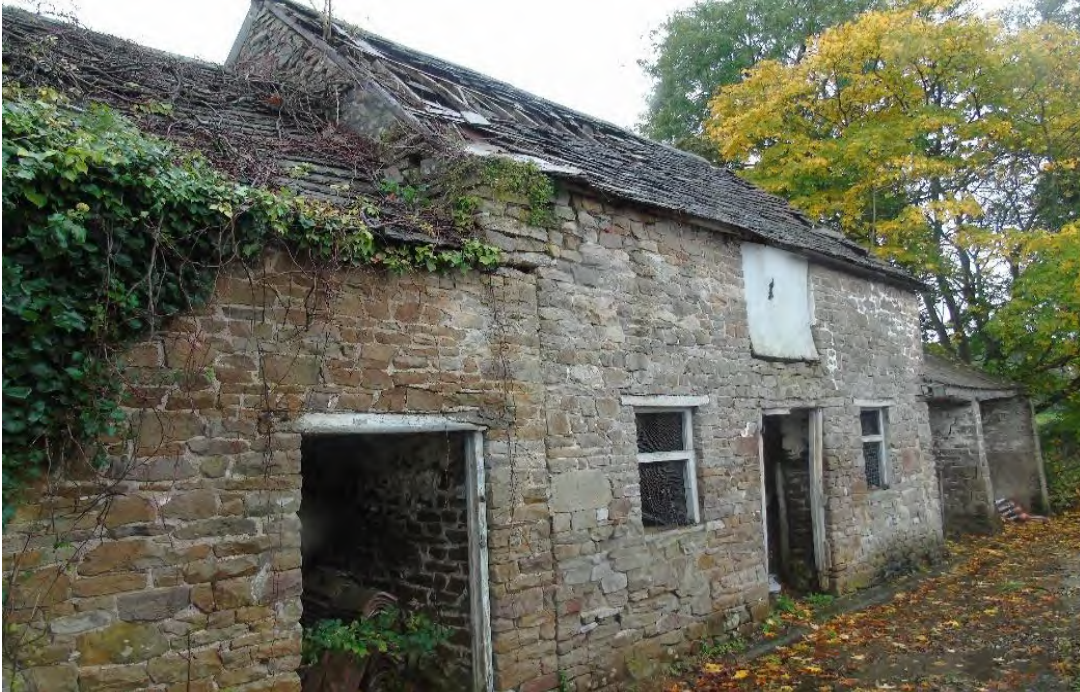
Ref.: WIC2

Condition: The outbuildings (barn and bakehouse) in poor/ very bad condition – lack of any maintenance has led to lost roofs, rotting structural timbers and resulting cracking and failing masonry.

Overall Condition: Very bad

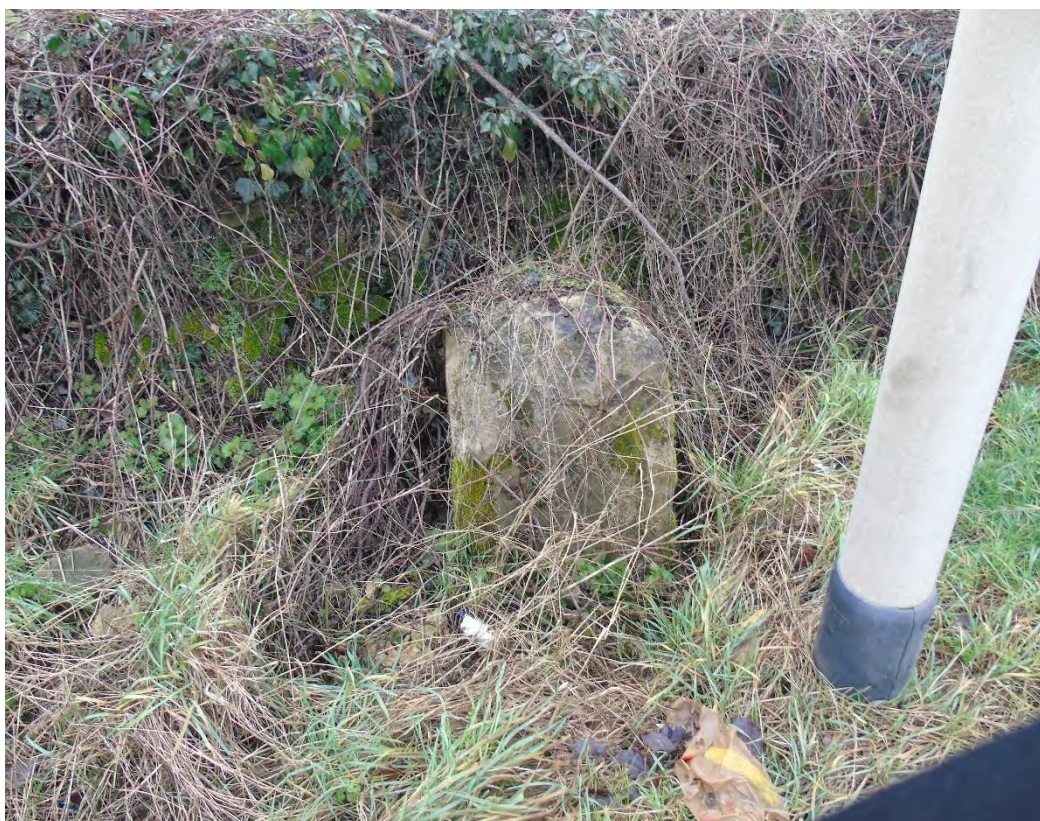
Ref.: SOD6

Condition: Cast iron fixed plate has been lost as is gradually the presence of this feature from the roadside.

Overall Condition: Very bad

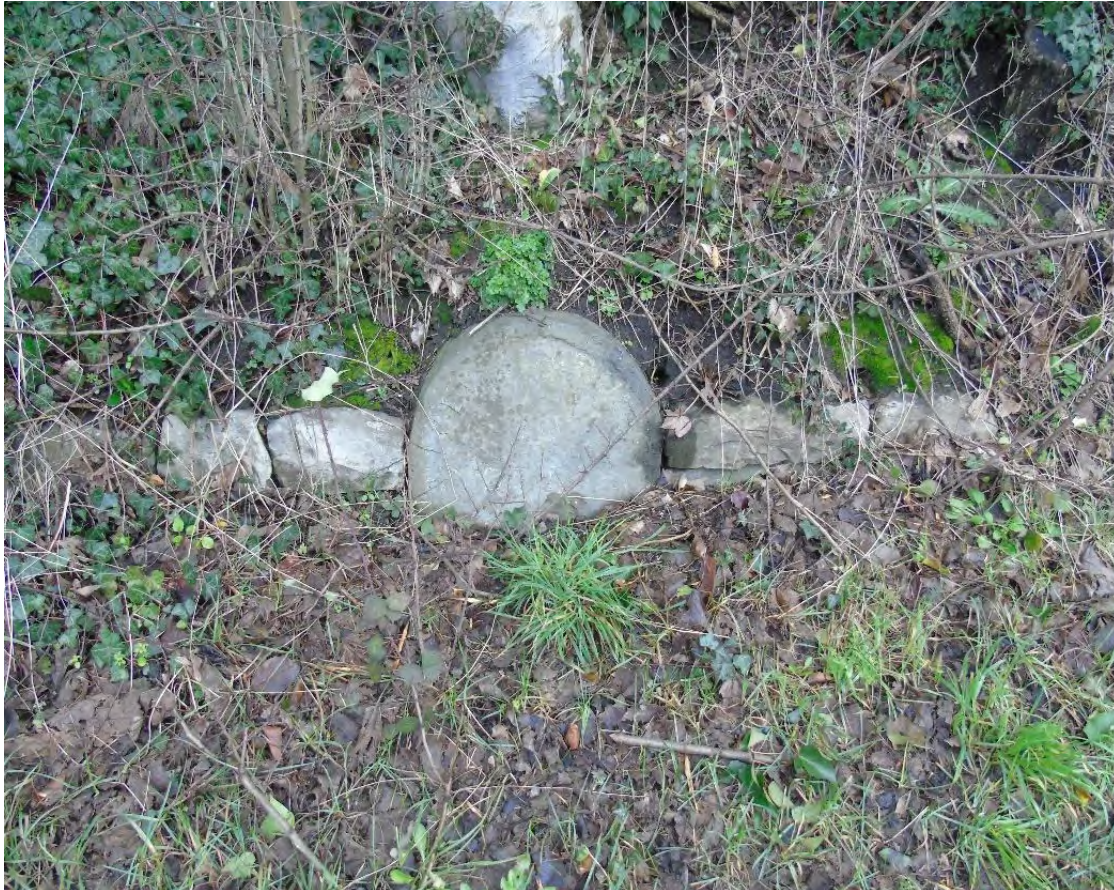
Ref.: SOD7

Condition: Appears to be sinking into the ground and all lettering now largely indiscernible. Fragments of the white paint used to distinguish the letters remain at close inspect, but in clear need of some restoration and reducing ground level would also help.

Overall Condition: Poor

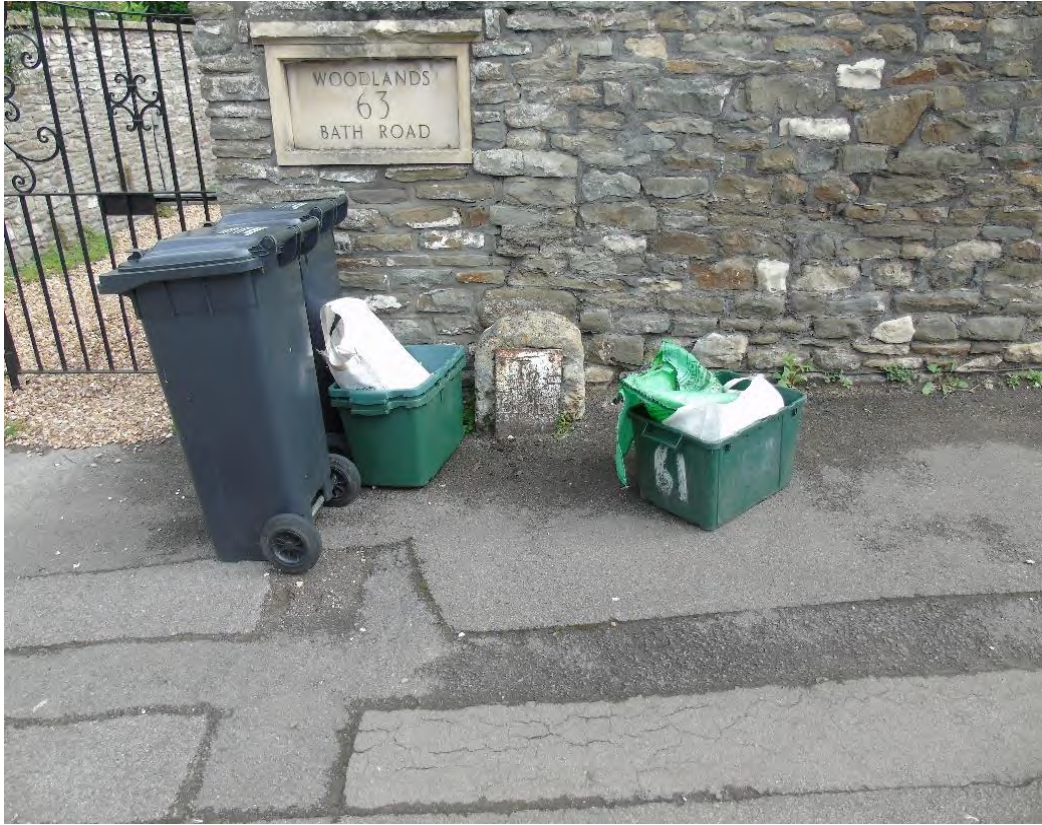
Ref.: OLD1

Condition: Cast iron plaque in poor condition and as noted in listed above, now partially submerged. The stone itself is showing signs of erosion but the prominence of this feature has already been compromised and risks being lost for good.

Overall Condition: Poor

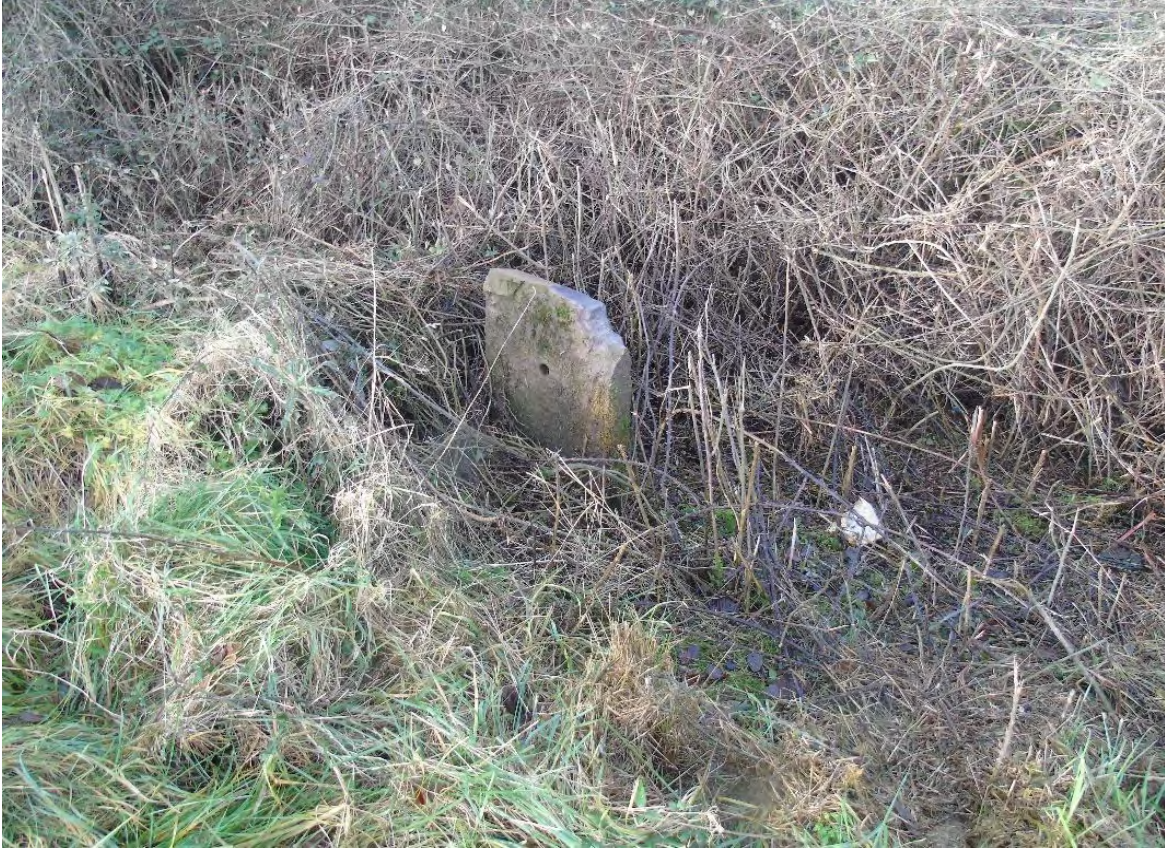
Ref.: HAW3

Condition: Iron plate lost and been subject to some heavy impact damage – either as result of the theft of the plate or through landscape management works. Again, like other milestones, the prominence of this historic feature has been all but lost.

Overall Condition: Very bad

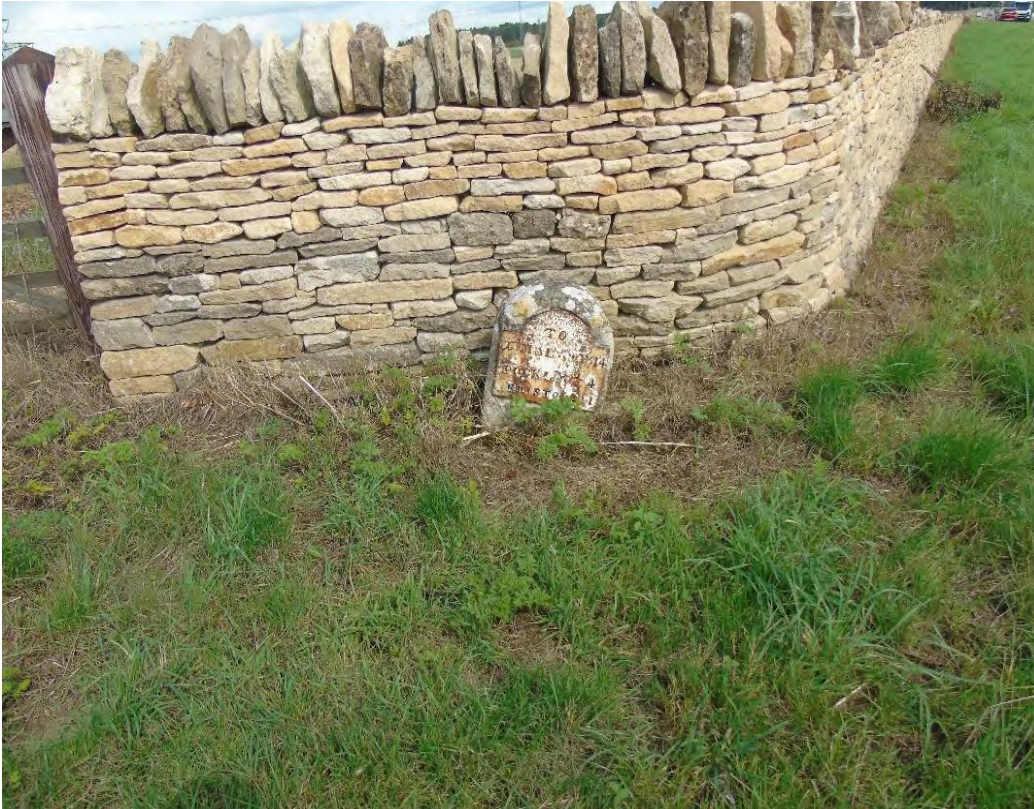
Ref.: DYR1

Condition: The cast iron plate remains in situ but could do with restoration as painted finish being lost to surface corrosion. Also dropped on one side and so could be with resetting. As with other milestone on this list, the potential contribution this feature should make to the immediate area has been significantly lost and so its future maintenance remains a concern.

Overall Condition: Poor

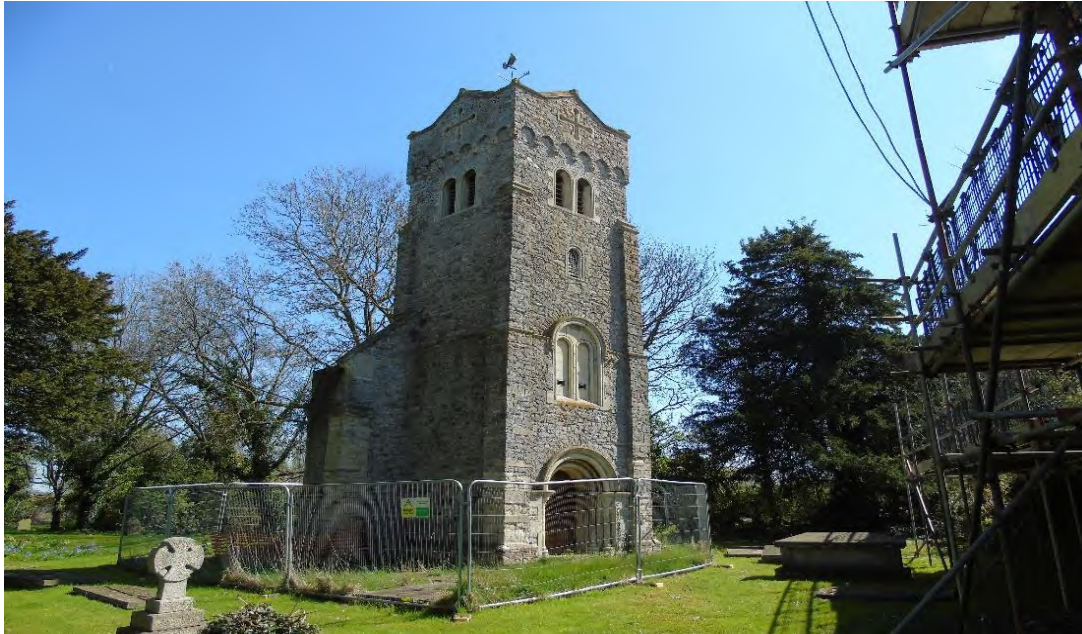
Ref.: PIL1

Condition: Ruinous. Several fractures in stonework to the tower -trackable through masonry and dressed stone windows surrounds. Remnants of nave detaching itself from tower structure with large cracks running along the joints. Roof also understood to be in poor condition. In clear need of some consolidation and investigation into possible settlement of foundations and subsequent remedial works.

Overall Condition: Poor

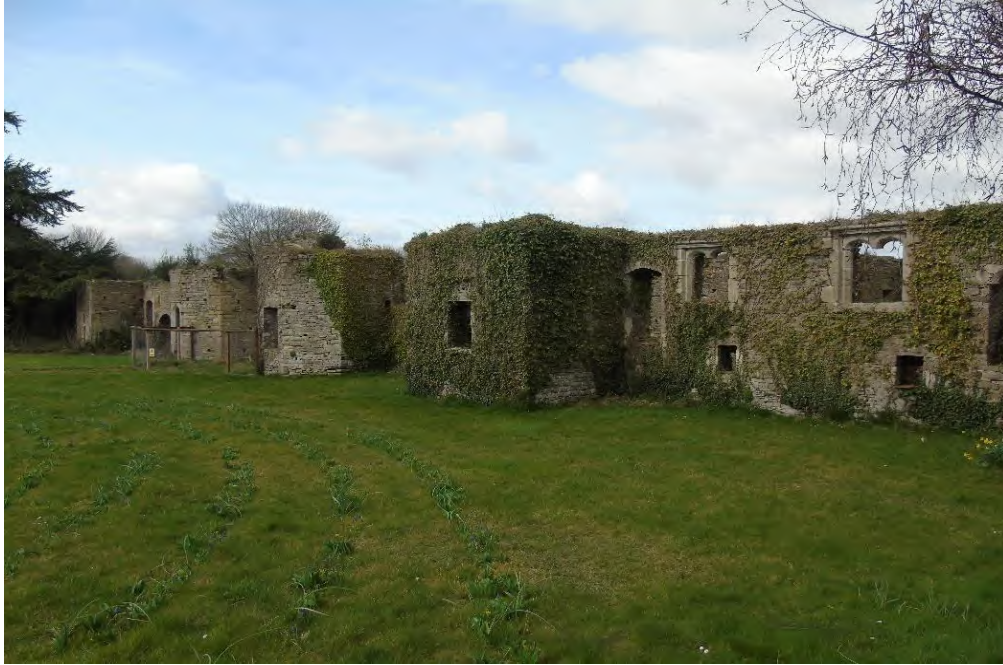
Ref.: THO2

Condition: Asset is expansive in nature but generally it is slowly disintegrating due to a combination of lack of maintenance, invasive planting and exposed walls tops/ core. A scheme of consolidation to stabilise the structure is clearly needed.

Overall Condition: Poor

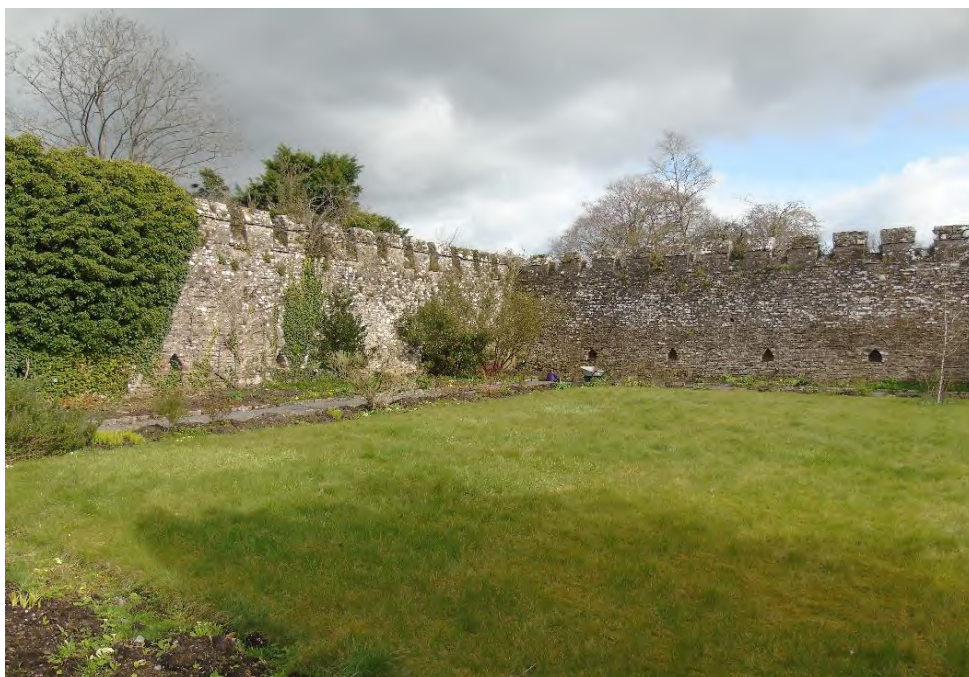
Ref.: THO3

Condition: Embattled parapets covered in ivy and invasive vegetation has penetrated masonry which Same for a number of buttresses. Areas of hungry joints with bedding mortar being eroded. Arches failing and core of wall exposed. In clear need of consolidation/ repointing.

Overall Condition: Poor

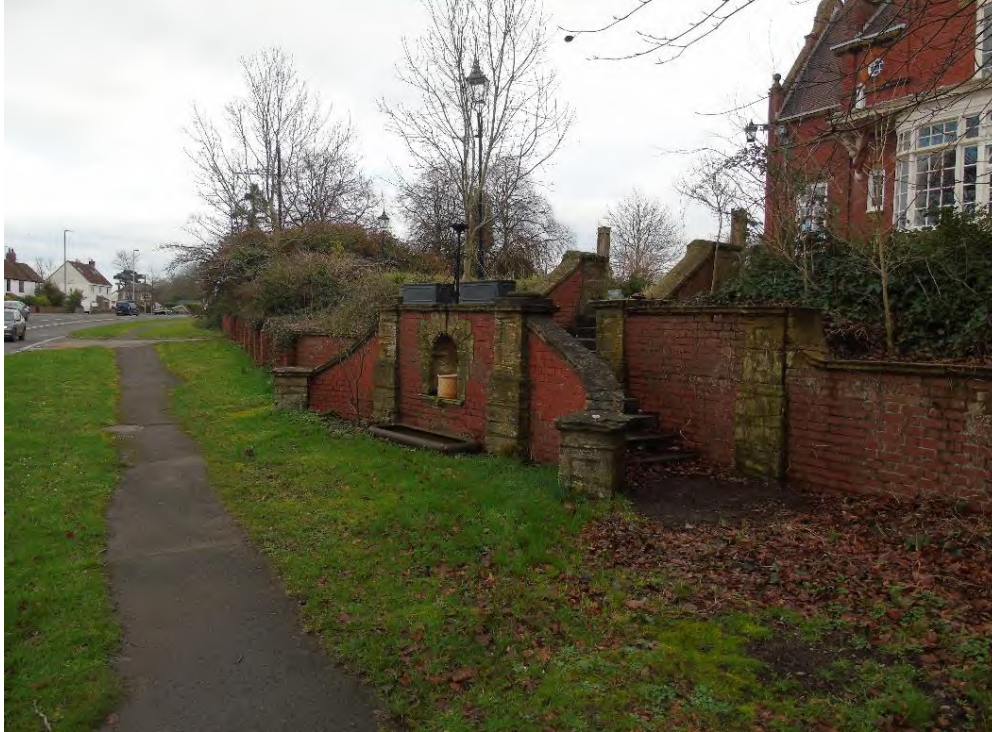
Ref.:ALM2

Condition: Due to lateral pressures being exerted from behind, there are both cracks in brick piers but also horizontal shear approximately 4 courses up from ground. Other brick piers with dressed stone copings have settled and other dressed stone features in poor condition. Sections also covered in ivy and being lost from view.

Overall Condition: Poor

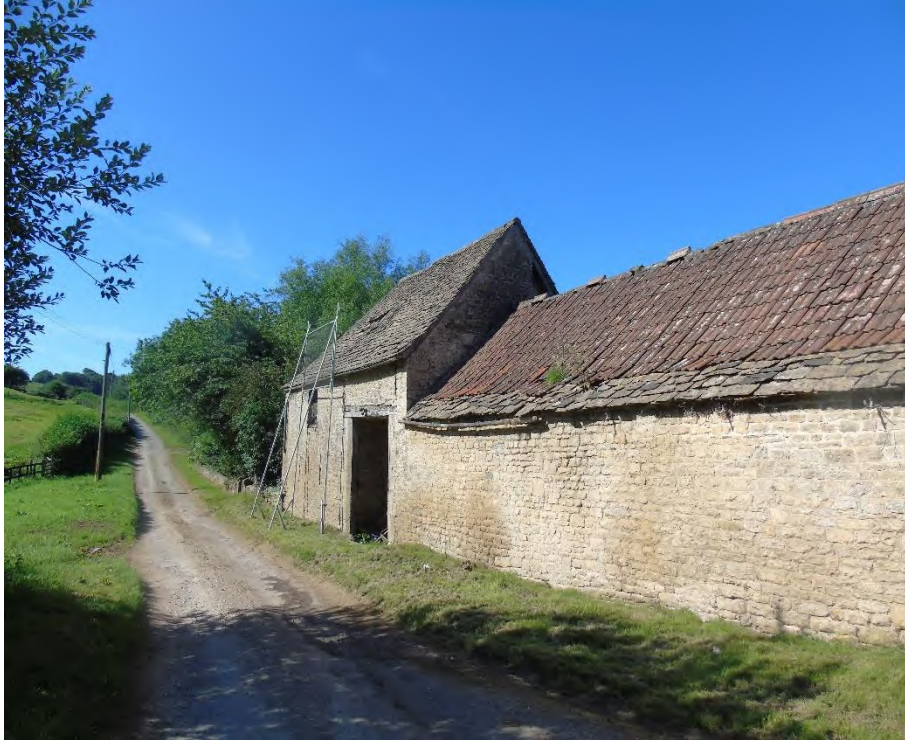
Ref.: HAW4

Partially occupied. Unoccupied parts have suffered significant water ingress in the past. Re-roofed since then, Patch repair of stone slate on single storey range recently completed.

Overall Condition: Poor

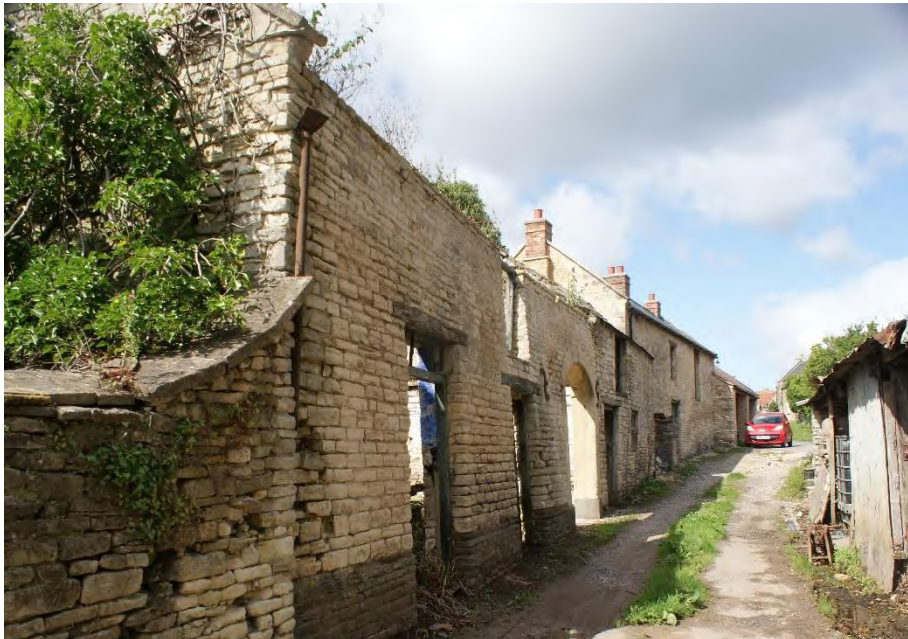
Ref: MAR3

Condition: Main house considered to be in fair condition bar wall of former wing to the left, this doesn't appear to be restrained and appears unstable with fragile stonework with washed out joints and broken transoms. The considered of the ruinous curtilage listed range of outbuildings to the south and east of the house also a concern.

Overall Condition: Fair to Very Bad

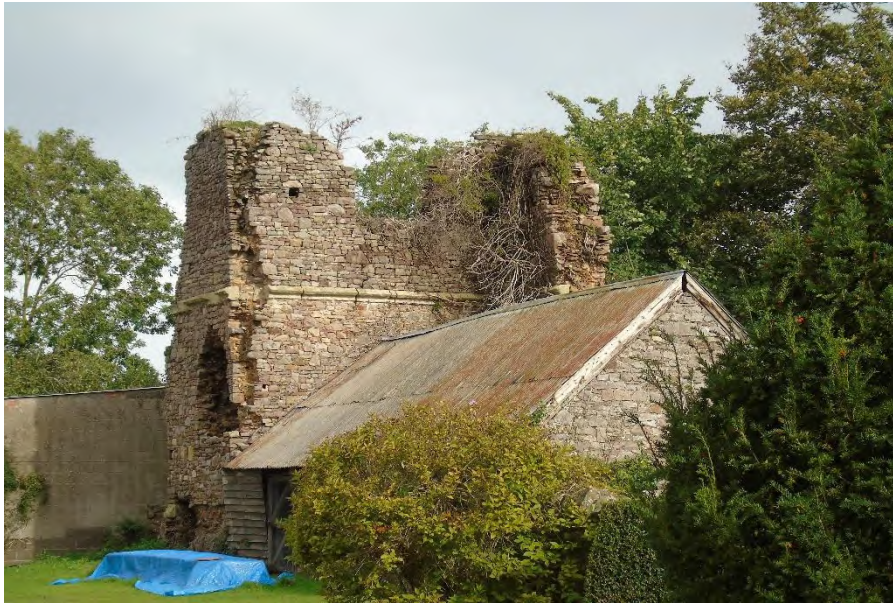
Ref: YAT1

Condition: Improving, as following scheme of consolidated secured via UU, the ivy has been treated and dieback being awaited where bedded into the structure and clearance where it has not. Wall tops still uncapped and loose masonry still falling. This though should be addressed by the scheme of consolidation approved but there is a significant time frame agreed and so one to monitor.

Date of last survey	11/10/2019	Occupancy	n/a
PRN	11788	Use	n/a
Roof	Missing	Walls	Poor to very bad
Chimneys	n/a	Rainwater Goods	Lost
Doors/Windows	n/a

Overall Condition: Poor

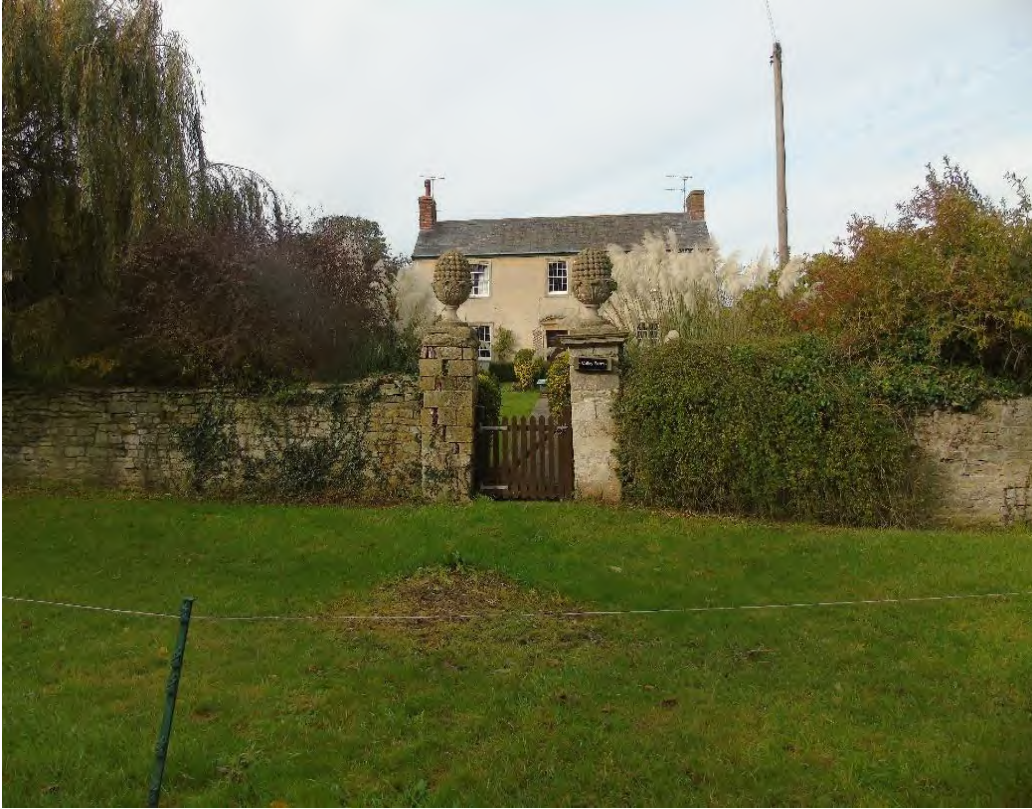
Ref.:OLV1

Condition: Pier to right hand side – in good condition but leaning to the left. Pier to the left side of entrance suffering from invasive planting jacking apart the joints with large gaps between stones and diagonal cracking. Coping to base of pineapple in poor condition. Without intervention, the weight of the pineapple finial will result in failure. Consolidation/ localised repair required to stabilise both structures.

Overall Condition: Very Bad
Priority Category: C
