A TECHNICAL ADVICE LEAFLET ABOUT

# Window Repairs

in Historic Buildings in  
South Gloucestershire

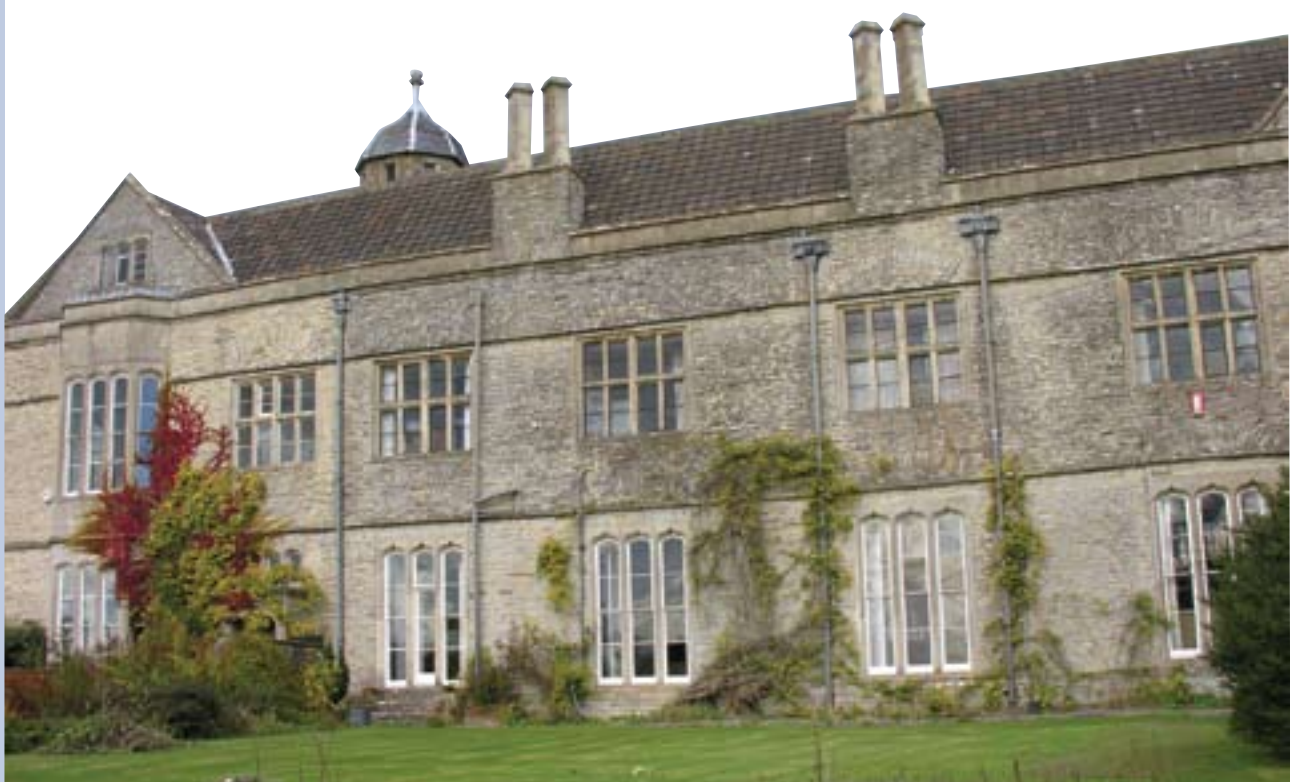
*Siston Court – The building has a variety of window patterns, which reflect the various phases of development over the centuries. Seventeenth century transom and mullion windows remain on the first floor, whereas the ground floor windows have been replaced with decorative sash windows in the nineteenth century.*

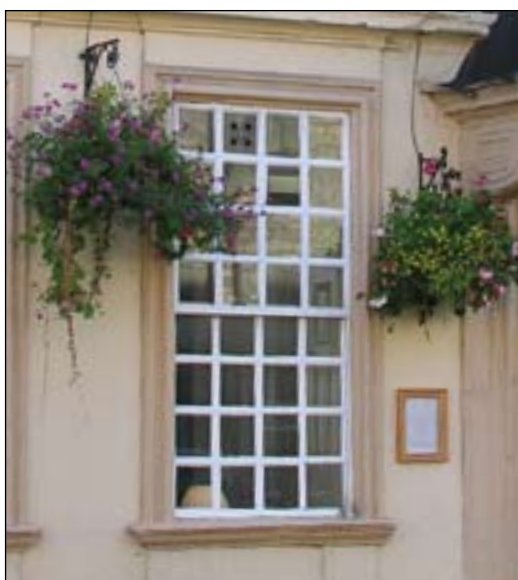
*Early sash window with small panes and wide glazing bars*

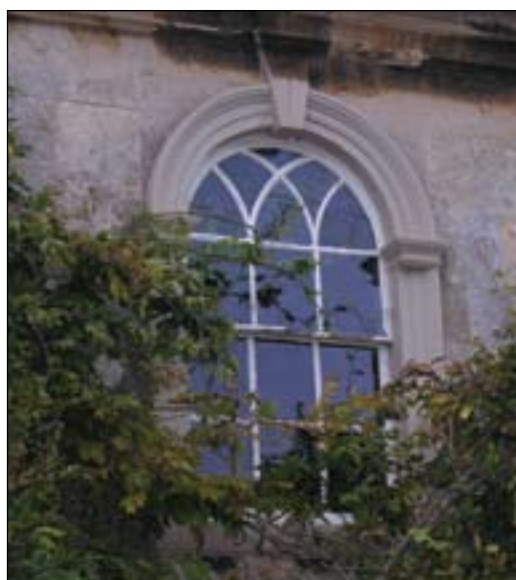
*Early nineteenth century plain arched sash window with Gothic style glazing bar decoration.*

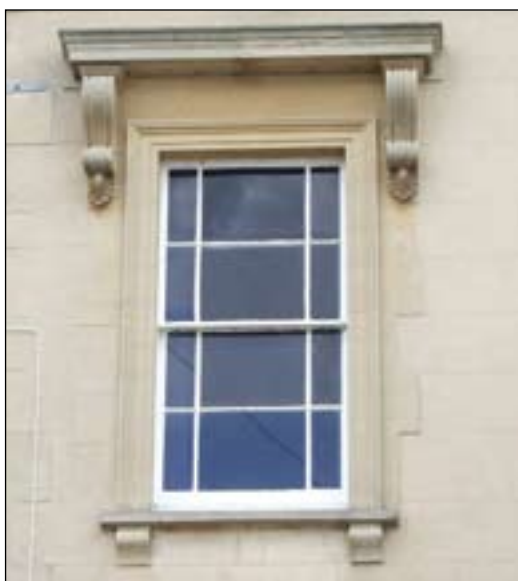
*Sash window with marginal glazing and moulded stone surround on corbels, and hoodmould on decorative brackets.*

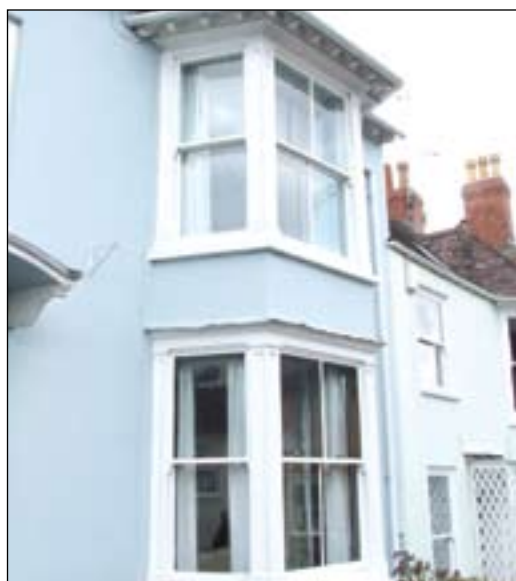
*Victorian sashes with large panes and horns.*

As glass manufacturing processes improved during the 19th century, sash windows became more varied and moved away from the small pane sashes to designs with fewer glazing bars and larger panes of glass. The introduction of heavier plate glass made it necessary to strengthen the sashes and as a result 'horns' started appearing on the lower joints of the top sashes.

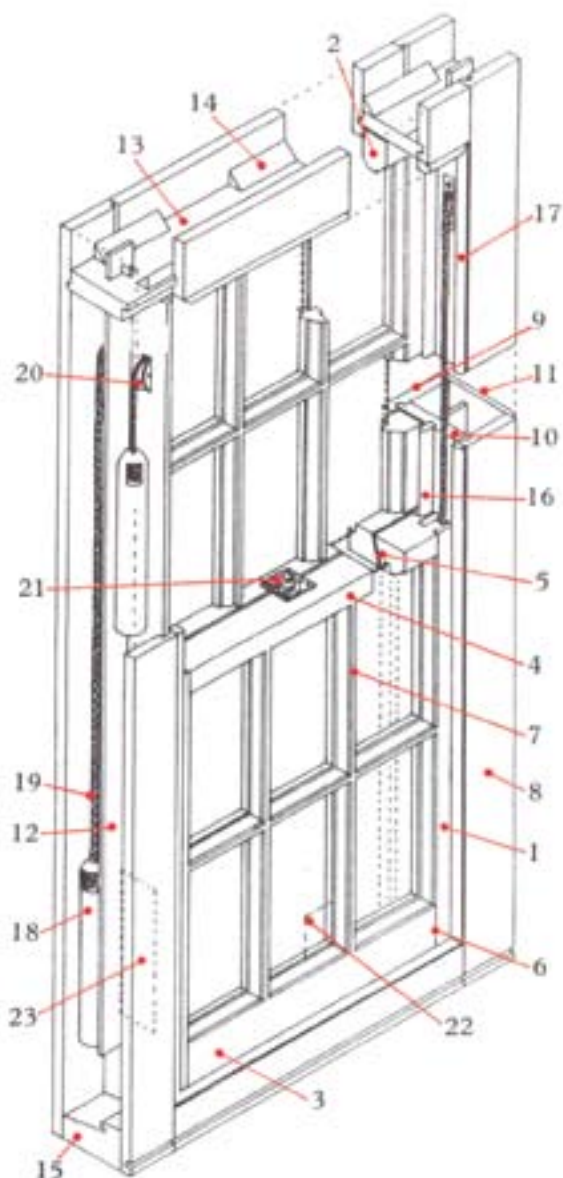
- 1 Vertical stile
- 2 Top rail
- 3 Bottom rail
- 4 Meeting rail
- 5 Bevelled face
- 6 Through mortice and tenon joint
- 7 Glazing bar
- 8 Inner lining
- 9 Outer lining
- 10 Pulley lining
- 11 Back lining
- 12 Parting slip
- 13 Soffit lining
- 14 Triangular fixing block
- 15 Cill
- 16 Parting bead
- 17 Stop bead
- 18 Counter weight
- 19 Sash cord
- 20 Pulley wheel
- 21 Sash fastener
- 22 Single sheet glazing held in place with sprigs and putty
- 23 Access pocket

© English Heritage. Detailed cross sectional diagram through a traditional timber vertical sliding sash window.

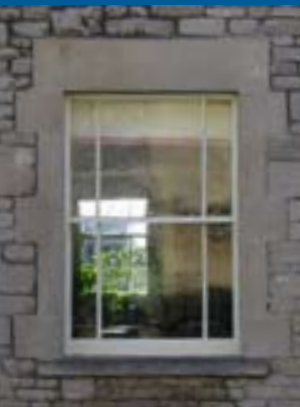
*Traditional nineteenth century timber vertical sliding sash window with marginal glazing and slender glazing bars.*

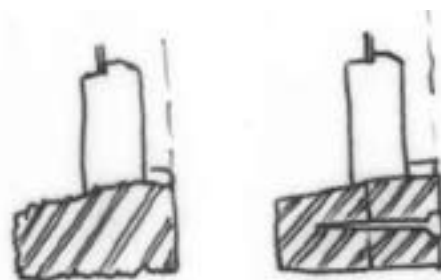
*Surface timber of cill cut away and new timber piece sliced on.*

Most window cills in the area are oak and it is unusual for the timber to decay beyond more than a surface area. The timber can usually be cut back from the surface to allow for a new section to be let in, although the form of the splicing piece will depend upon the location and extent of decay.

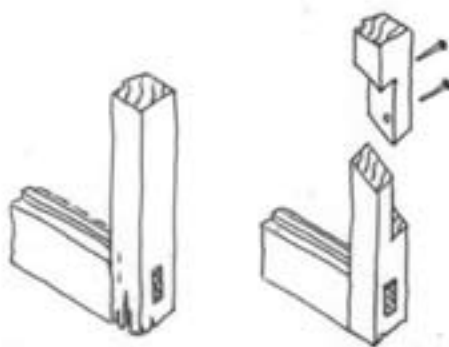
*A new section is spliced on and fixed with the joint face given minimal exposure*

Sashes can be removed from the box by releasing the staff bead and then the parting beads, ensuring that the weights do not drop to the bottom of the sash box. Each sash can then be removed for repairs. By drilling out the wedges and releasing the tenons of the sash, the stiles can be eased away to allow new sections of timber to be spliced in. This is difficult work and it is at this point that the glazing and glazing bars are most vulnerable.

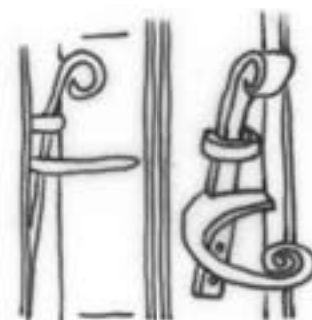
The spring catch usually had a decorative base plate which was fixed to the iron casement, on which was a horizontal bar with bent end which could pivot up and be received by a small iron bar which was set in to the window frame in order to secure the window. A variant on this design was a vertical spring catch known as the Woodman catch.

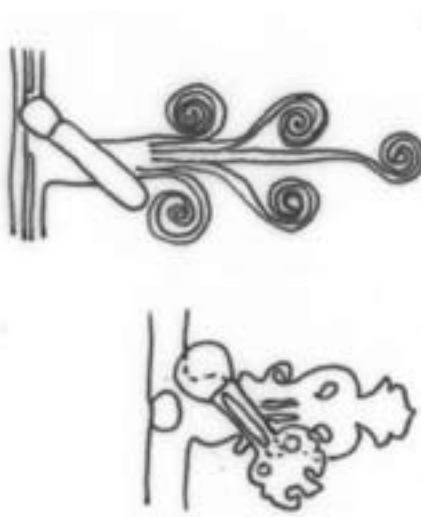
The turnbuckle catch was used commonly on casement windows in Gloucestershire. A decorative baseplate is attached to the metal casement in the same way, and the attached turnbuckle can swivel and fasten either behind the fixed metal frame of the window if the surround is stone, or if the surround is timber the metal window frame is usually omitted and the catch clipped behind a projecting metal plate. The design of the baseplate can be highly decorative, and in South Gloucestershire the double scroll and open heart design are both common.
