A TECHNICAL ADVICE LEAFLET ABOUT

Window Repairs

in Historic Buildings in South Gloucestershire

This leaflet is one of a series of non-statutory guidance notes produced by South Gloucestershire Council in support of its Local Plan policies relating to historic buildings.

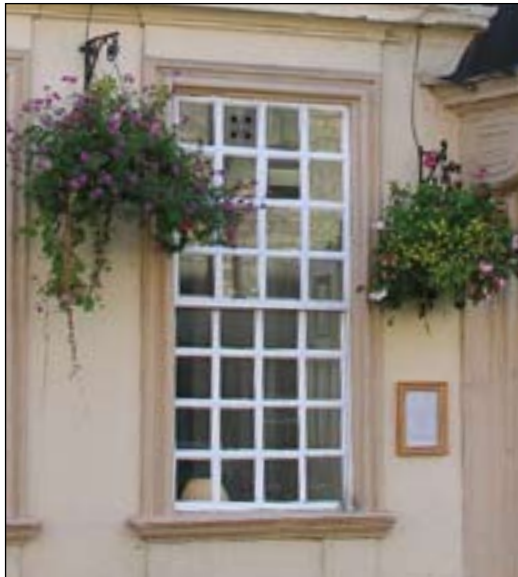
Early sash window with small panes and wide glazing bars

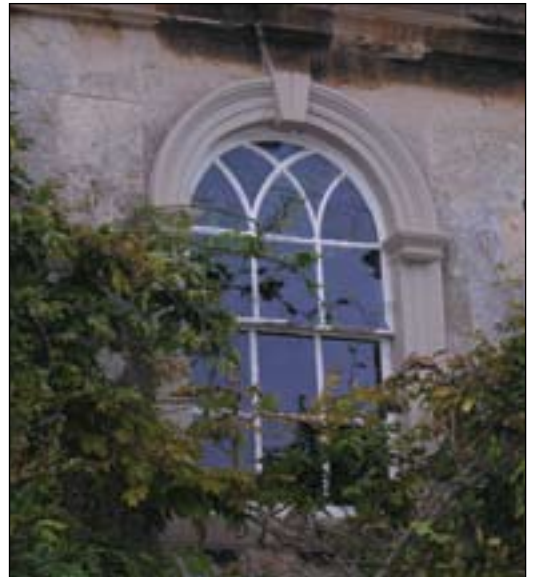
Early nineteenth century plain arched sash window with Gothic style glazing bar decoration.

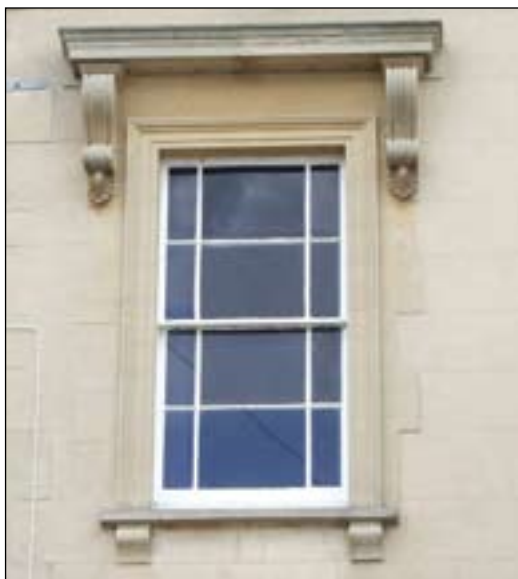
Sash window with marginal glazing and moulded stone surround on corbels, and hoodmould on decorative brackets.

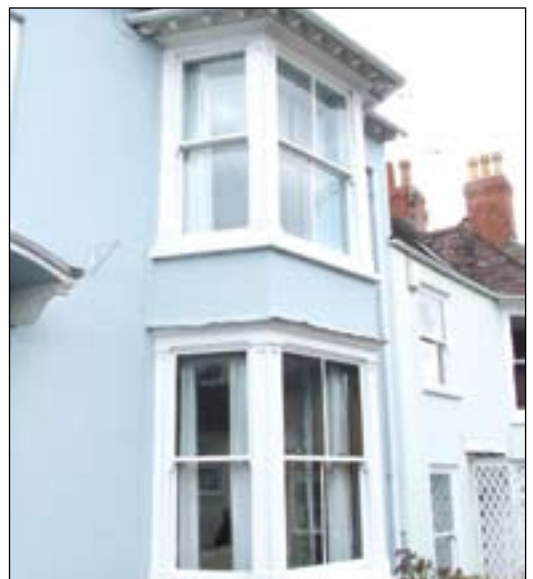
Victorian sashes with large panes and horns.

As glass manufacturing processes improved during the 19th century, sash windows became more varied and moved away from the small pane sashes to designs with fewer glazing bars and larger panes of glass. The introduction of heavier plate glass made it necessary to strengthen the sashes and as a result 'horns' started appearing on the lower joints of the top sashes.

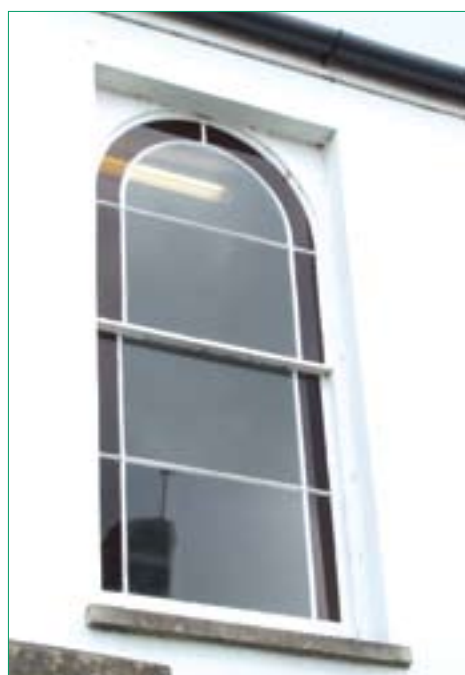
Early nineteenth century plain arched sash window with coloured marginal glazing, typical of this period of window.

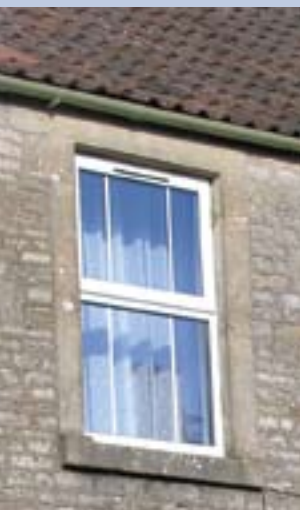
Modern top hung uPVC window with stick-on glazing bars and trickle vent, and 'storm proof' design.

Modern windows tend to be poorly detailed and heavy in appearance with the 'storm-proofed' opening 'lights' set outside the main frame, protruding cills and no or crudely detailed mouldings. Double-glazing windows are easy to spot due to their external mirror-like reflection and spacer bars. Modern materials such as uPVC, stained hardwoods, 'stick-on' lead or glazing bars only add further to the loss of character of a period building. The difference between traditionally detailed timber casement and sash windows, and modern uPVC alternatives, can be seen in the images on this page.

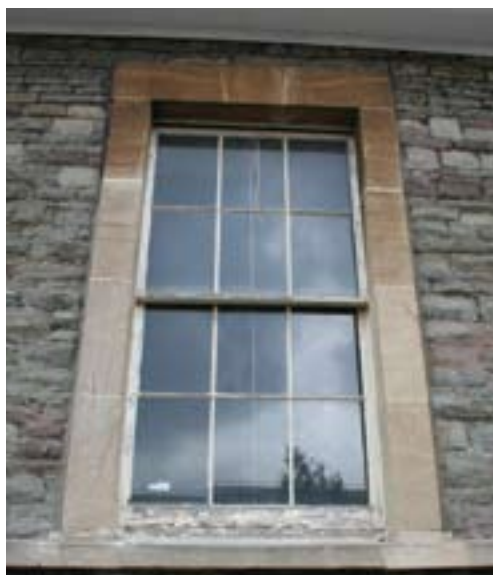
Before Repairs

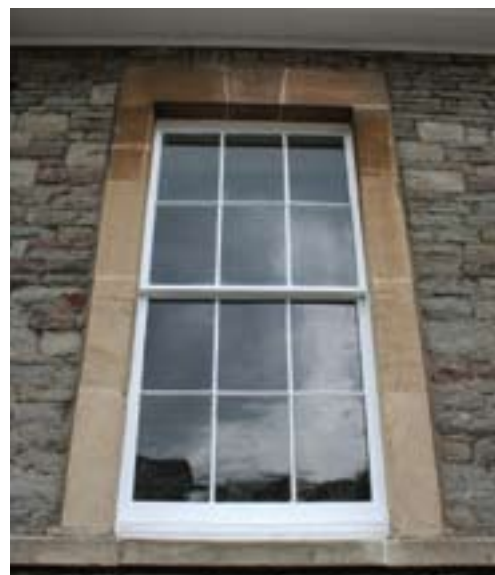
After Repairs

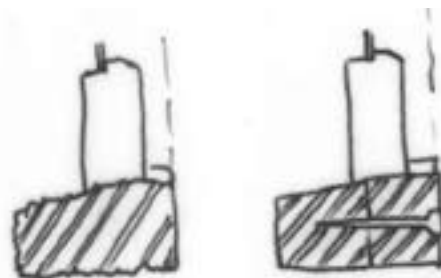
Surface timber of cill cut away and new timber piece sliced on.

Most window cills in the area are oak and it is unusual for the timber to decay beyond more than a surface area. The timber can usually be cut back from the surface to allow for a new section to be let in, although the form of the splicing piece will depend upon the location and extent of decay.

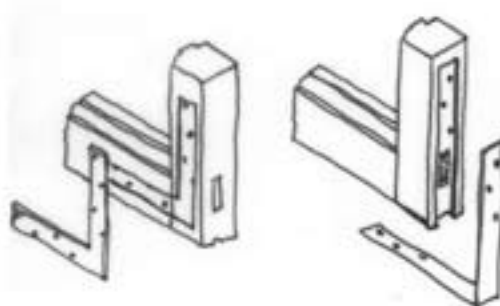
If the bottom rail has dropped it may be possible to secure it by use of L-plates attached to the sash or casement surface. If the decay is extensive it may be necessary to replace the bottom rail and splice in new sections to the stiles. The new bottom rail should be profiled to match the original exactly. Remember to use rust-resistant fixings.

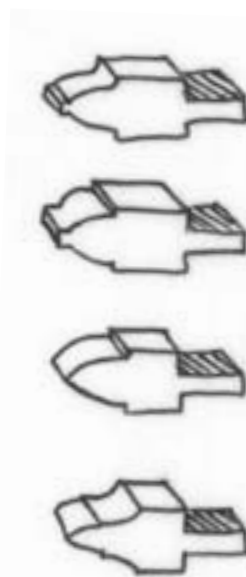
Glazing bars vary in design through the area. They can be as fine as 14 or 16mm with profiles like lamb's tongue, ovolo or ogee. It is very important to the building's character and appearance to match the glazing bar details exactly, and not to accept a 25mm standard ogee bar to replace a much finer one, for example.

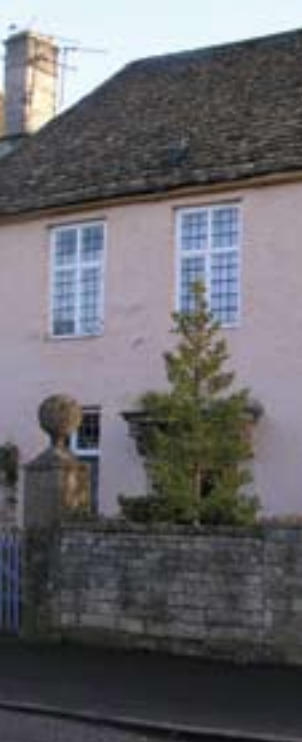
Traditional buildings rely on good ventilation and the ability for moisture to be transferred by evaporation through the wall surface and via working flues. It is advisable to provide lockable window stays to allow windows to be fixed ajar in order to provide background ventilation without harm to the character of the building. Trickle vents should never be incorporated into historic windows.
